Addendum No.: 5  
Solicitation No.: 24-TA004989DJ  
Project No.: 6109670  
Solicitation Title: LMWTP Sedimentation Basin C Sludge Collection Upgrade  
Addendum Date: January 11, 2024  
Procurement Contact: Dave Janney, Procurement Agent III

# STRUCTURAL CONDITION ASSESSMENT PHOTOS

LMWTP Sedimentation Basin C  
Condition Assessment

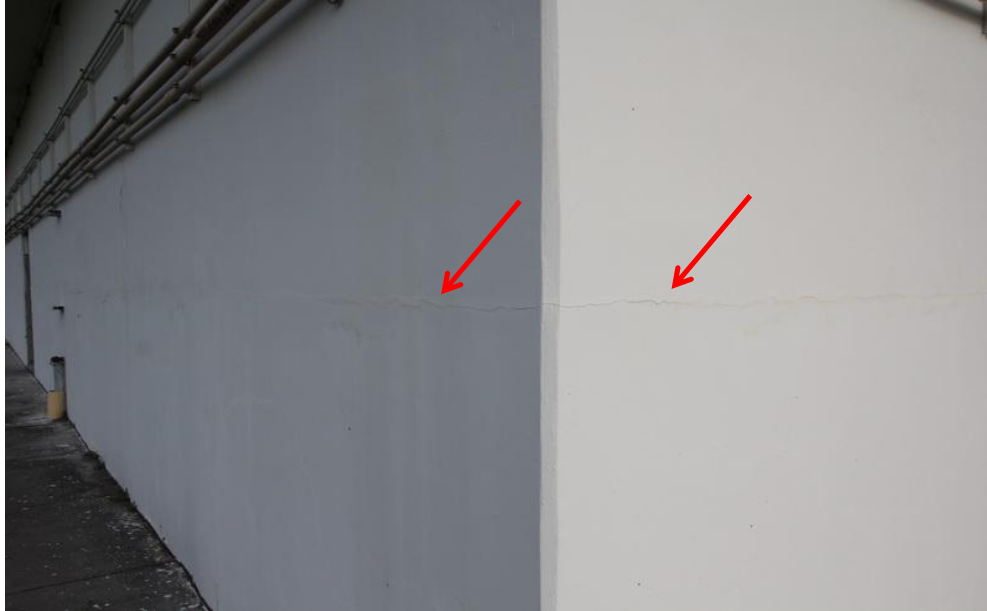
Photo No. 1

Remarks: Typical hairline width horizontal crack in the exterior face of the flocculator basin (red arrows).

Location: Southeast corner of the structure.

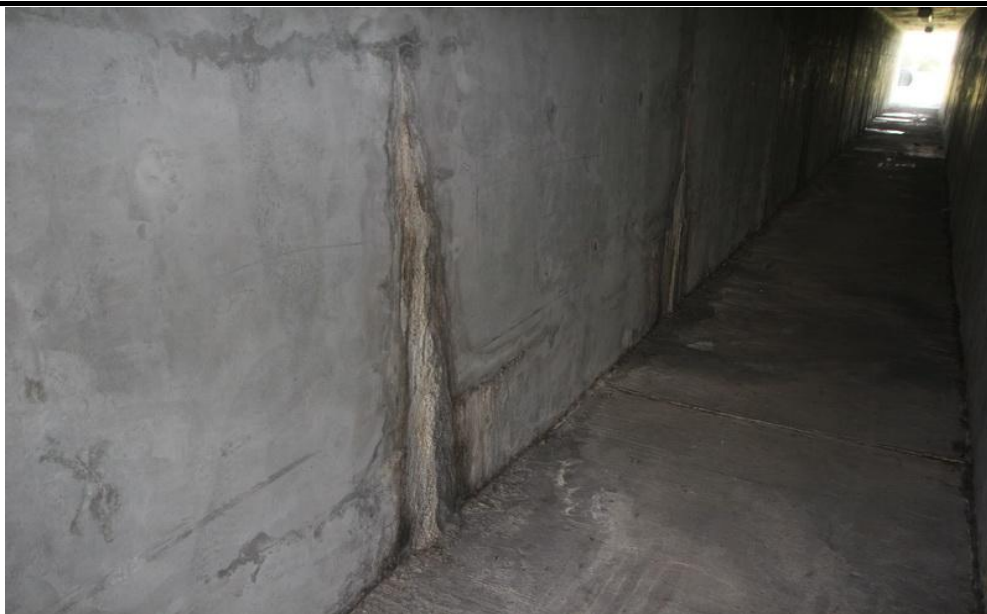
Photo No. 2

Remarks: Typical vertical hairline width cracks in the exterior face of the sedimentation basin wall with efflorescence, apparent fungal growth and dampness.

Location: East wall below the common inflow channel.

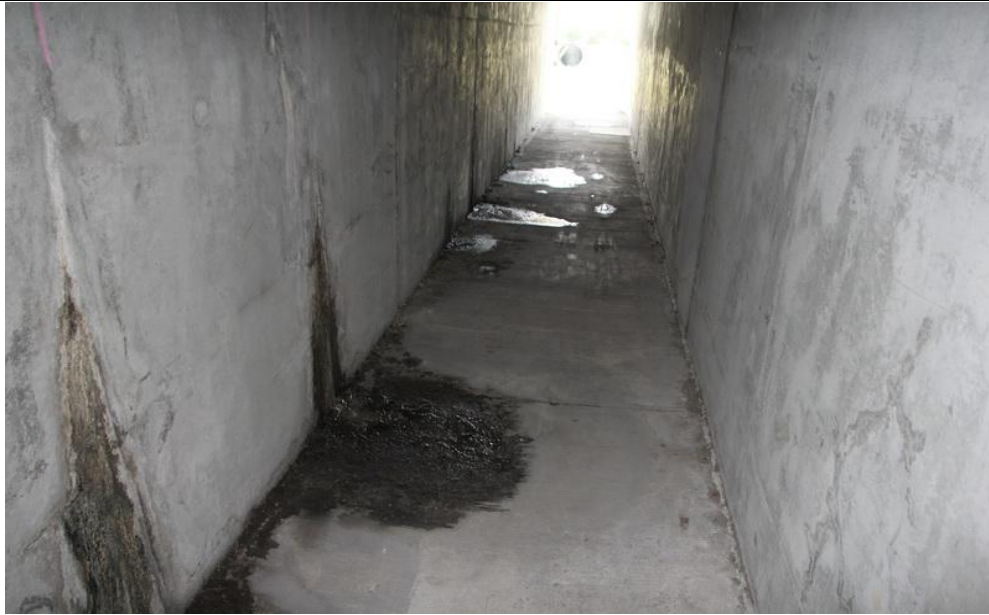
Photo No. 3

Remarks: Typical vertical hairline width cracks in the exterior face of the sedimentation basin wall with efflorescence, apparent fungal growth and dampness.

Location: East wall below the common inflow channel.

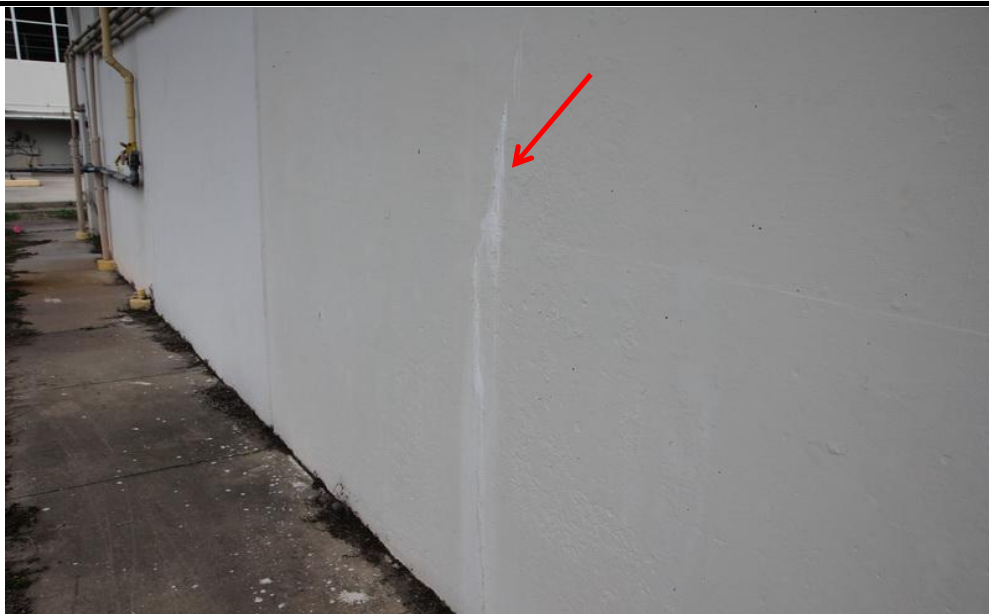
Photo No. 4

Remarks: Typical vertical hairline width crack in the exterior face of the sedimentation wall with efflorescence (red arrow).

Location: South wall.

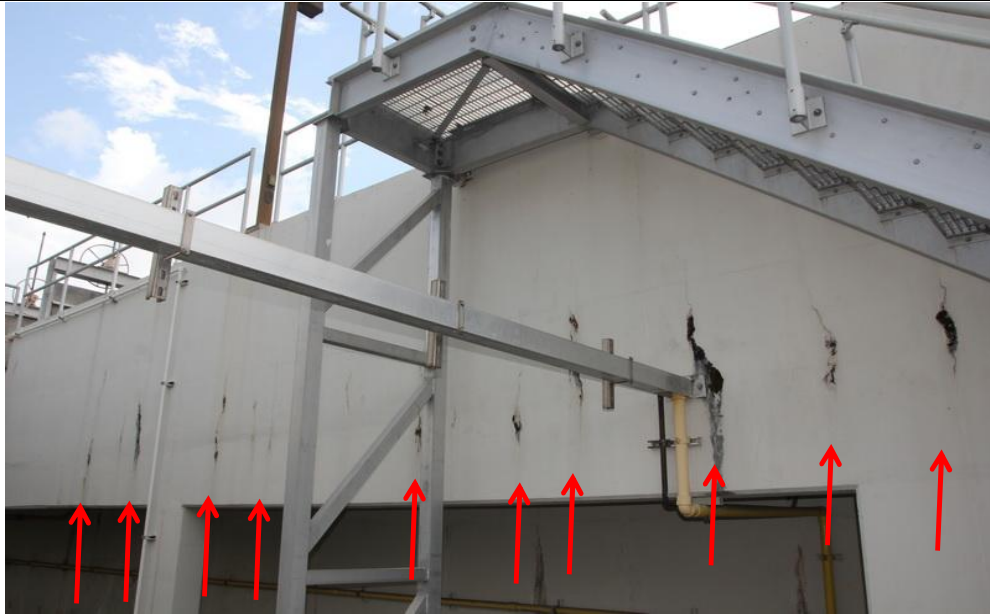
Photo No. 5

Remarks: Typical vertical cracks with efflorescence, stains and apparent fungal growth (red arrows).

Location: Western wall of the settled water collection channel.

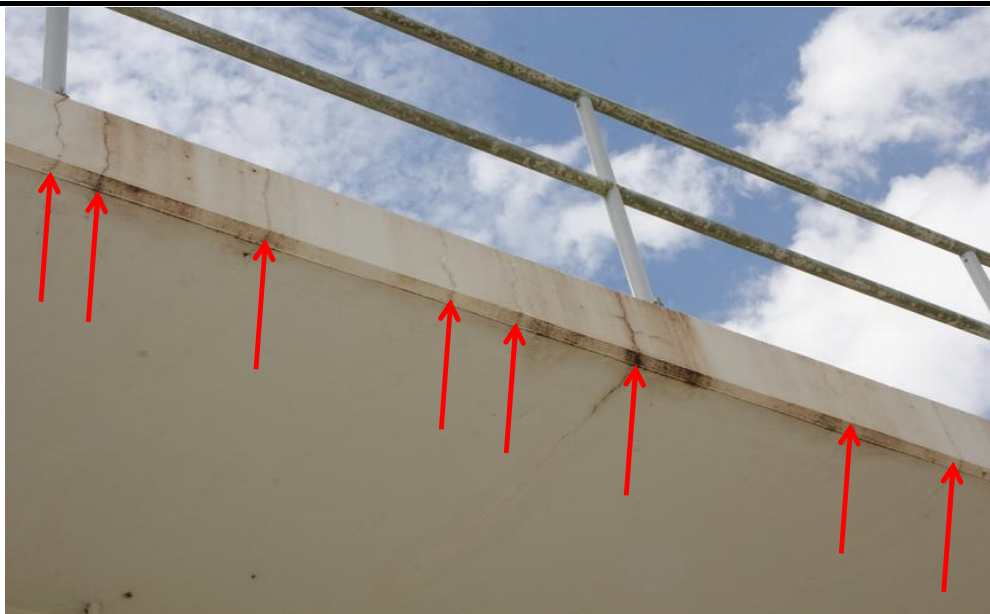
Photo No. 6

Remarks: Typical vertical cracks on the exterior face of the cantilever walkway (red arrows).

Location: Walkway near the northeast corner of the structure.

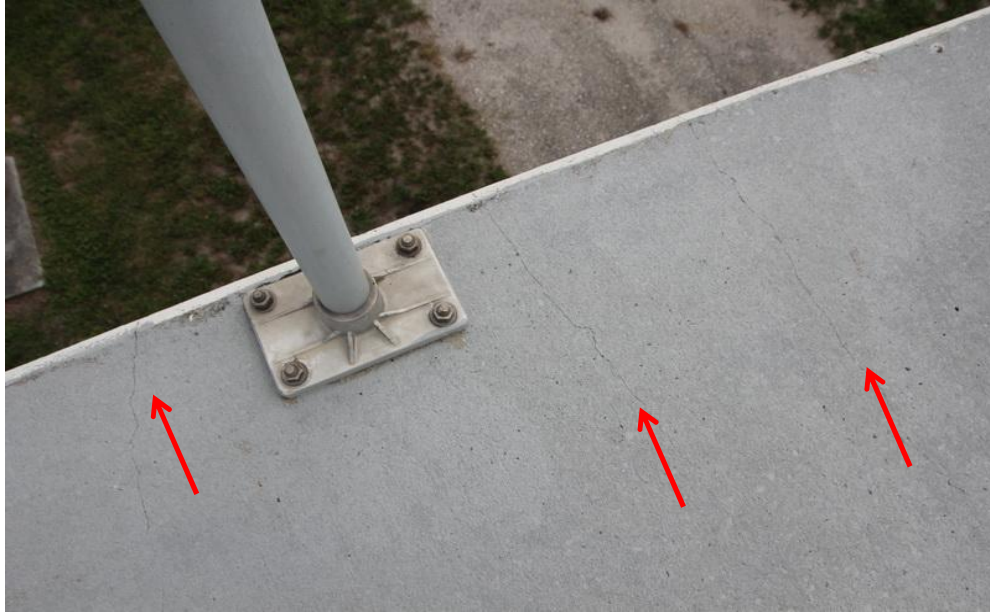
Photo No. 7

Remarks: Typical transverse cracks in the top surface of the walkway (red arrows).

Location: Walkway near the northeast corner of the structure.

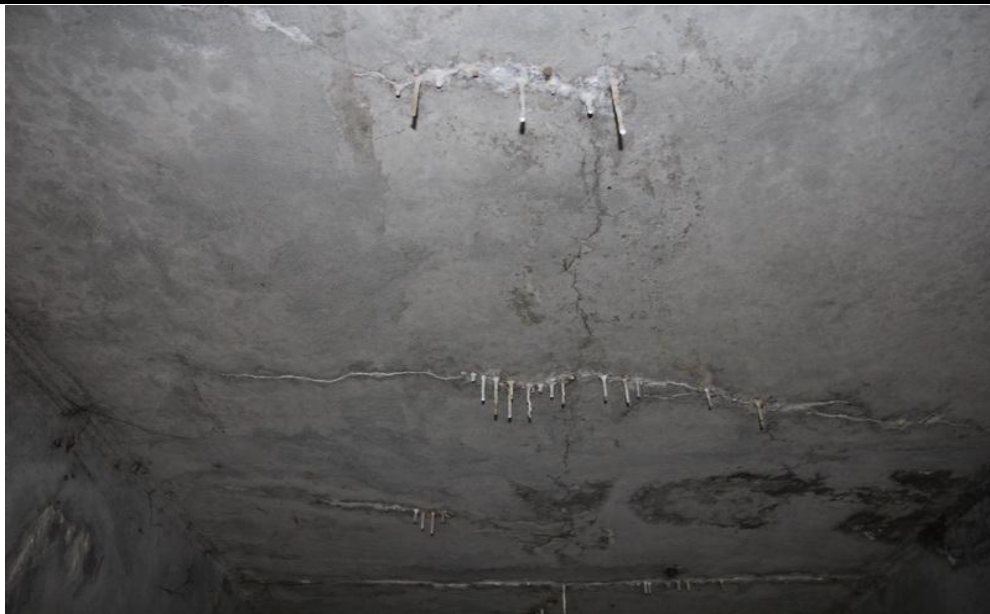
Photo No. 8

Remarks: Typical transverse cracks with efflorescence along the underside of the channel slab.

Location: Underside of the channel between the sedimentation and flocculator basins.

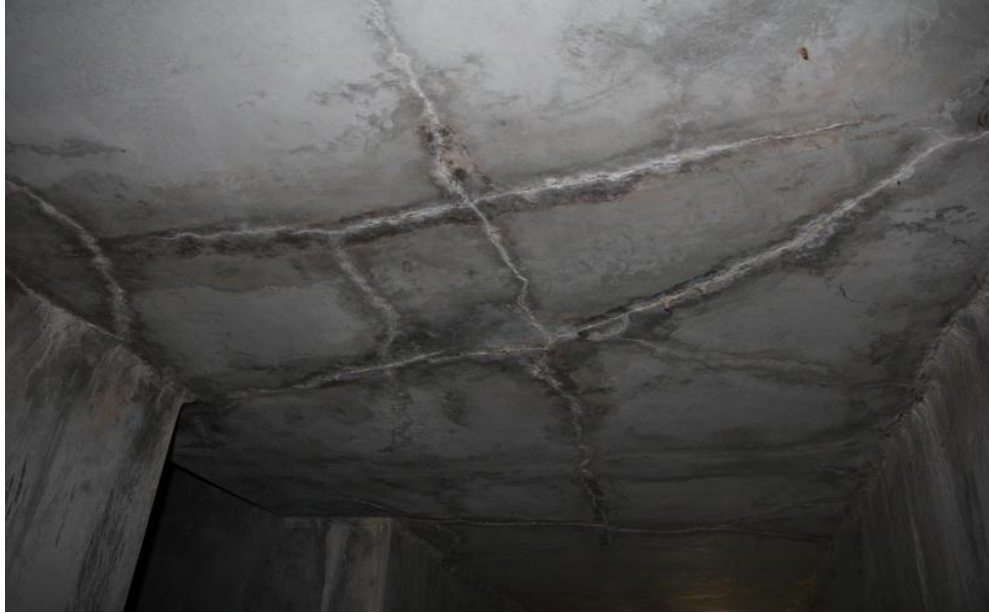
Photo No. 9

Remarks: Closely spaced longitudinal and transverse cracks with efflorescence on the underside of the channel slab.

Location: Underside of the channel at the intersection of the north and south sedimentation and flocculator basins.

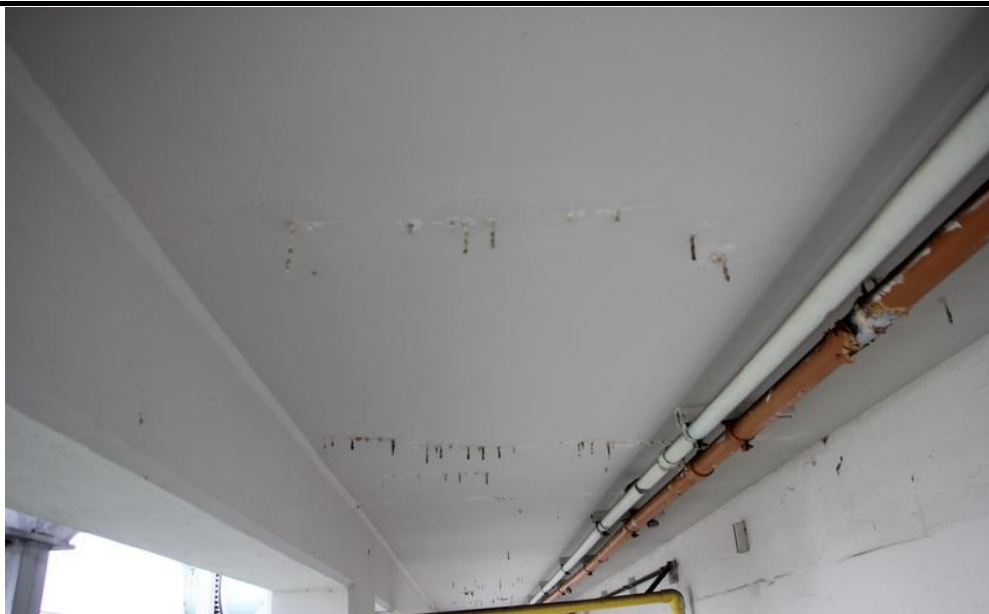
Photo No. 10

Remarks: Typical transverse cracks with efflorescence along the underside of the channel slab.

Location: Underside of the settled water collection channel at the western end of the structure.

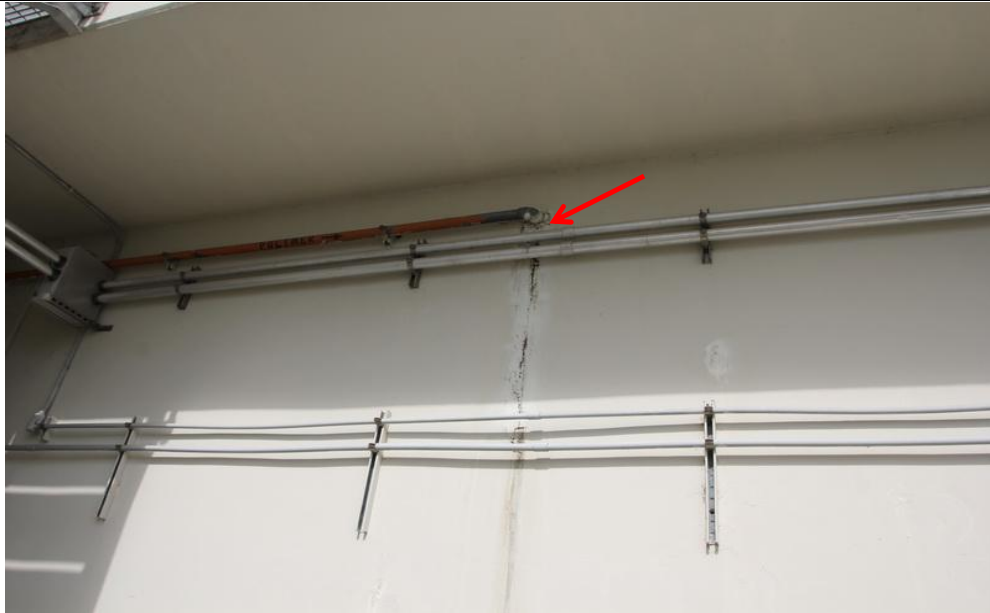
Photo No. 11

Remarks: Efflorescence and apparent fungal growth extended from a pipe penetration (red arrow).

Location: North side of the eastern wall of the flocculator basins.

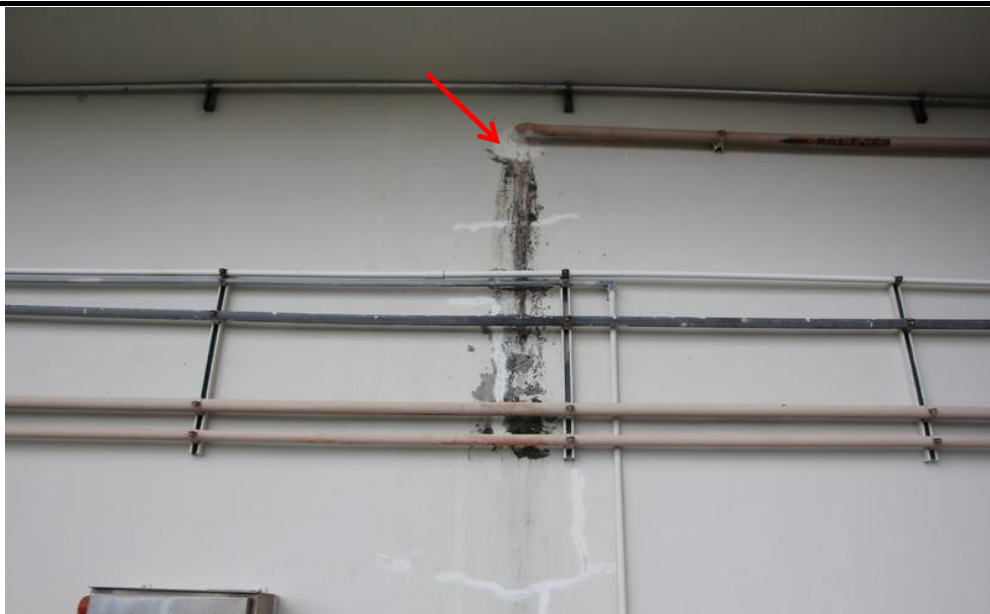
Photo No. 12

Remarks: Efflorescence and apparent fungal growth extended from a pipe penetration (red arrow).

Location: South side of the eastern wall of the flocculator basins.

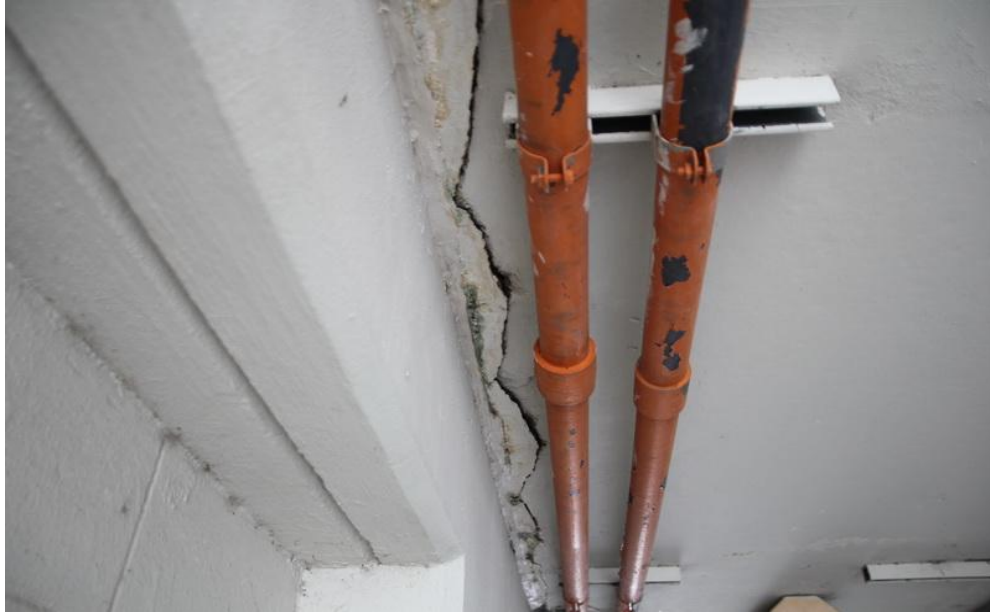
Photo No. 13

Remarks: 4" wide incipient spall with stains.

Location: Underside of the eastern channel at the intersection with the lime building.

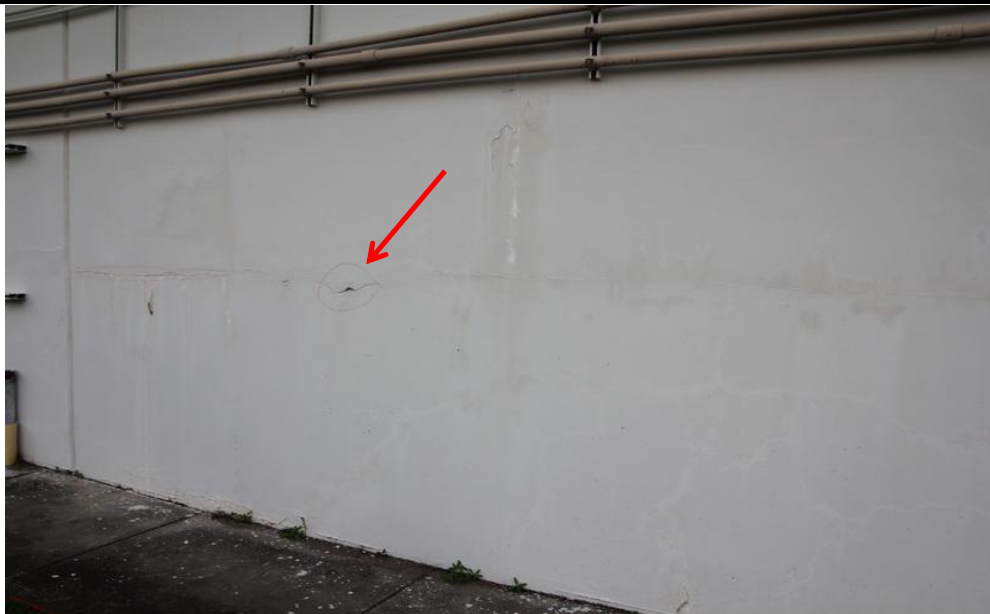
Photo No. 14

Remarks: Apparent 4" diameter failed patch (red arrow).

Location: South wall of structure (refer to Mark A of Figure 13).

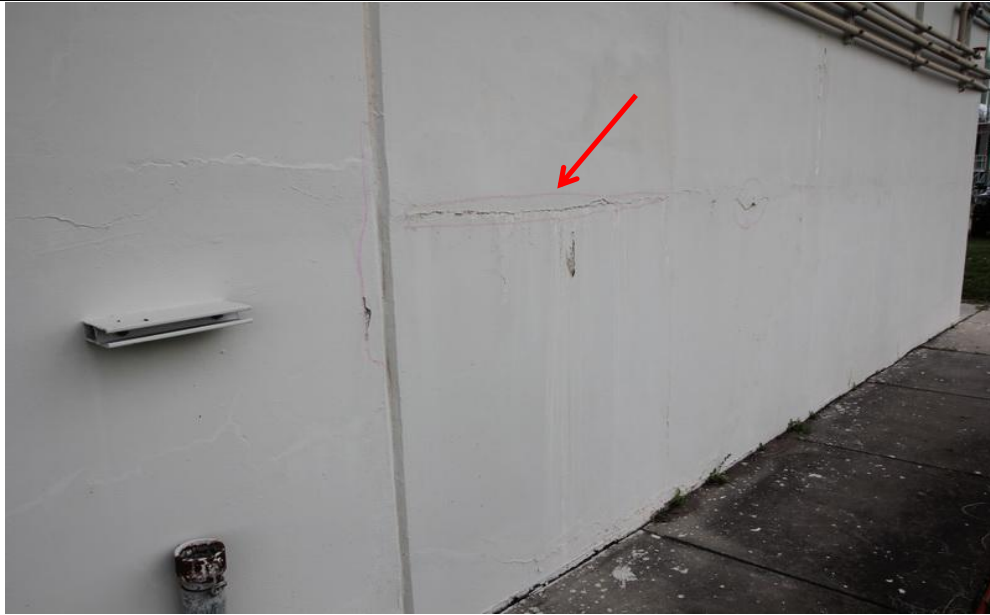
Photo No. 15

Remarks: 28"x3" area of delaminated concrete along the edge of a joint (red arrow).

Location: South wall of structure (refer to Mark B of Figure 13).

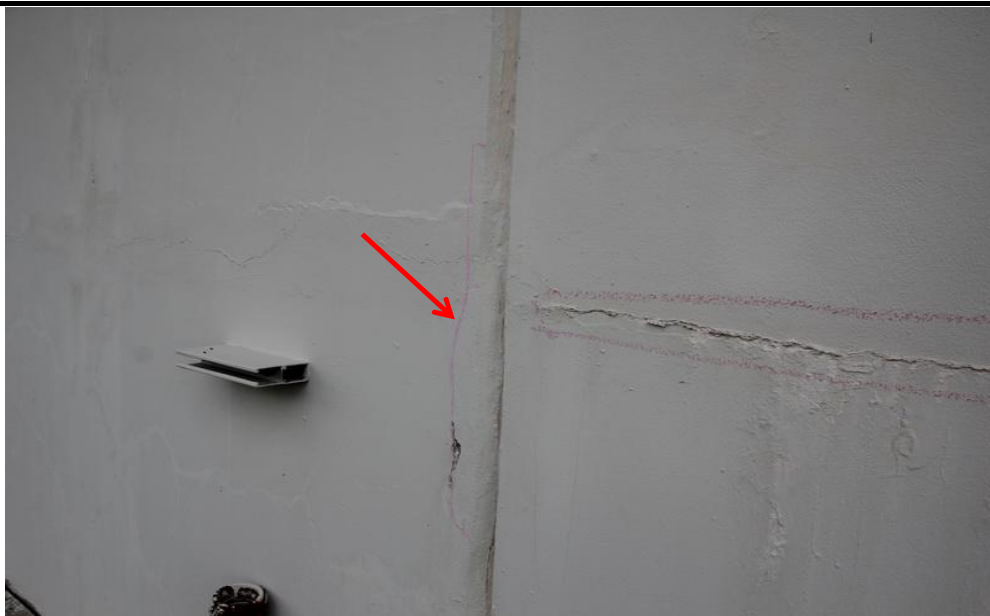
Photo No. 16

Remarks: 18"x5" area of delaminated concrete (red arrow).

Location: South wall of structure (refer to Mark C of Figure 13).

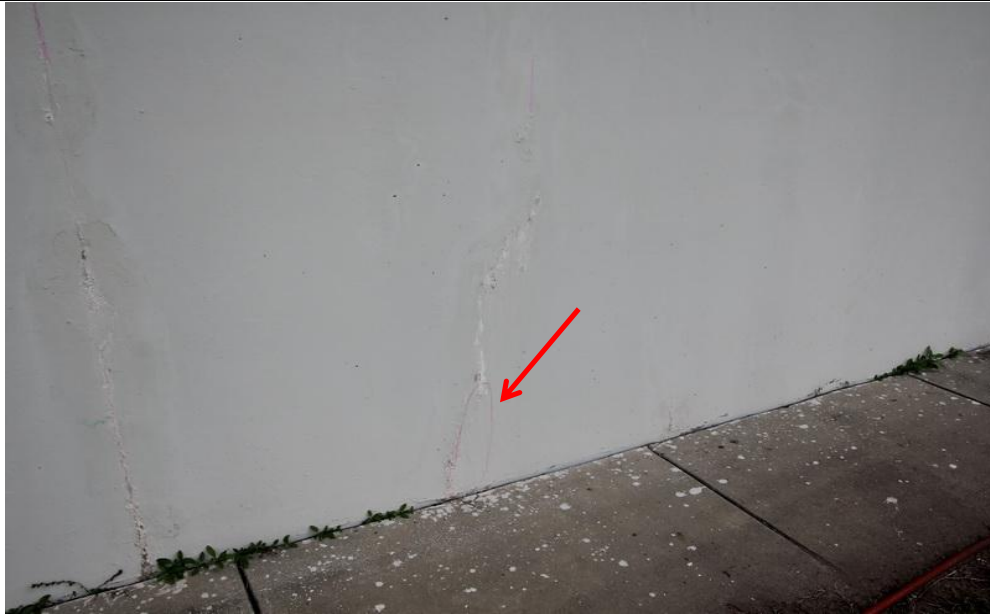
Photo No. 17

Remarks: 32"x2" area of delaminated concrete (red arrow).

Location: South wall of structure (refer to Mark D of Figure 13).

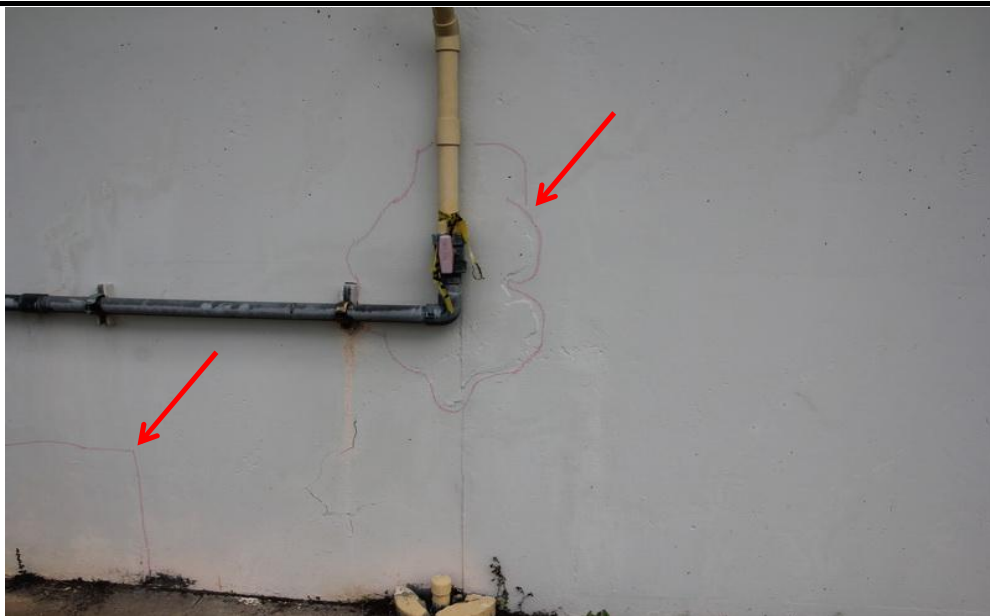
Photo No. 18

Remarks: Two 24"x36" areas of delaminated concrete (red arrows).

Location: South wall of structure (refer to Mark E and F of Figure 13).

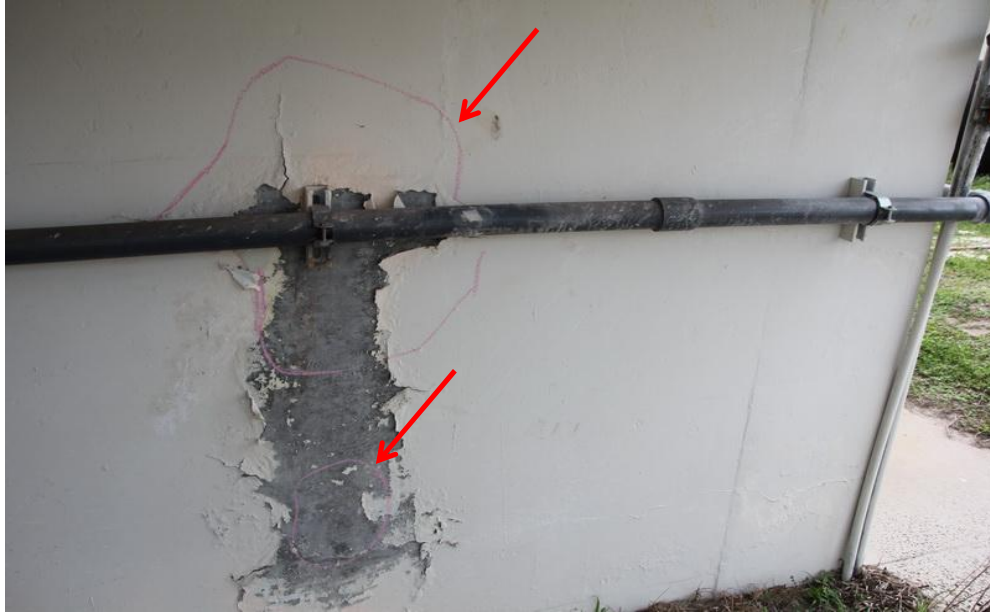
Photo No. 19

Remarks: 18"x24" and 8"x10" areas of delaminated concrete (red arrows).

Location: West wall of structure (refer to Mark G of Figure 13).

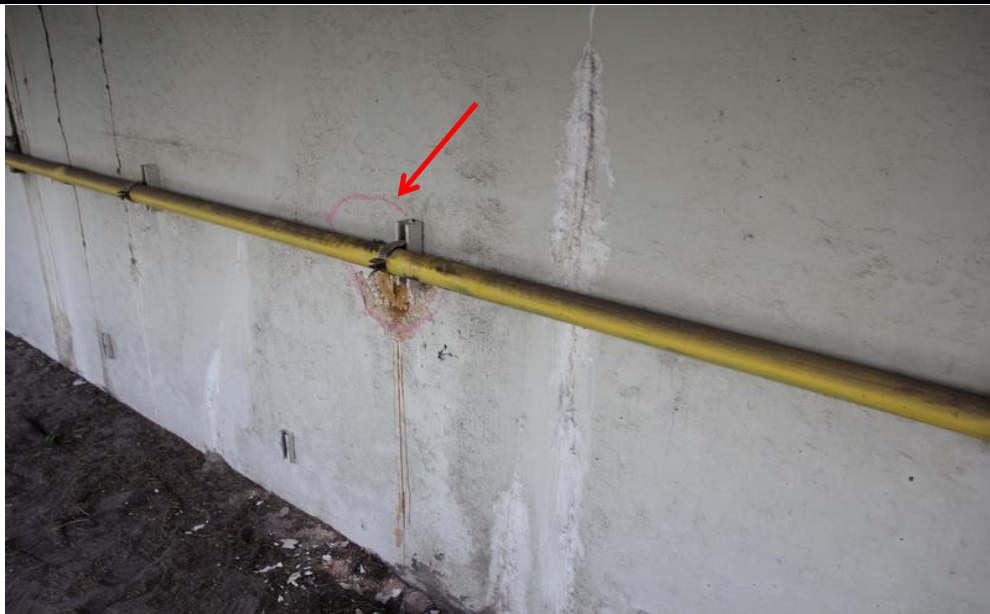
Photo No. 20

Remarks: 12" diameter area of delaminated concrete with stains (red arrow).

Location: West wall of structure (refer to Mark H of Figure 13).

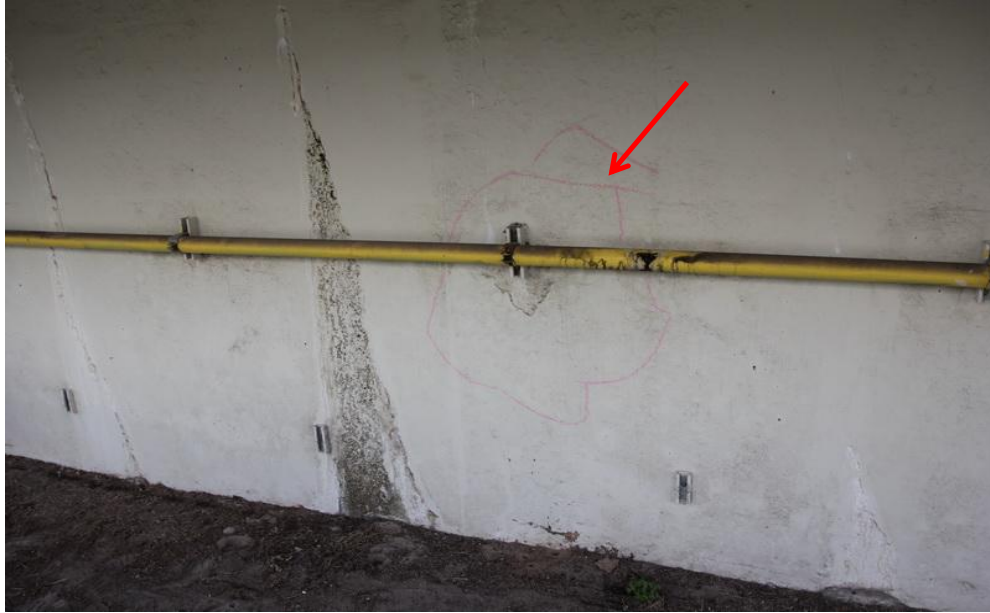
Photo No. 21

Remarks: 28"x30" area of delaminated concrete (red arrow).

Location: West wall of structure (refer to Mark I of Figure 13).

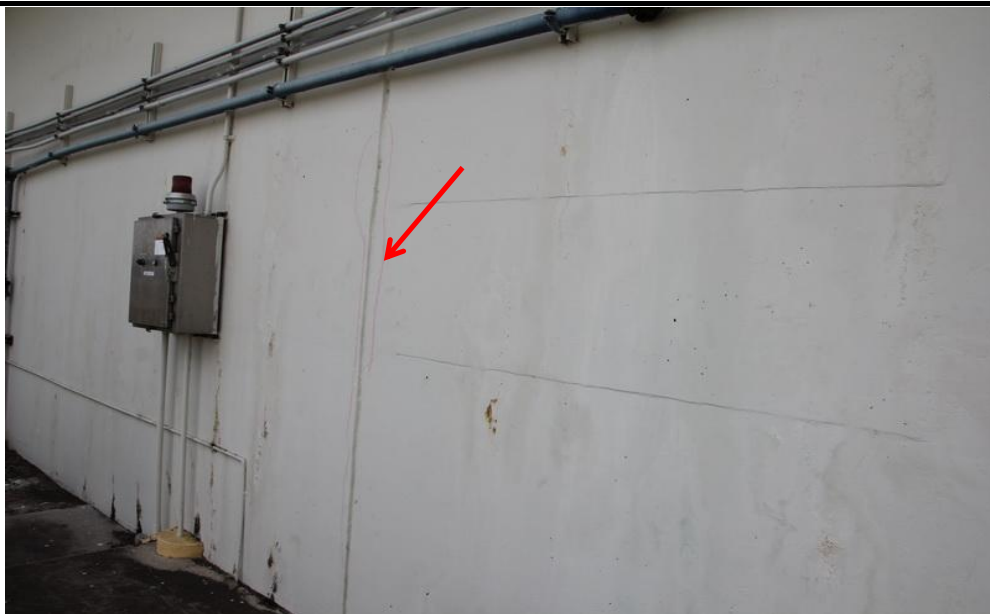
Photo No. 22

Remarks: 66"x6" area of delaminated concrete (red arrow).

Location: North wall of structure (refer to Mark J of Figure 13).

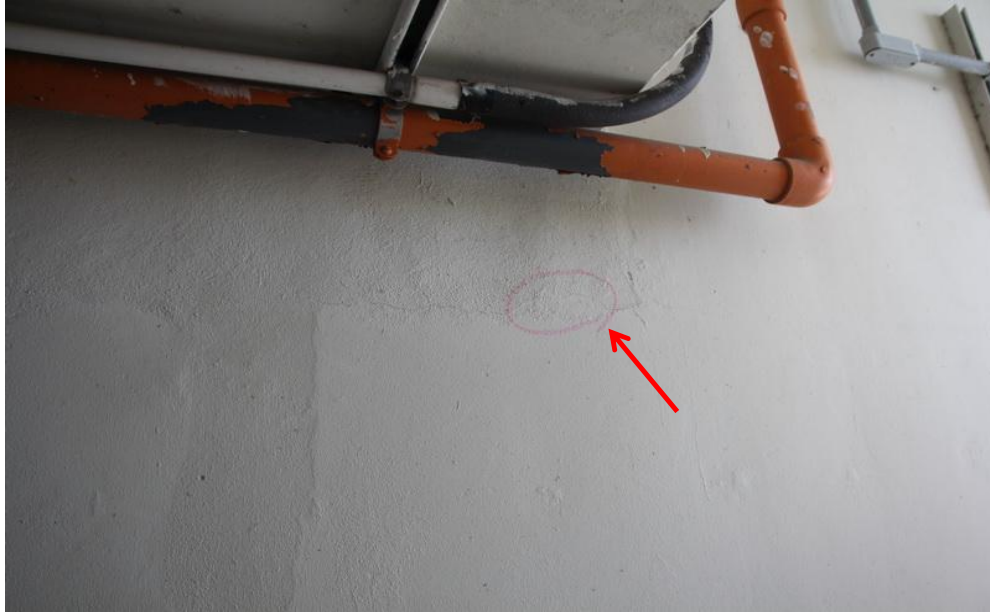
Photo No. 23

Remarks: 4" diameter apparent failed patch (red arrow).

Location: East wall of structure (refer to Mark K of Figure 13).

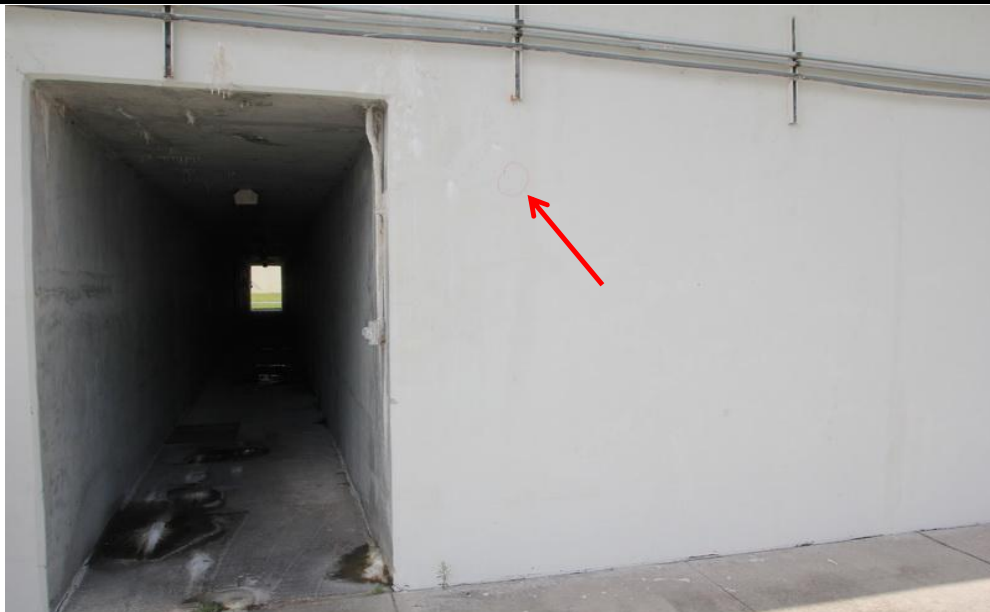
Photo No. 24

Remarks: 6" diameter area of delaminated concrete (red arrow).

Location: North wall of structure (refer to Mark M of Figure 13).

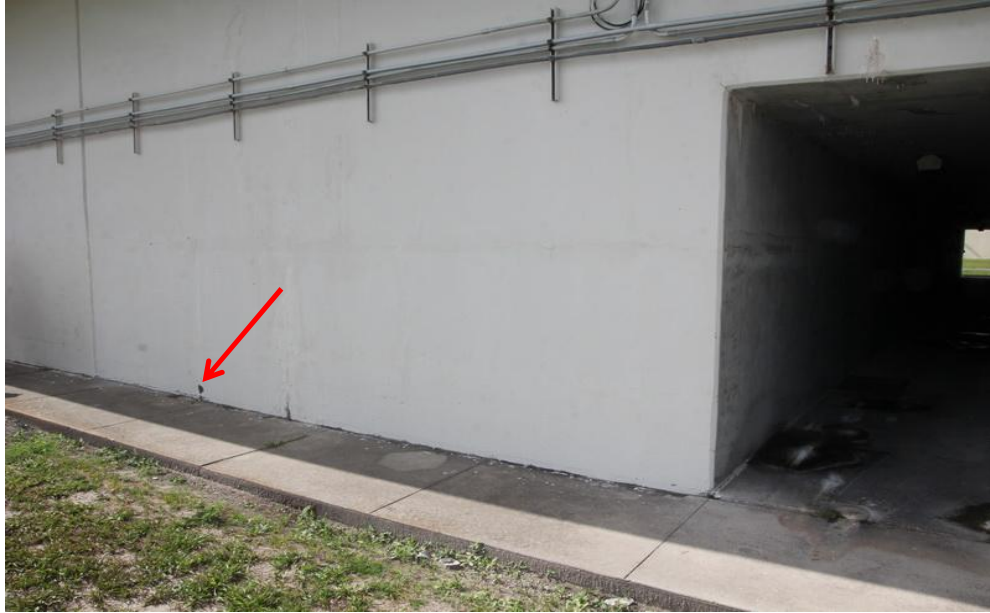
Photo No. 25

Remarks: 3" diameter spall with exposed corroded reinforcement (red arrow).

Location: North wall near the eastern end (refer to Mark N of Figure 13).

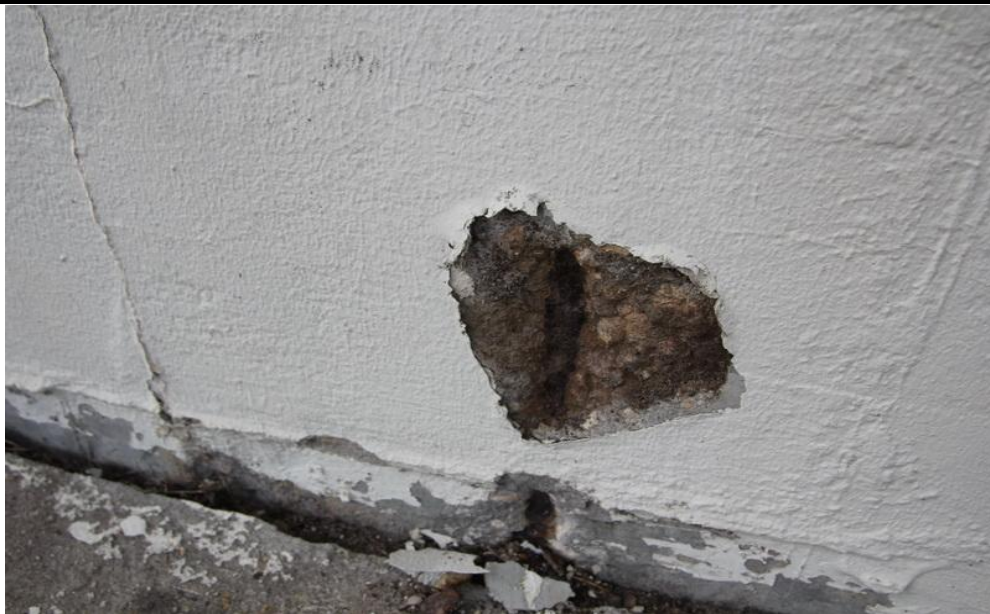
Photo No. 26

Remarks: Close up view of Photograph 25.

Location: North wall near the eastern end (refer to Mark N of Figure 13).

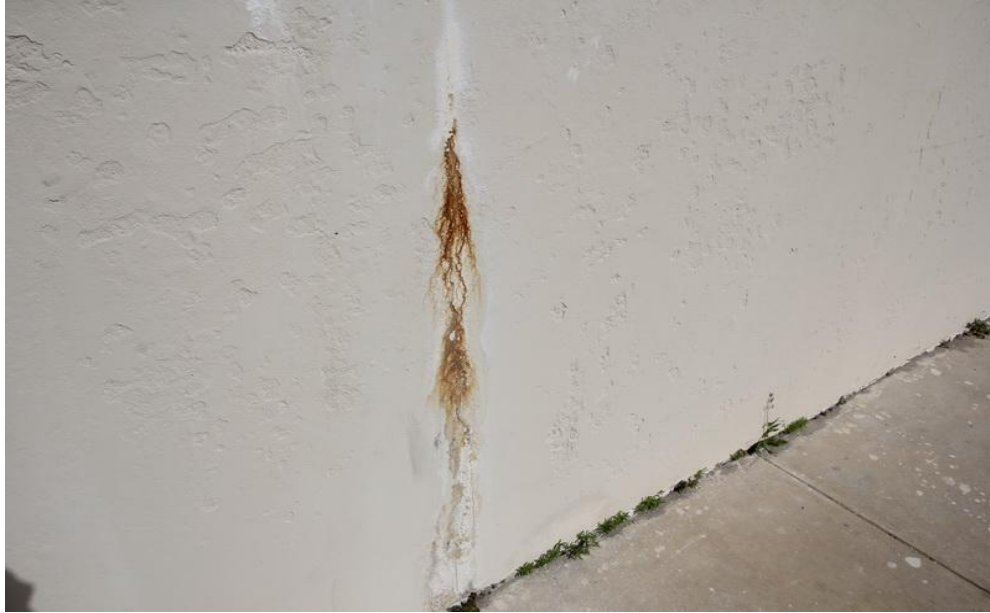
Photo No. 27

Remarks: Typical vertical crack in exterior of wall with stains consistent with corrosion.

Location: North wall shown (refer to Mark O of Figure 13).

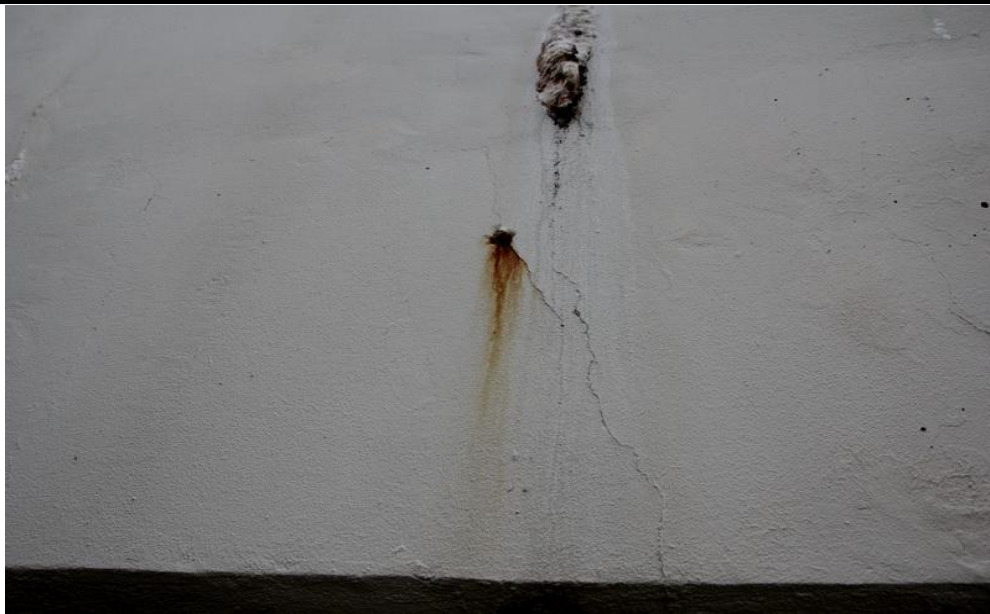
Photo No. 28

Remarks: Isolated corrosion stain in the wall surface.

Location: West wall of the structure (refer to Mark P of Figure 13).

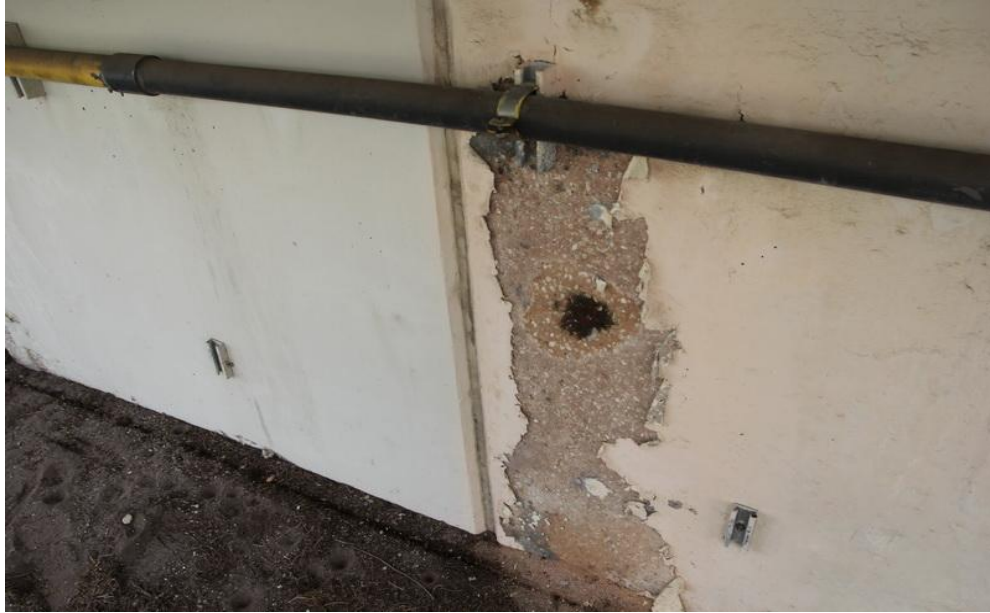
Photo No. 29

Remarks: Isolated corrosion stain in the wall surface.

Location: West wall of the structure (refer to Mark P of Figure 13).

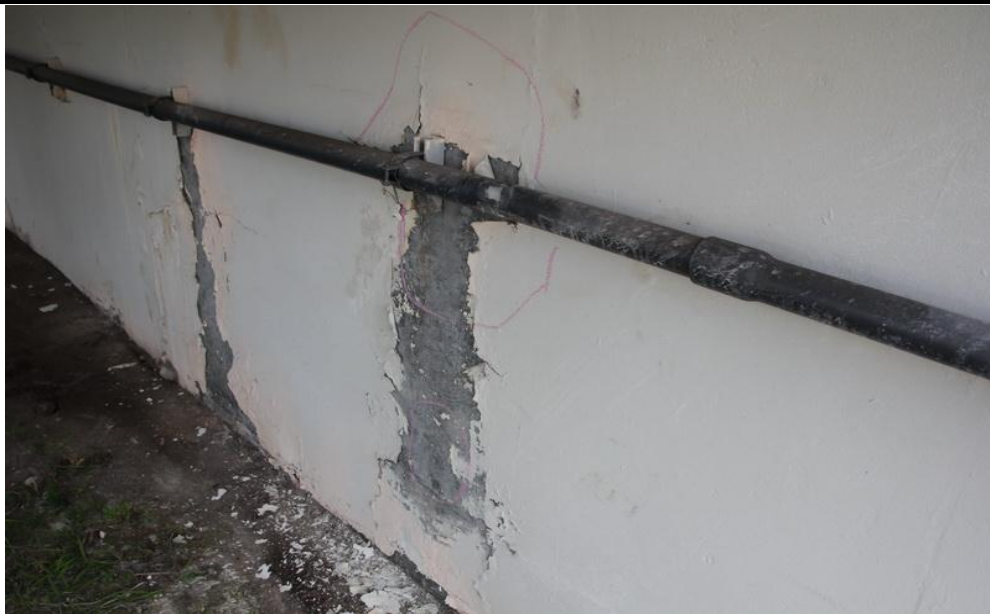
Photo No. 30

Remarks: Typical separated wall coating.

Location: West wall of the structure (refer to Mark Q of Figure 13).

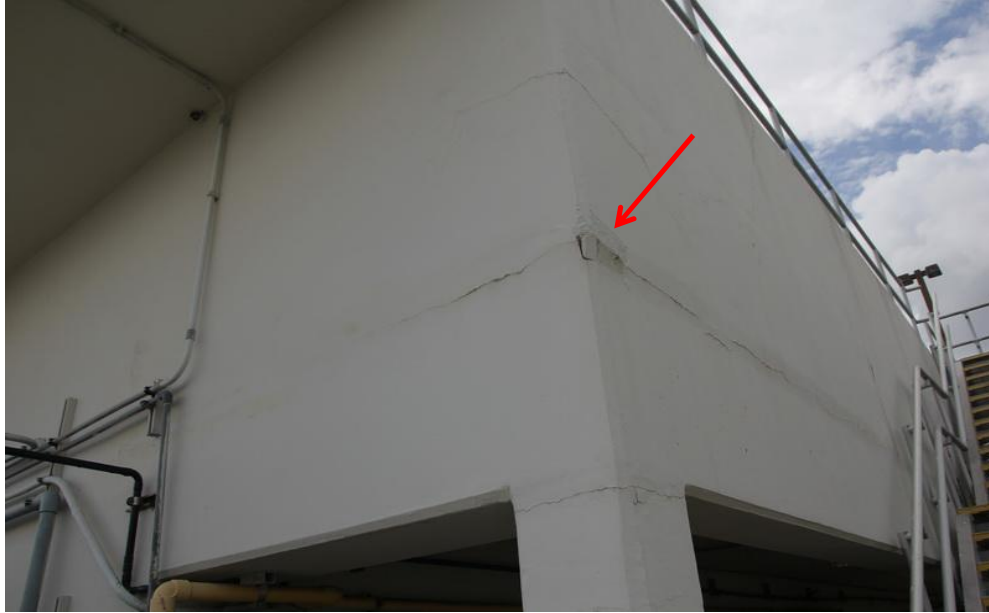
Photo No. 31

Remarks: Horizontal crack and incipient spall consistent with a construction joint at the base of the channel wall (red arrow).

Location: Northwest corner of the structure.

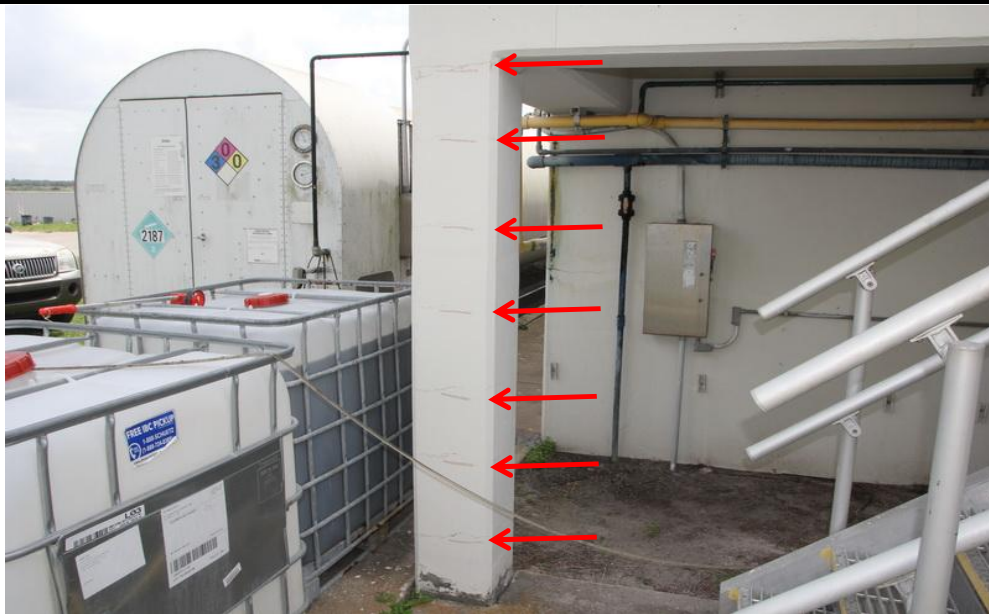
Photo No. 32

Remarks: Horizontal hairline width cracks with no stains along the height of the column. Cracks marked with chalk on column and with red arrows.

Location: Northwest column shown, southwest column similar.

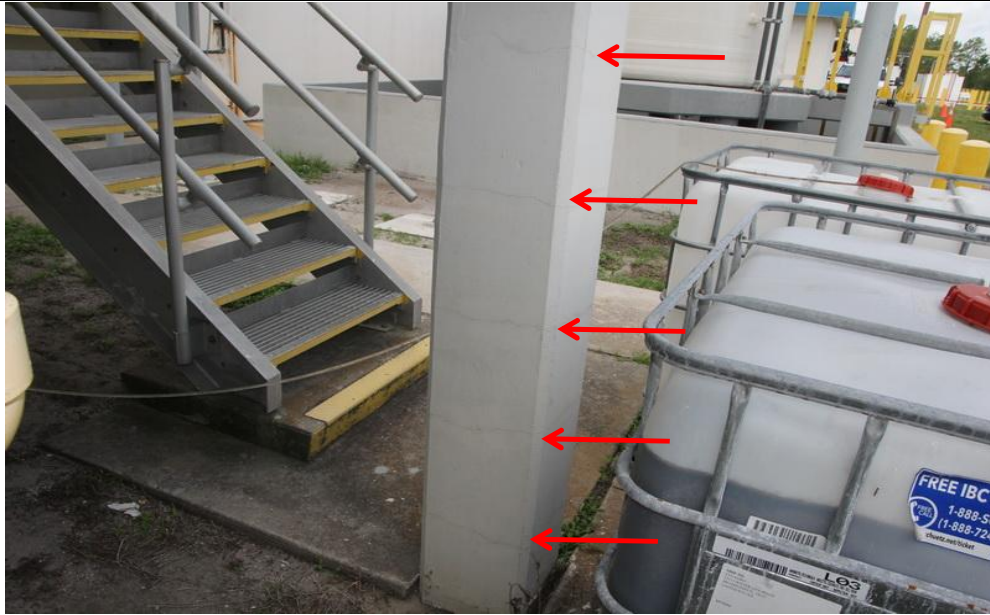
Photo No. 33

Remarks: Horizontal hairline width cracks with no stains along the height of the column (red arrows).

Location: Northwest column shown, southwest column similar.

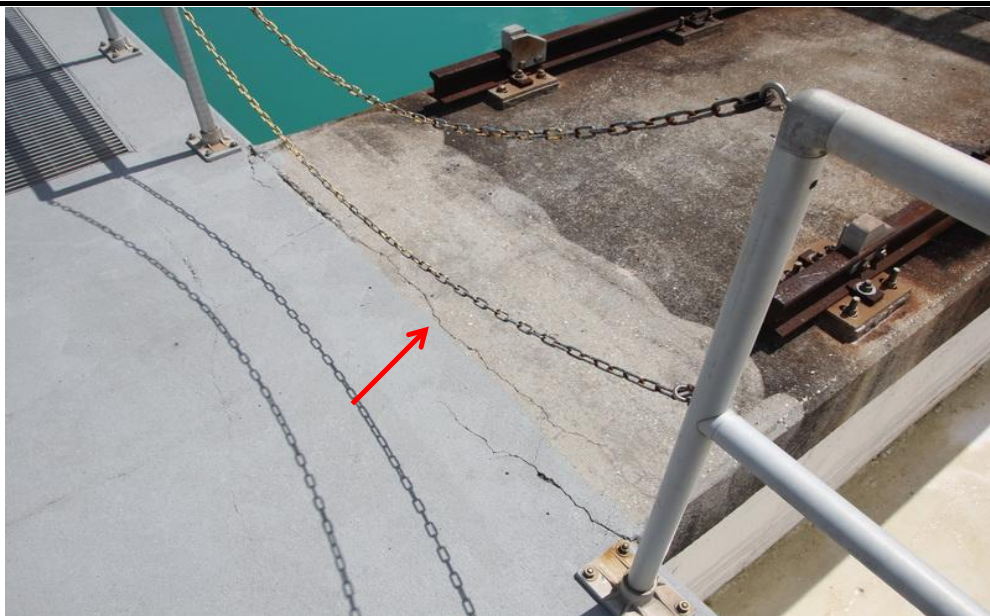
Photo No. 34

Remarks: Transverse crack consistent with a cold joint at the end of the walkway (red arrow).

Location: Southern end of the walkway over the center wall of the sedimentation basins.

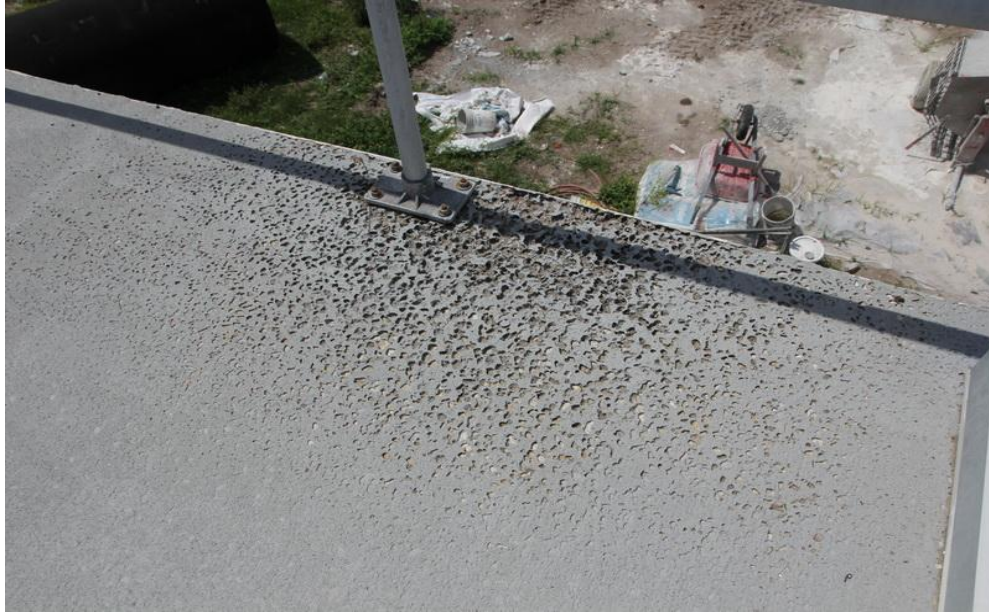
Photo No. 35

Remarks: Isolated area of significant pitting in the concrete surface of the walkway.

Location: Southwest corner of the structure.
