Addendum No.: 5  
Solicitation No.: 24-TA004989DJ  
Project No.: 6109670  
Solicitation Title: LMWTP Sedimentation Basin C Sludge Collection Upgrade  
Addendum Date: January 11, 2024  
Procurement Contact: Dave Janney, Procurement Agent III

# STRUCTURAL CONDITION ASSESSMENT PHOTOS

LMWTP Sedimentation Basin C  
Condition Assessment

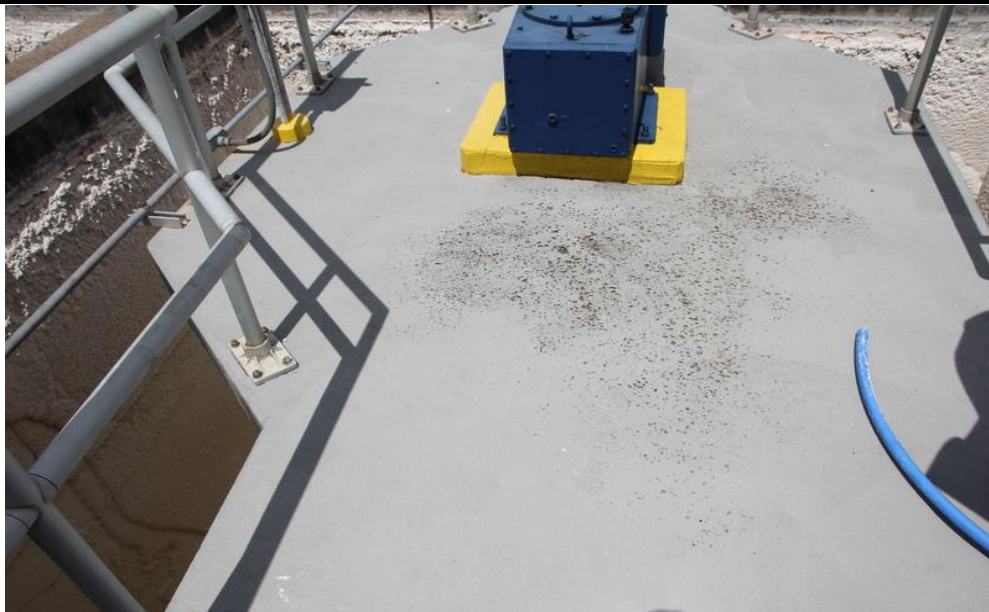
Photo No. 36

Remarks: Isolated area of significant pitting in the concrete surface of the walkway.

Location: South of the wall between the sedimentation basins at the east end.

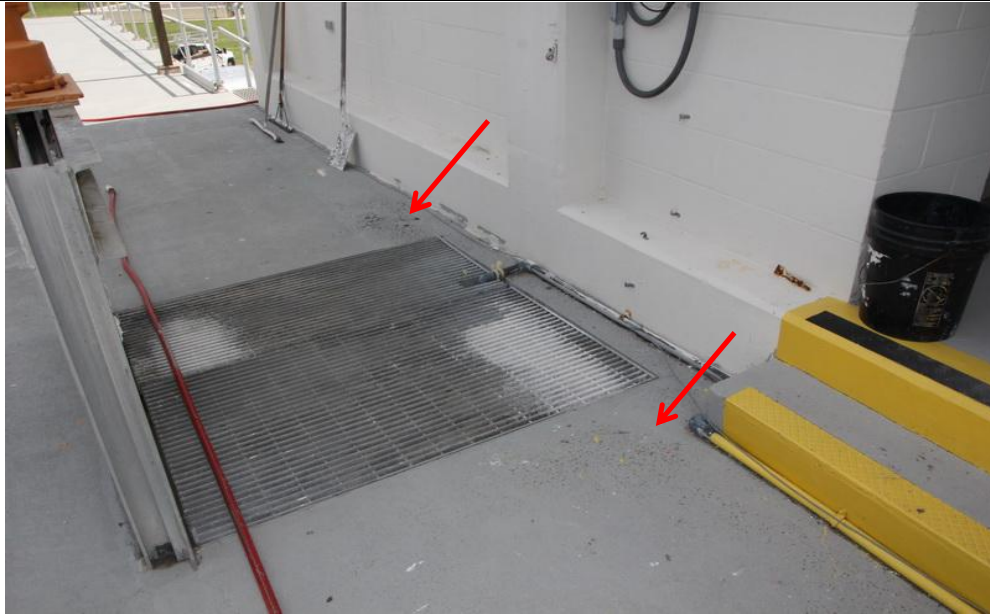
Photo No. 37

Remarks: Isolated area of significant pitting in the concrete surface of the walkway (red arrows).

Location: Adjacent to the lime building.

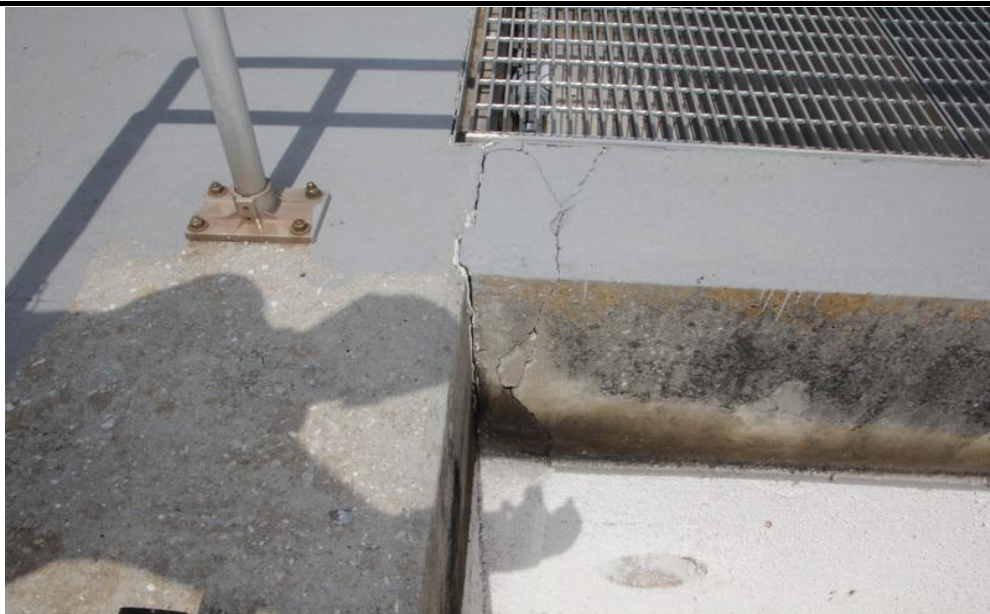
Photo No. 38

Remarks: Cracks with no stains at the end of the beam over the precast wall panel.

Location: Southern end of the beam at the western end of the southern sedimentation basin.

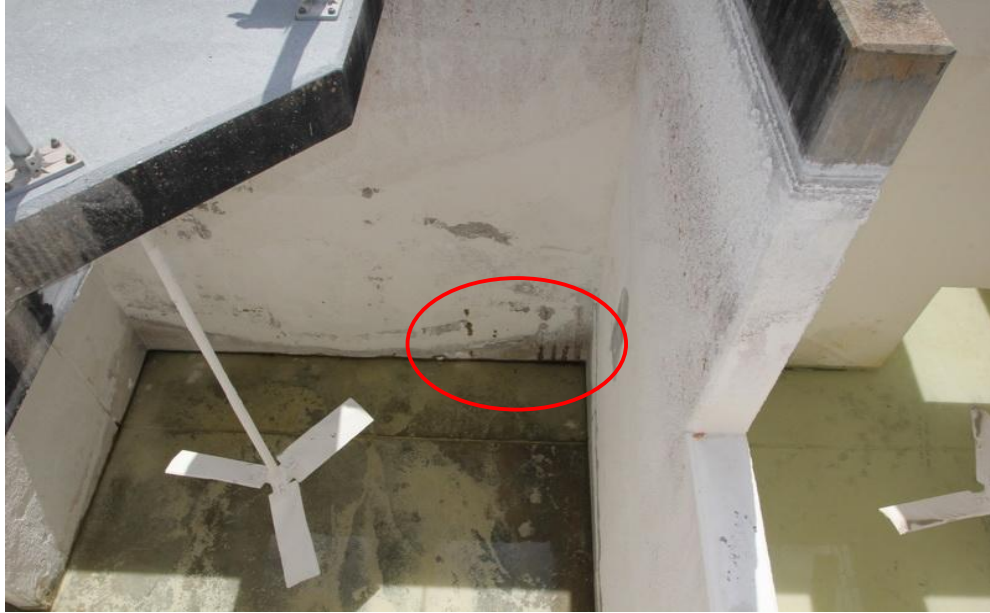
Photo No. 39

Remarks: Exposed, corroded reinforcement at the base of the flocculator basin wall (red outline).

Location: Eastern wall of the middle flocculator basin adjacent to the southern sedimentation basin.

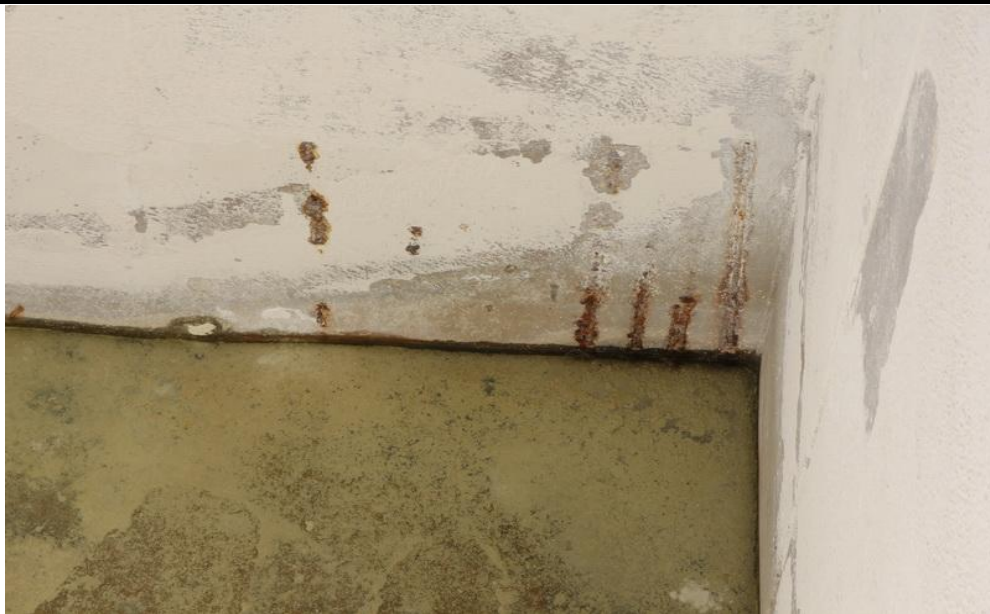
Photo No. 40

Remarks: Close up view of Photograph 39.

Location: Eastern wall of the middle flocculator basin adjacent to the southern sedimentation basin.

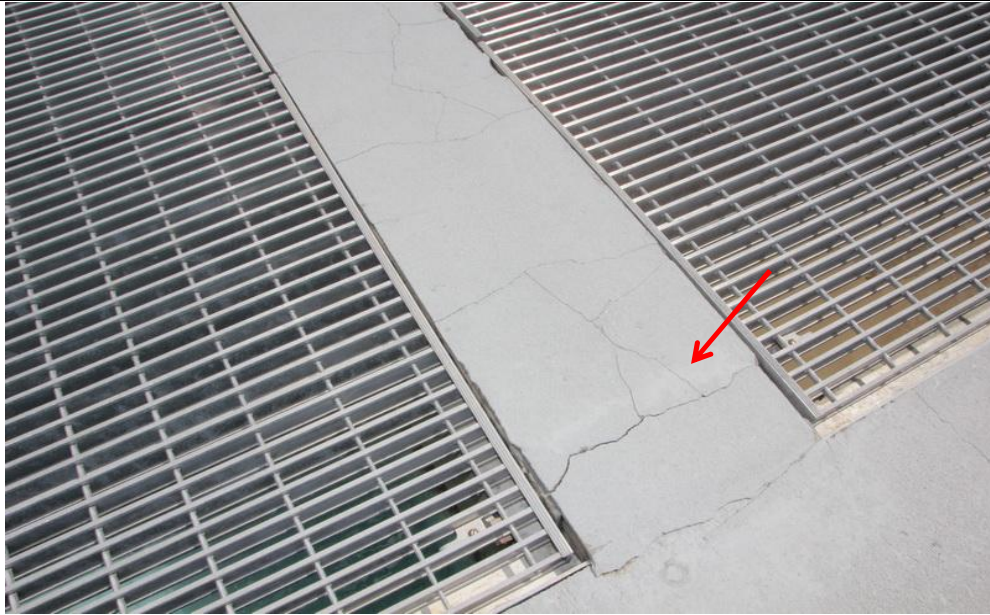
Photo No. 41

Remarks: Cracked, delaminated coating on top of the channel wall (red arrow).

Location: Southern end of the channel wall at the western end of the structure.

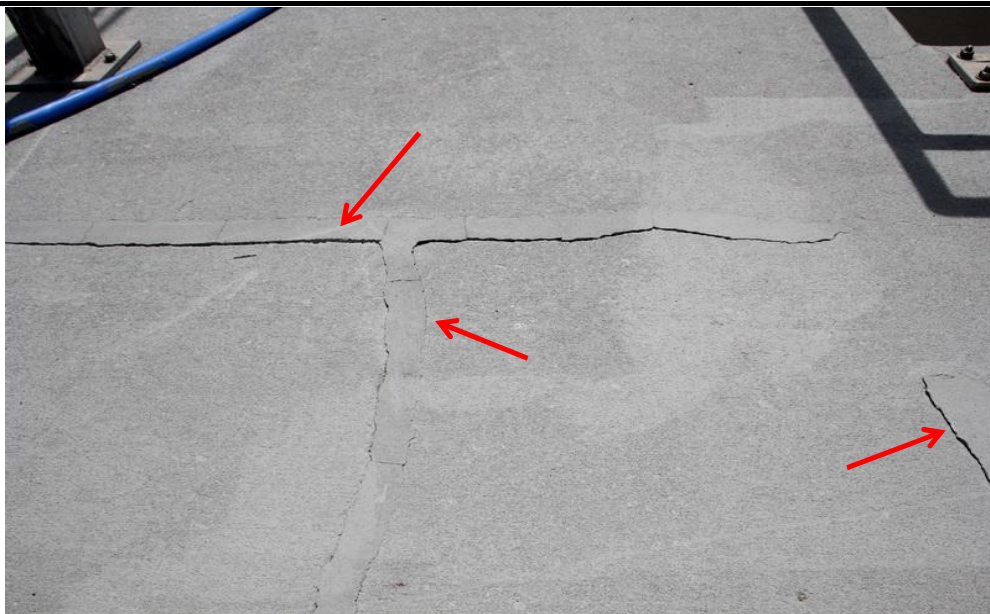
Photo No. 42

Remarks: Apparent patches with cracks and delaminations in the top of the walkway (red arrows).

Location: Center of the structure between the sedimentation and flocculator basins at the east end.

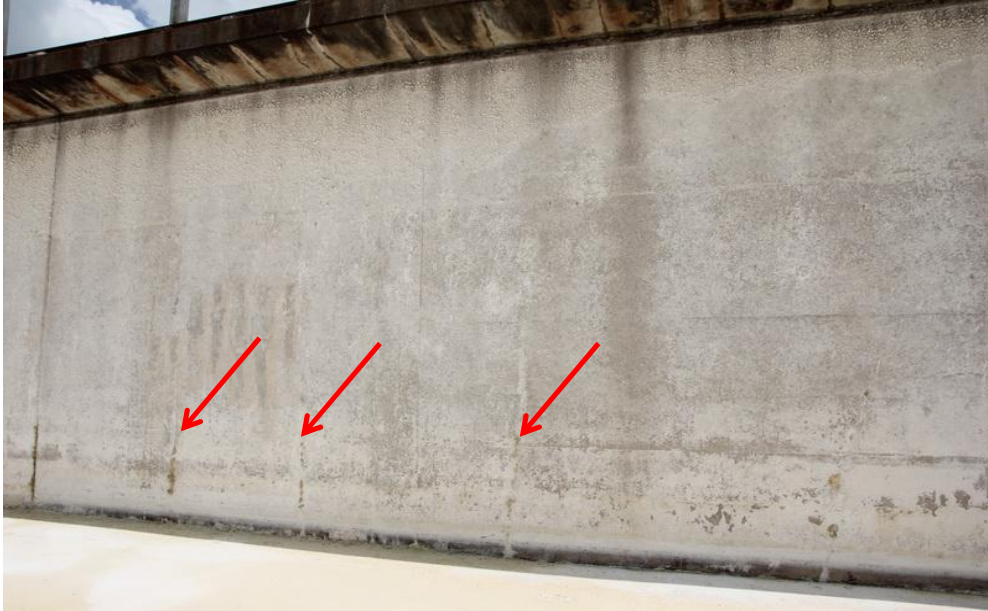
Photo No. 43

Remarks: Isolated vertical cracks and cold joints with apparent dampness consistent with leaks (red arrows).

Location: Southern face of the interior wall between the north and south sedimentation basins.

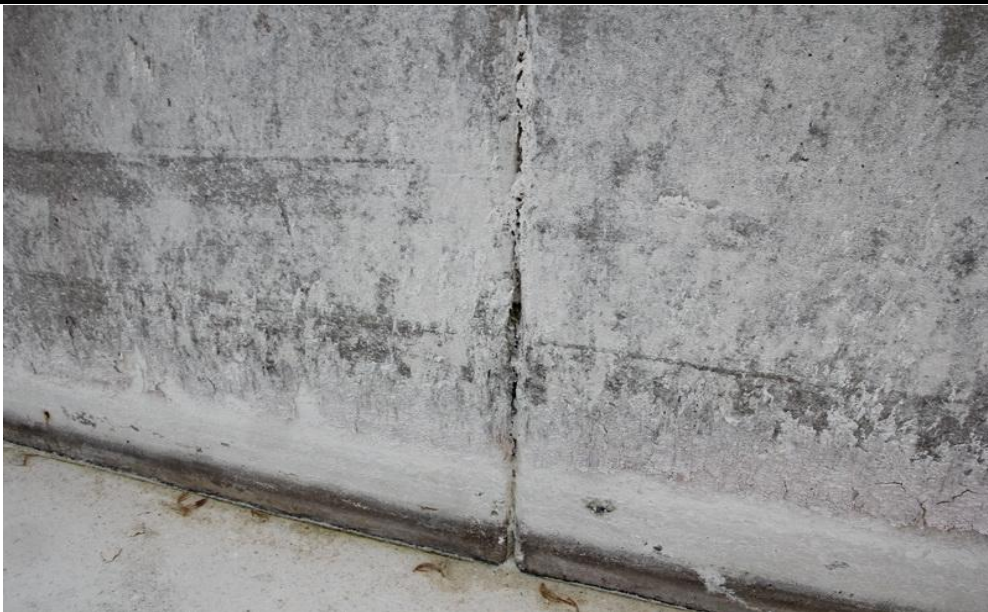
Photo No. 44

Remarks: Typical deteriorated sealant along a wall joint.

Location: Southern face of the interior wall between the north and south sedimentation basins.

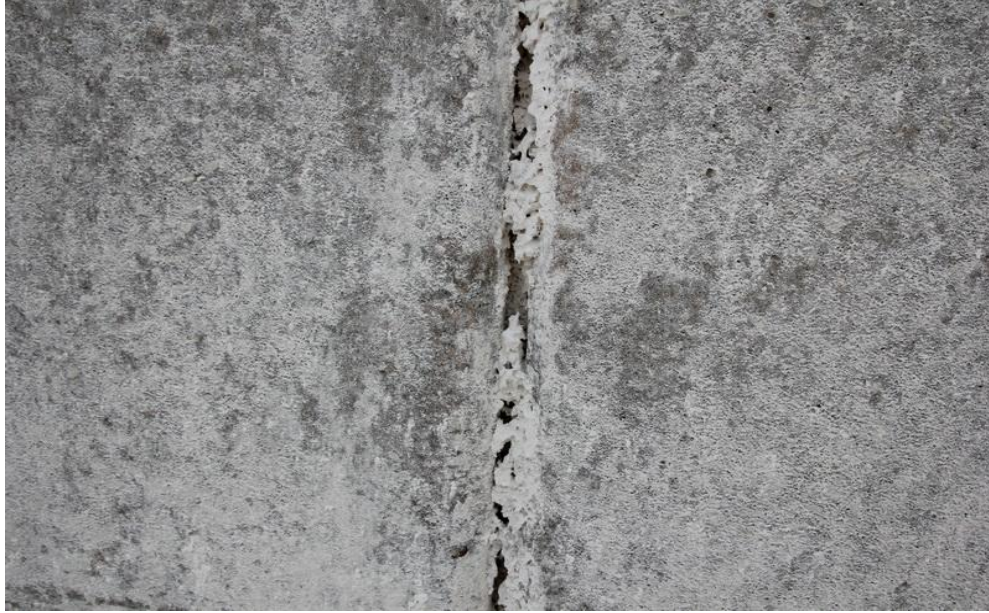
Photo No. 45

Remarks: Close up view of Photograph 44.

Location: Southern face of the interior wall between the north and south sedimentation basins.
