Manatee County  
Lake Manatee WTP Basin A Inspection

## SUMMARY REPORT

DRAFT | March 2021

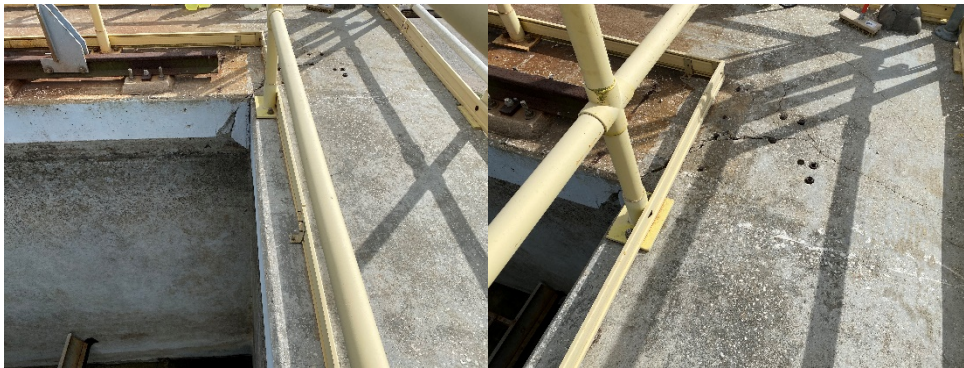
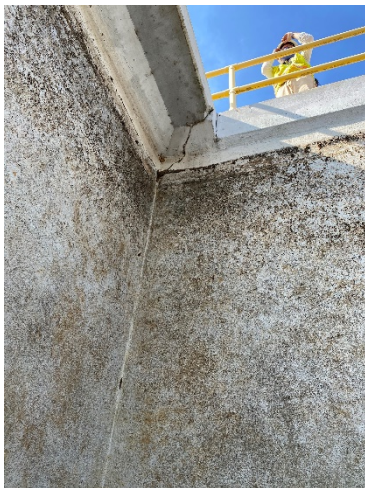
- **Condition A and H:** In the South-West corner of Basin A and near the main divider wall, there are several cracks in the concrete walkway that run diagonally across the width of the walkway.

Condition A – Location: cracks on walkway slab.

1. **Concrete cracks (Conditions A, C, H, I):** Repair cracked concrete with an epoxy injection to prevent it from deteriorating further. Clean the area in the vicinity of the cracks that will be injected with epoxy, so they are free from dirt and any other loose matter. Leave the area in a generally clean condition after the epoxy injection is complete. Refer to Appendix B for condition locations.

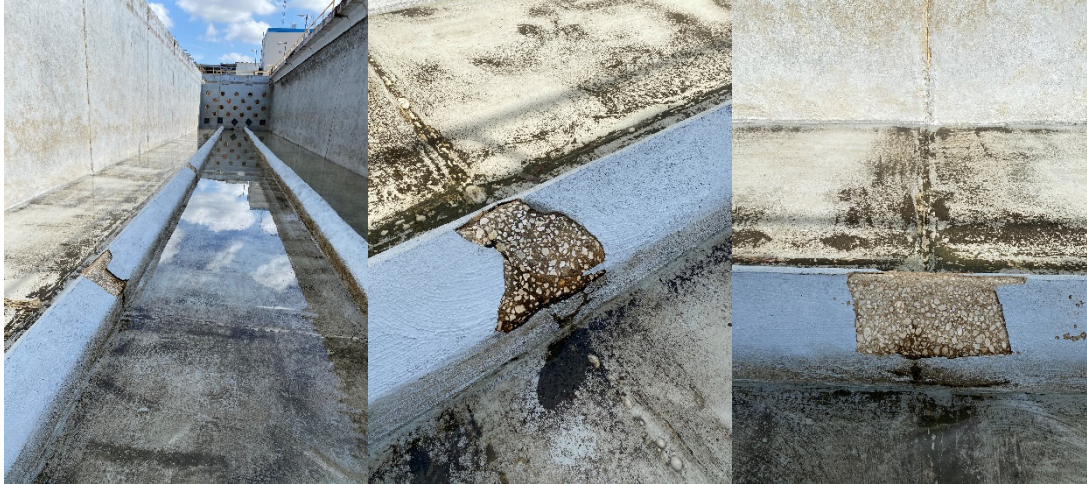
- **Condition B:** Localized spalling of concrete overlay material (wearing surface) and crack formations were observed at the south section of the basin, along the divider curb at locations matching with the N-S expansion joints on the slab. It appears that the spalling of concrete and the formation of cracks were caused due to restrained thermal movements at these locations, since there were not expansion joints observed across the curbs at the locations of the N-S expansion joint.

Condition B – Location: spalling of mortar (wearing surface) at curbs.

4. **Spalling of overlay concrete (Condition B) and Installation of expansion joints across divider curbs:** Saw cut and remove sections of concrete curb. The cut sections of concrete along the curb will be 4-inch long each centered at each location of the expansion joints in the slab to allow for the removal of existing expansion joint material and installation of new expansion joint material in the slab [see **Condition L** depicting concrete curb straddling over the expansion joints in the slab].

- a. After installation activities of new expansion joints in the slab get completed, new ½" expansion joints across the curbs, along with new formed concrete on both sides of the expansion joint to fill the 4" gap of removed concrete will be installed. The new concrete will be cast against existing concrete surface in saturated surface dry conditions. Additionally, saw cut and remove spalled concrete area to a minimum depth of ½", epoxy inject existing cracks with grout as required, and fill damaged perimeter area of the curb with structural repair mortar to be cast and bonded to the existing surface in saturated surface dry conditions with an epoxy bonding agent.

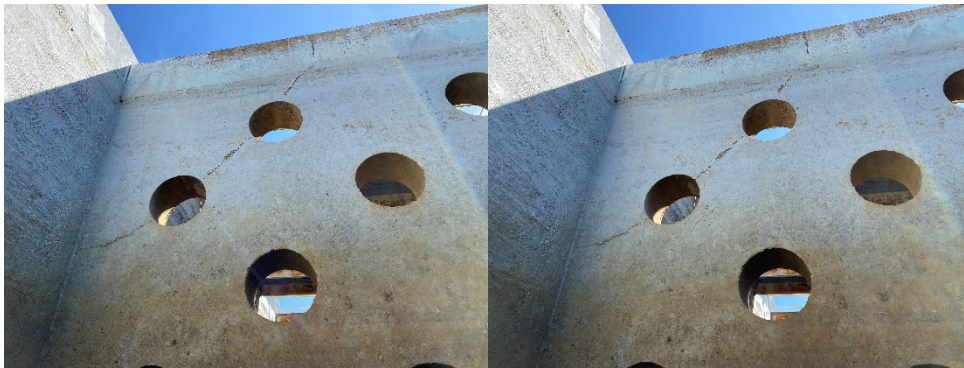
- **Condition C:** At the North-East corner of the train, there is a crack formation at the corner of the baffle wall.
- **Condition D:** Damage of expansion joints surrounding concrete. This condition typically occurred at all vertical expansion joint wall locations.

Condition C – Location: formation of diagonal cracks on baffle walls.

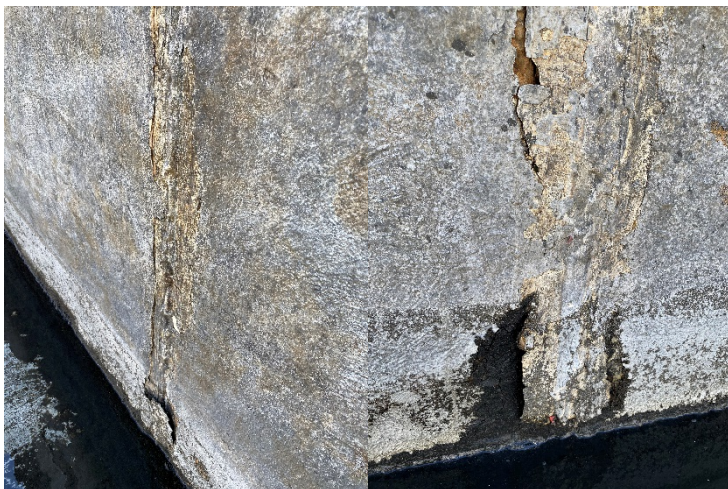
Condition D – Location: damage of expansion joints surrounding concrete.

2. **Damaged concrete cover (Condition D):** Remove loose material and high-pressure water wash down the entire damaged surface area. Saw cut and remove to ½" thickness minimum, and repair damaged concrete with concrete repair mortar. At the time of application of concrete repair material, substrate shall be saturated to a surface dry condition.

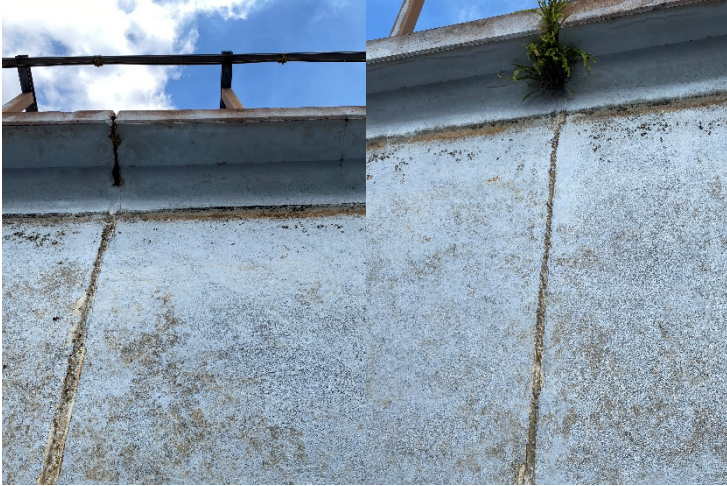
- **Condition E and J:** All expansion joints appear to be damaged and deteriorated.
- **Condition F:** All interior wall surfaces appear to have coating decay.

Condition E – Location: wall expansion joint material deterioration.

3. **Expansion joints (Conditions E, J, and L):** Provide high-pressure water wash down of walls and slabs around expansion joints, and clean existing concrete surfaces to bare concrete. Remove and replace the sealant, backer rod, and existing expansion joint material in its entirety. Where necessary repair damaged concrete by bonding mortar with an epoxy bonding agent. As per the installation of new expansion joint material in the slab running underneath the divider curbs (**Condition B**), see next sub-section.

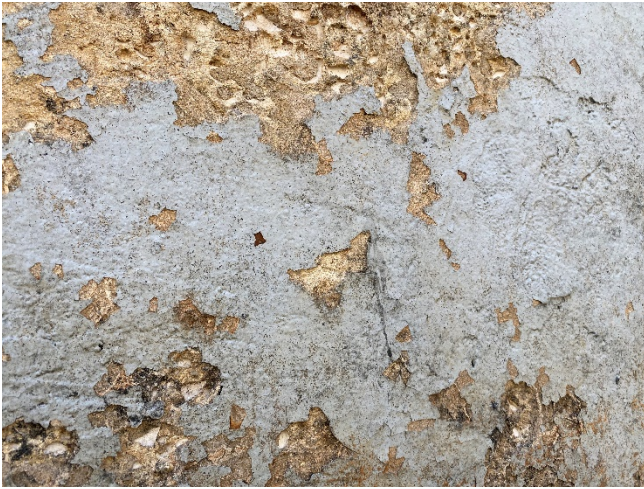
Condition F – Location: coating decay at walls.

6. **Coating decay (Condition F):** Provide high-pressure water wash down of walls and clean existing concrete surfaces to bare concrete. Remove existing coating, repair any cracks as necessary and install new coating as directed by the manufacturer. Carollo will consult with a coating consultant to determine the appropriate coating, and will provide additional information in the final version of this TM.

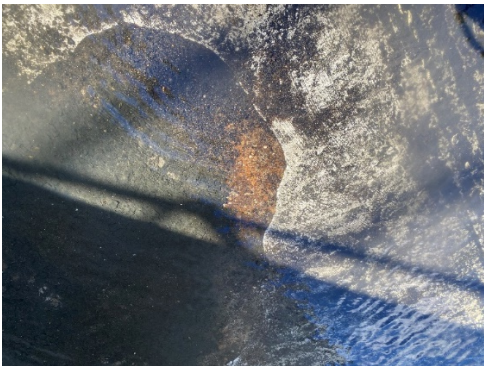
- **Condition G:** Slab appears to have a spalled concrete surface area of 7 ft x 7 ft approximately where the depth of spall appears to be about 1". Carollo was unable to fully observe the extent of the damage due to rainwater ponding and mud covering the floor slab area.

Condition G – Location: slab appears to show concrete degradation over South-West corner of South Train.

- b. Refer to Appendix B for locations of the curb.
5. **Damaged Concrete surface (Condition G):** Removed loose material of spalled concrete. After removal of spalled area which appears to be 1" in depth, saw cut, chip and remove to ½" thickness minimum, within the perimeter, rectangular in shape, of the damaged area. Prepare new surface to surface-dry-condition and fill with concrete repair mortar.

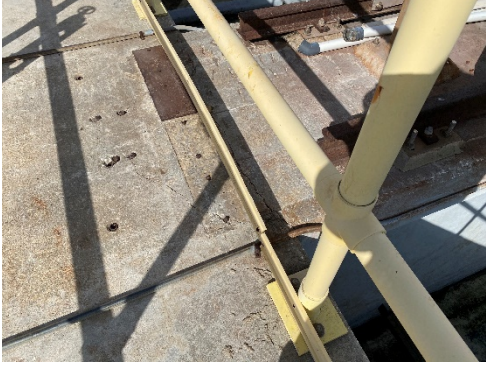
Condition H – Location: cracks on walkway slab.

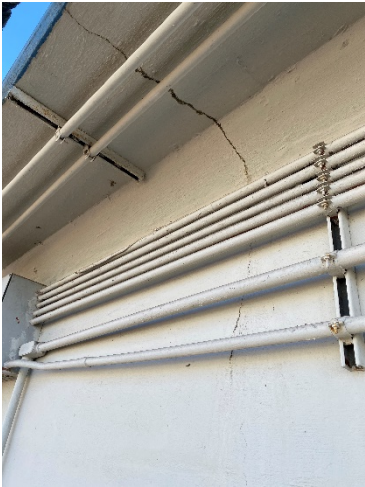
- **Condition I:** At the perimeter of the North wall, there is a crack formation on the outside face of the wall.
- **Condition K:** At the junction of Filter A and B, a crack is actively leaking through the expansion joint. Carollo was unable to determine the origin of the leak while the channel was in service.

Condition I – Location: crack formation on the outside face of perimeter wall.

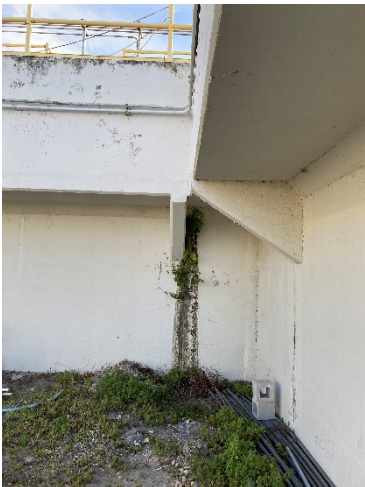
Condition J – Location: expansion joint material deterioration.

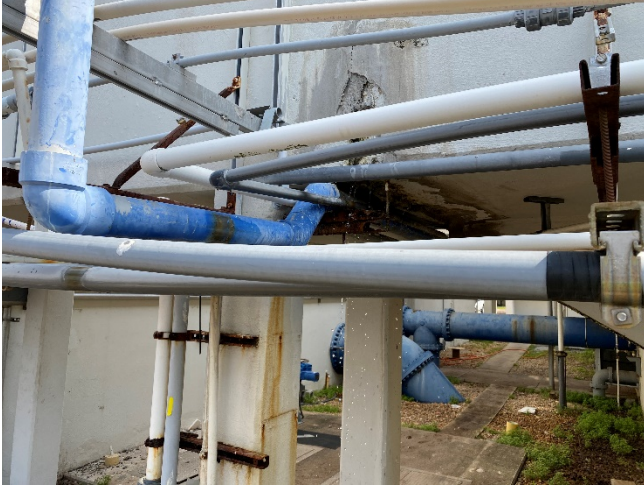
Condition K – Location: leak through expansion joint.

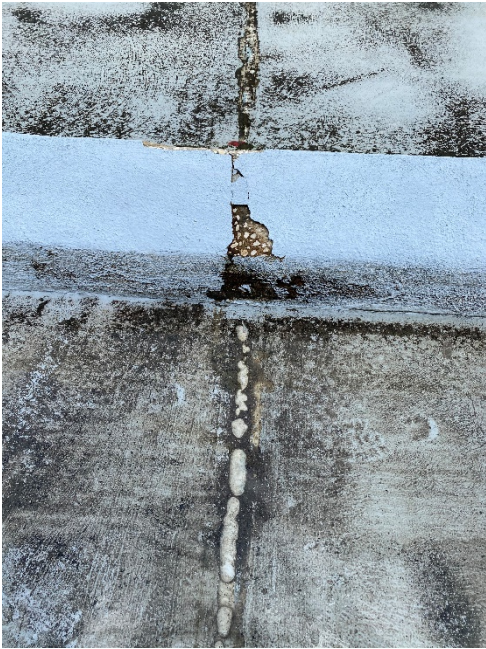
- **Condition L:** Expansion joint material deterioration over the entire floor slab.

Condition L – Location: slab expansion joint material deterioration.
