REFERENCE: REQUEST FOR PROPOSAL No. 15-2112CP, Construction Manager at Risk Services for the Merrill Lynch Building Restoration and Remodeling Project

ADDENDUM No. 2

RE: *Merrill Lynch Building*
1002 Manatee Ave. West, Bradenton, Florida
KEG Project #11DS-0001.001

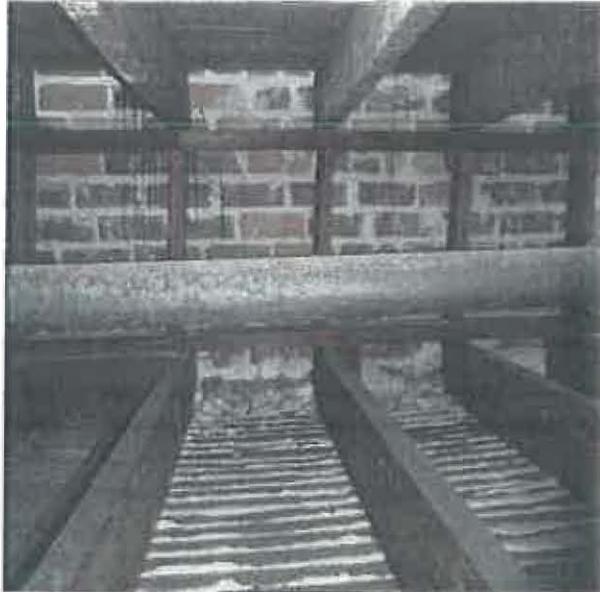
The Merrill Lynch building is a two story structure measuring approximately 90' x 150' in plan and was built in the late 1940s. The roof framing consisted of 2x6 or 2x8 roof joists spanning from the exterior brick wall to interior steel beams and from interior steel beam to interior steel beam. Common attachments of roof framing consisted of toe-nailing observable only from the side faces of the 2x members. There was no evidence of hurricane straps or tie downs at exterior or interior bearing points. The support of the ceiling was an independent wood framing spanning generally in the same direction as the roof joists.

Photo 1: Roof and Ceiling Framing

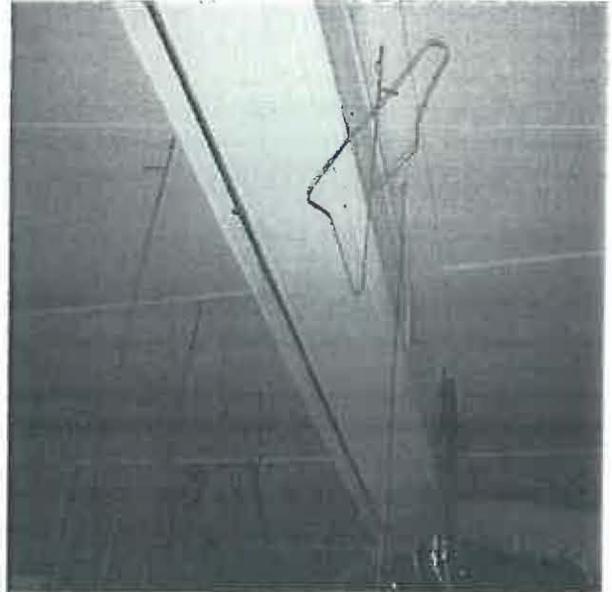
The floor framing appears to be built in similar manner as the roof framing, but could not be confirmed due to the floor framing being completely covered by gypsum board. The gypsum board most likely was installed to achieve a fire rating between the two floors. Based on the shapes of the gypsum board, it appears that the steel columns align from floor to floor and the 2nd floor steel beams run in the same direction as the roof.

Our observation of the floor framing was extremely limited and therefore an analysis of the floor system can not be completed. Partial or complete demolition of the gypsum board would be required to determine the actual design capacity of the 2nd floor framing. Karins Engineering Group, Inc. has provided a table of

Photo 2: Finishes over 2nd Floor Framing

Based on the preliminary location of the proposed elevator and new stair location, and our limited observation of the flooring framing, Karins Engineering Group recommends further investigation after demolition occurs to determine most economical framing. We believe that the framing will need to be reinforced and the use of headers will be required.

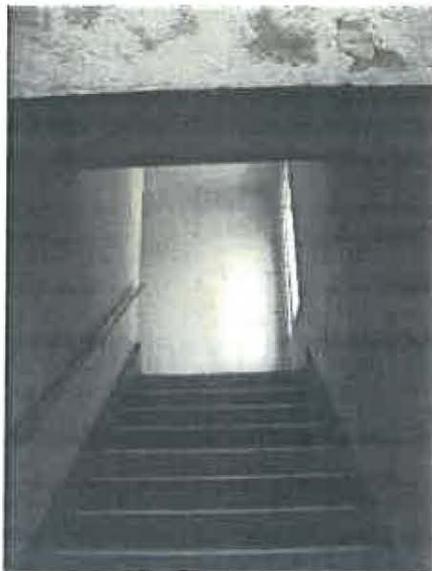
The stair on the back of the building next to 10th Street appears to have been added at a later date than the original structure. These stairs do not conform to current code due to the head height limitations not being met in multiple locations.

Photo 3: Low Head Height at Stairs

The stair on the back of the building next to 10th Street does not conform to current code due to the head height limitations not being met in multiple locations. Karins Engineering Group recommends rebuilding the stairs and achieving the proper head height required by the Florida Building Code. Rebuilding the stairs would require that the intermediate landing be lowered. This will increase the length of the landing at the bottom of the stairs and place the first stair tread closer to the intermediate landing, creating enough head height to meet the FBC. Lowering the intermediate landing also lengthens the stair stringers at the top of the stairs. With a longer run at the top of the stairs, the 2nd floor framing will need to be adjusted to accommodate the new position of the stairs. Usage and head height will be reduced underneath the stairs and the tenant should be notified of the changes.
