PHASE I ENVIRONMENTAL SITE ASSESSMENT

**Taylor Nursery
907 63rd Avenue East
Bradenton, Manatee County, Florida**

GLE Project No. 10310-00099

July 2010

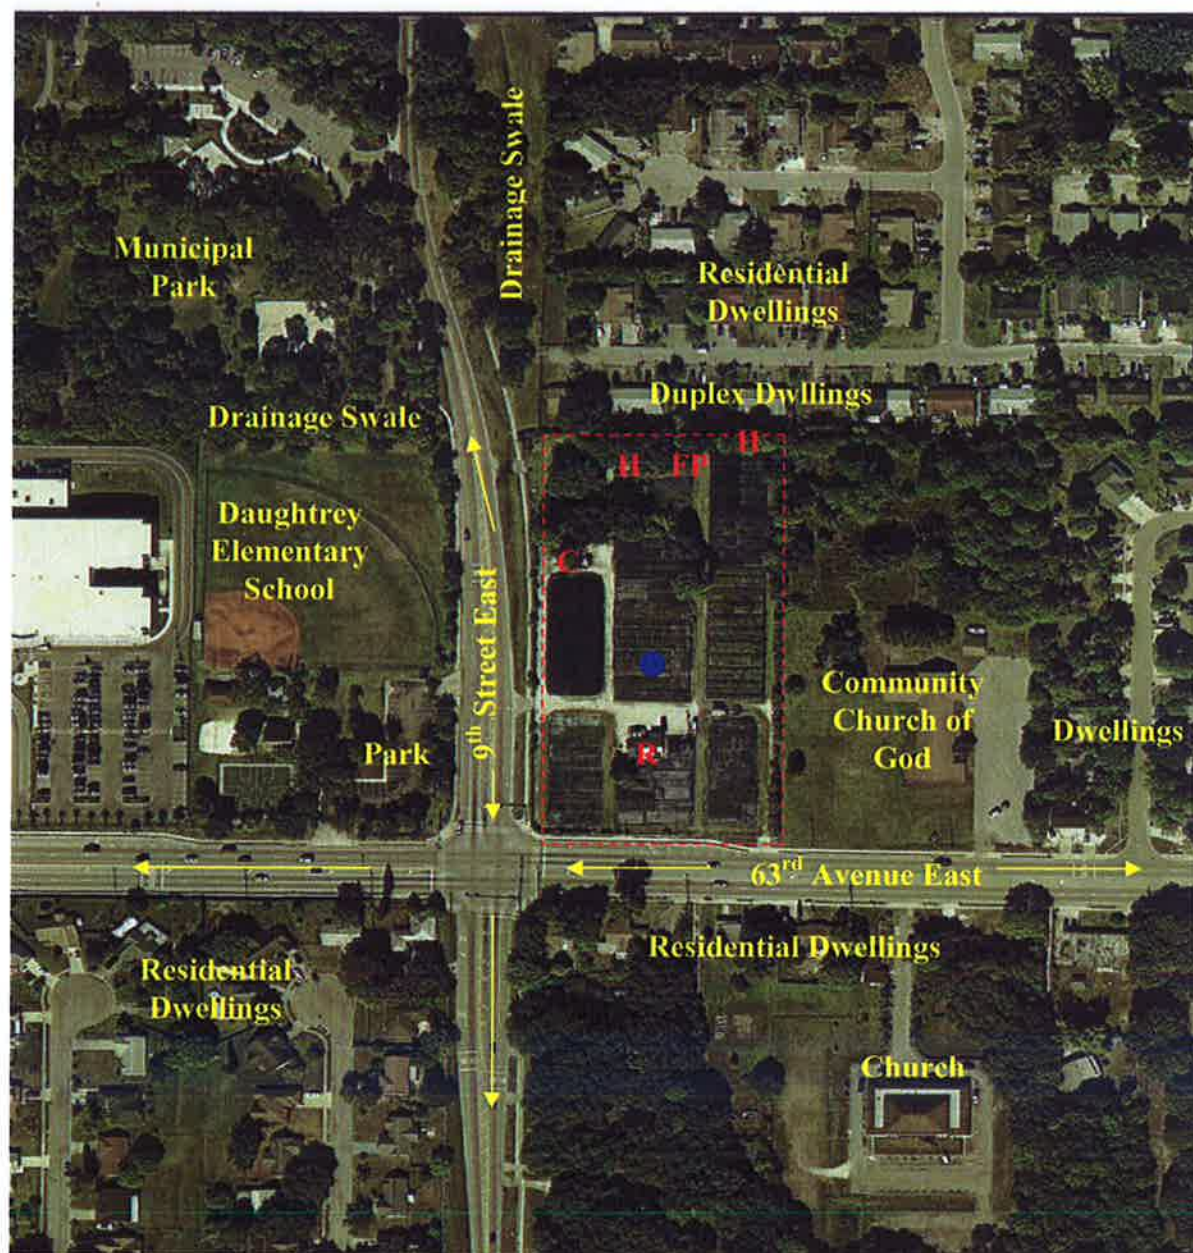
Drawn MAM	Job No. 10310-00099
Checked PRB	Figure A-1
Date 07/20/2010

● Water Well

R = Residence/Office

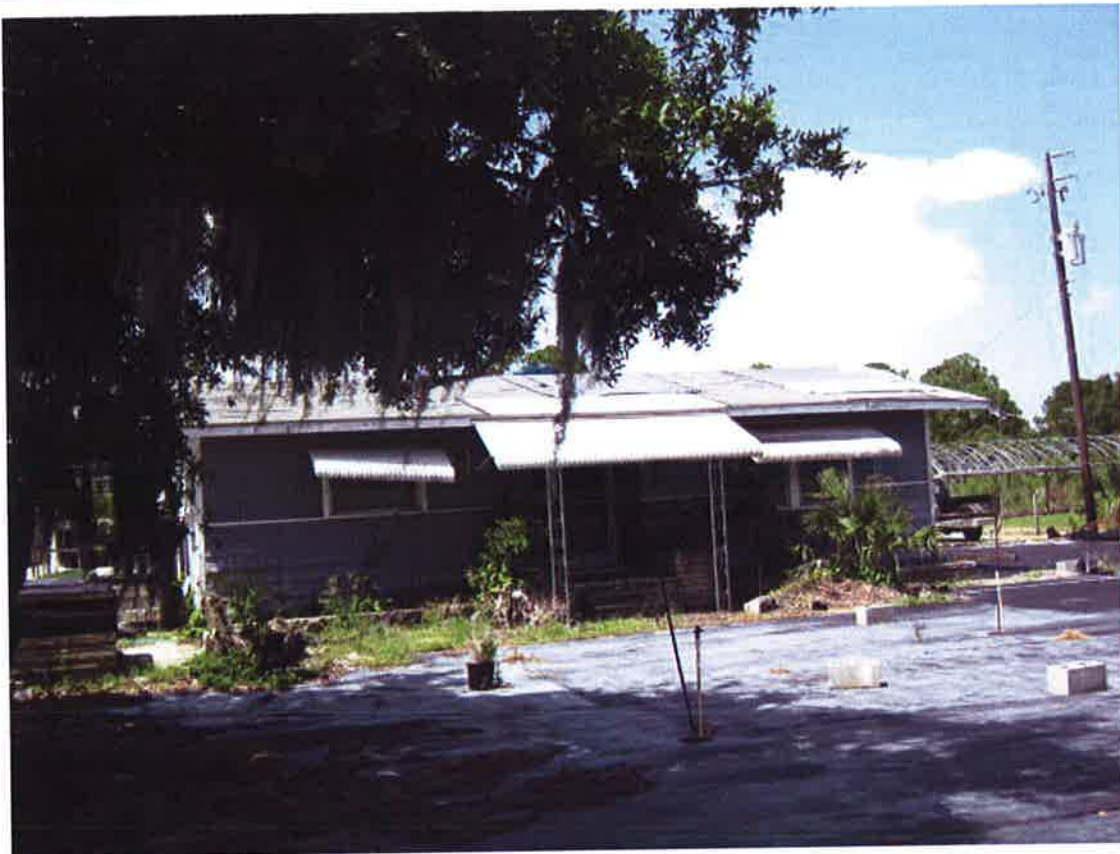
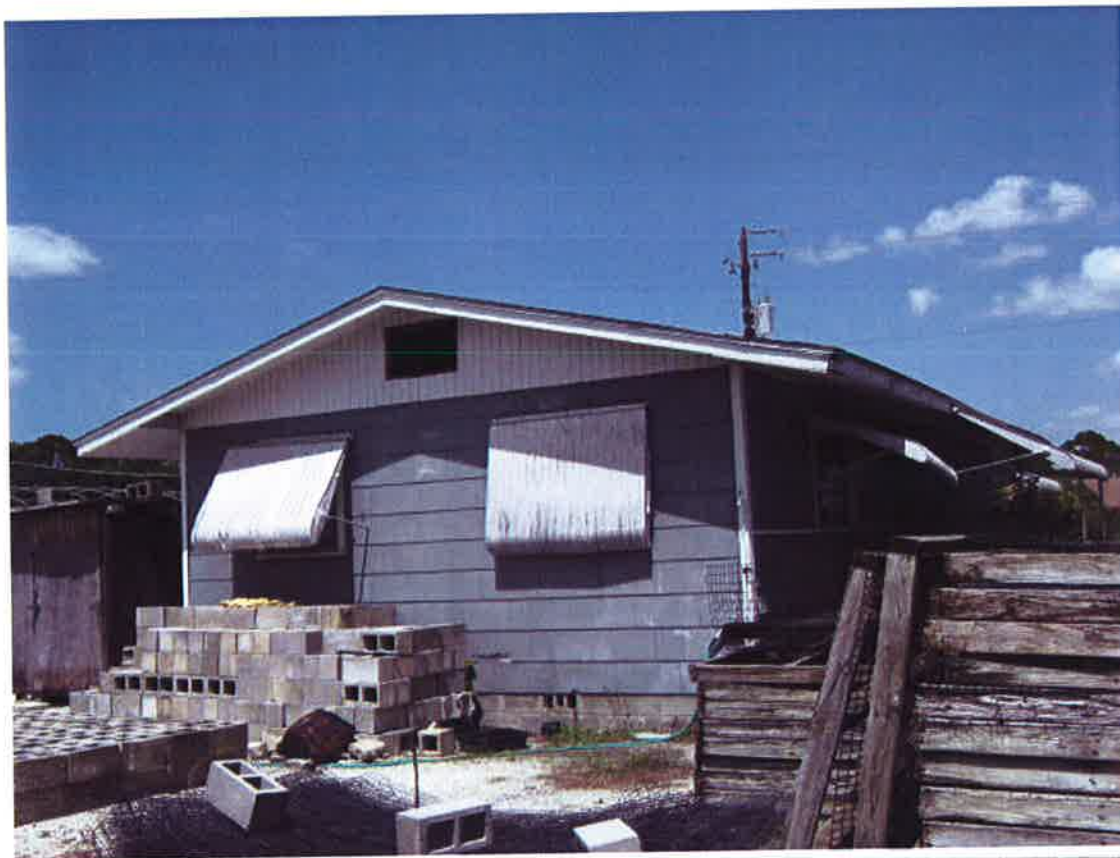
Photo B-1

During the Phase I ESA site visit, GLE noted Transite™ siding on the exterior walls of the onsite building structure as well as miscellaneous floor tile within the kitchen and lavatory area of this building. There is a potential for ACM to be present in the building components of this structure. Based on the date of construction referenced by the Manatee County Property Appraiser (MCPA) as being 1958 (pre-1978), there is a potential for LBP to be present on components of the onsite building structure. The potential for ACM and LBP to be present at the onsite building is considered a Business Environmental Risk (BER) as per ASTM Standard E1527-05, to the Property at this time.

Upper Photo: View of the residence/office located on the south-central portion of the Property.
Lower Photo: View of the residence/office located on the south-central portion of the Property.

Based on site observations, ACM is likely present in components of the building structure. In addition, there is potential for LBP to be present within the building structure. Therefore, GLE recommends that ACM and LBP surveys be conducted prior to the demolition or renovation of the onsite building.

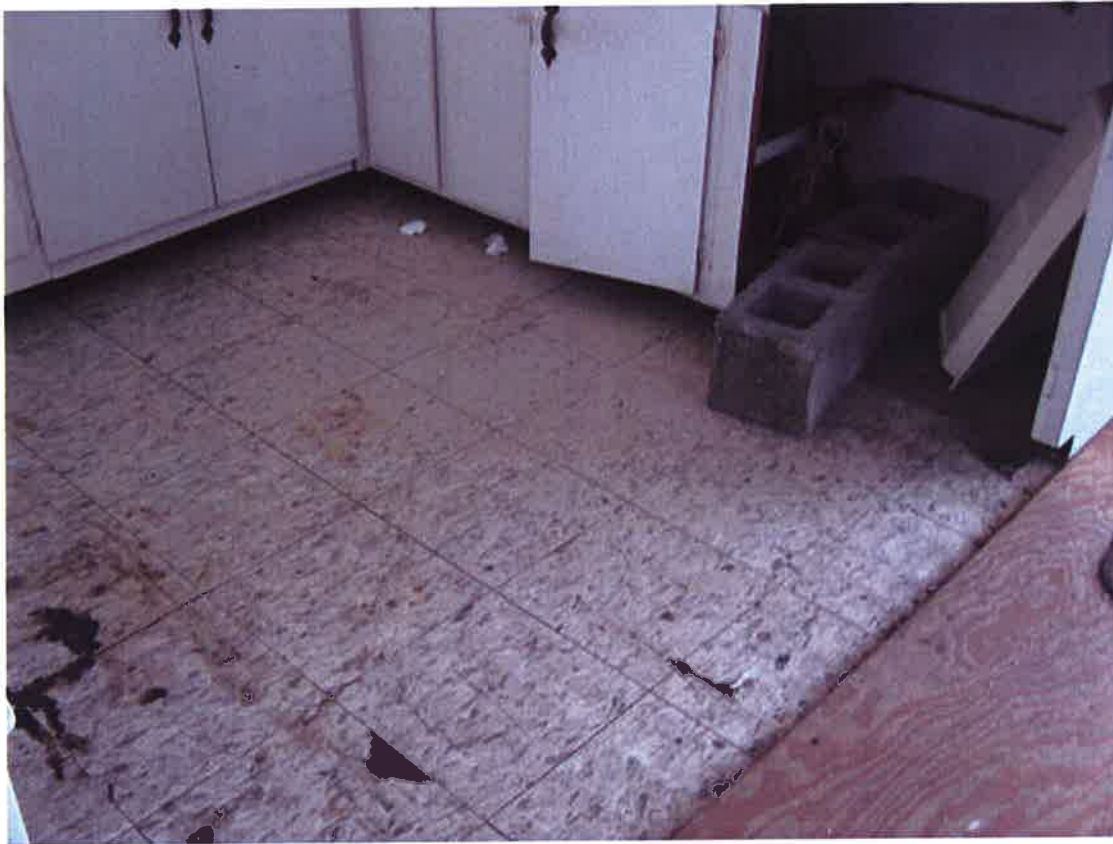
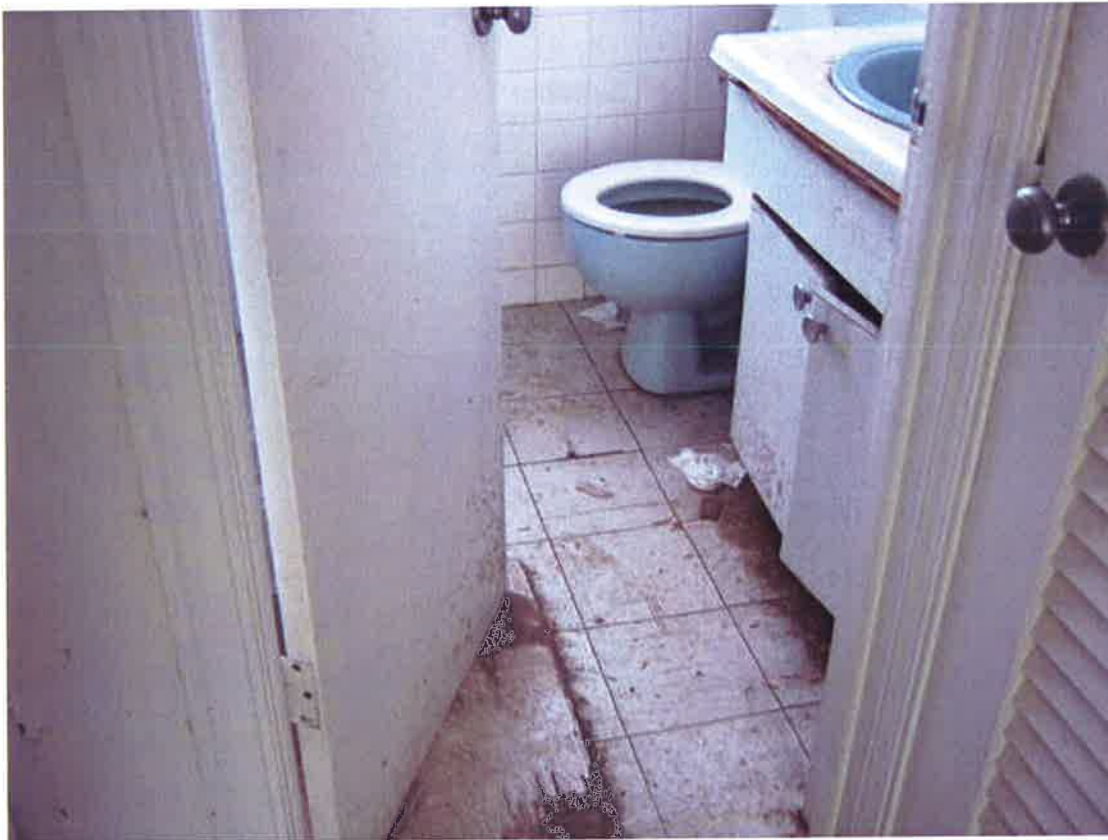
Photo B-2

Upper Photo: View of kitchen floor tile within the onsite residence/office. Lower Photo: View of bathroom floor tile within the onsite residence/office.

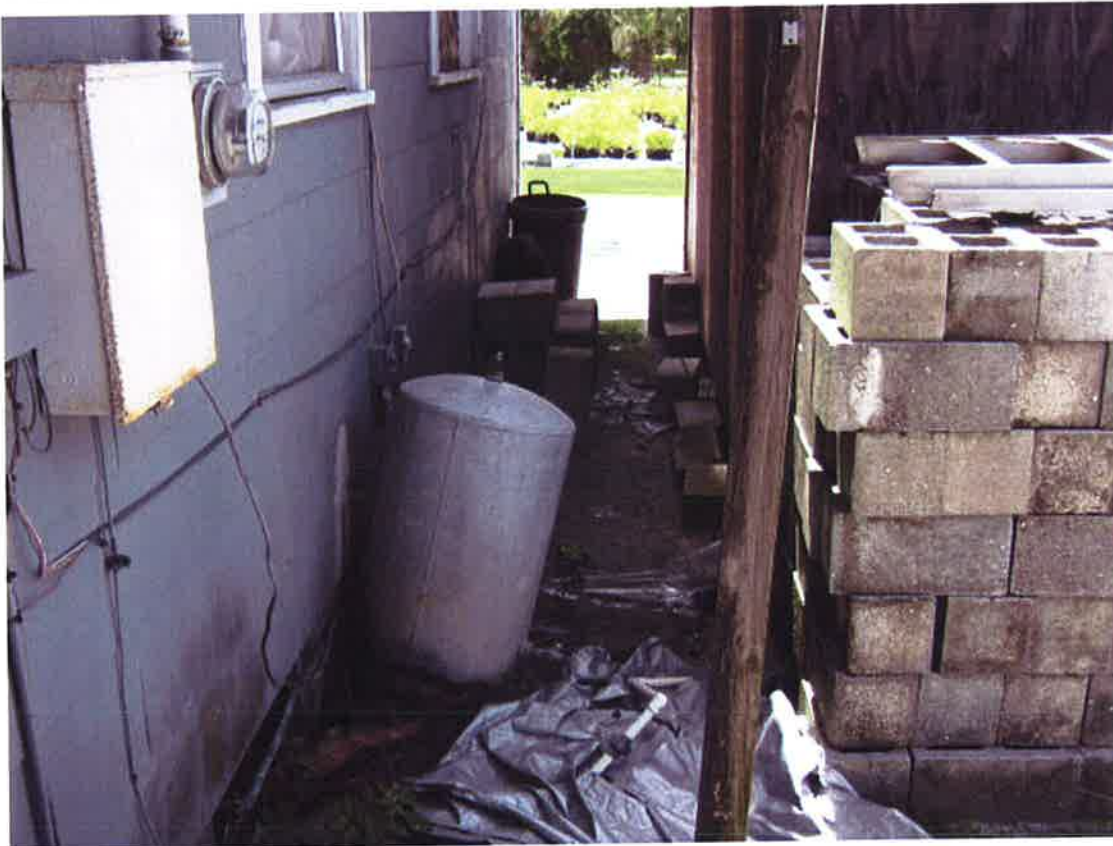
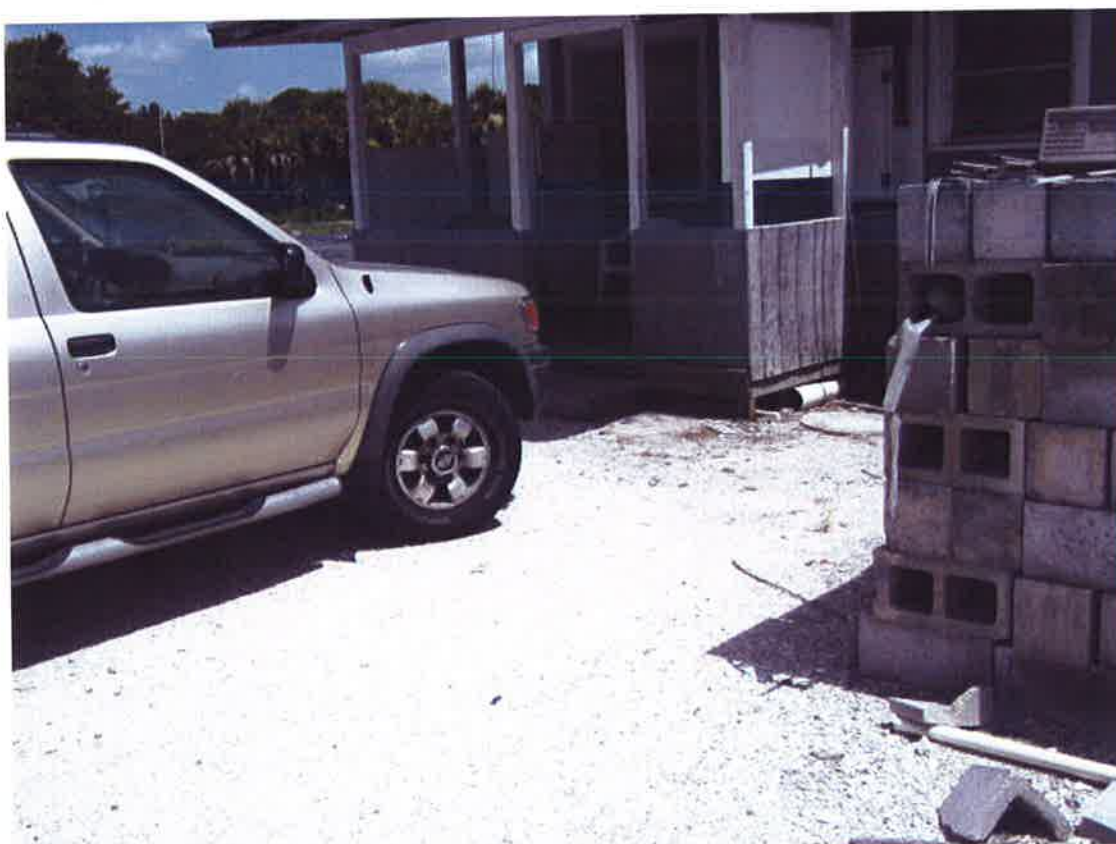
Photo B-3

GLE was informed that a water well was previously associated with the residence/office building located on the south-central portion of the Property. According to Mr. Greg Taylor, site contact/Property owner, this water well was not able to be located or properly abandoned when the Property was connected to the municipal water supply line. This former water well is apparently located in close proximity to the oak tree located to the southwest of the onsite structure referenced above. It should be noted that an irrigation water well is currently utilized onsite and located on the central portion of the Property.

Upper Photo: View of former water holding tank previously associated with the onsite residence/office.
Lower Photo: View of the former septic tank/drain field area previously associated with the onsite residence.

GLE recommends that the onsite water wells (the former water well and the irrigation water well) should be abandoned in accordance with applicable water management district regulations if no longer intended to be utilized for this designated purpose. Special assessment activities may be required in order to locate the former water well previously associated with the onsite building structure.

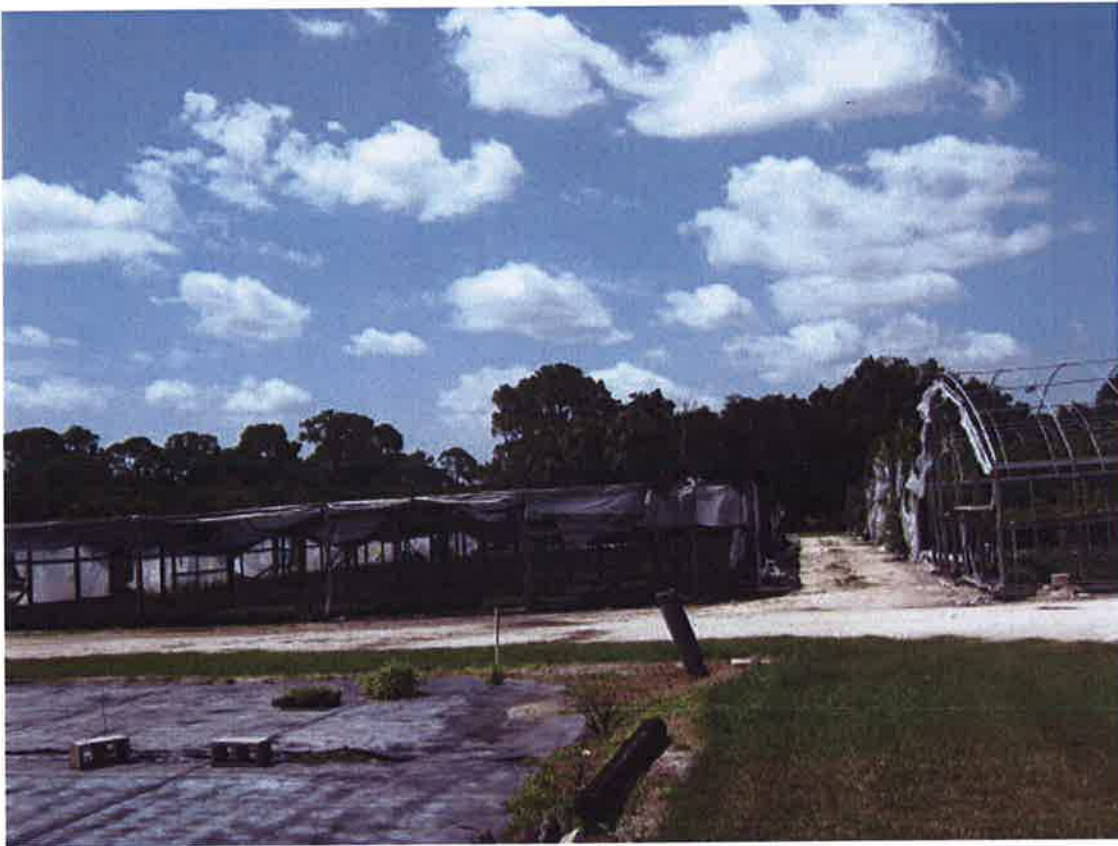
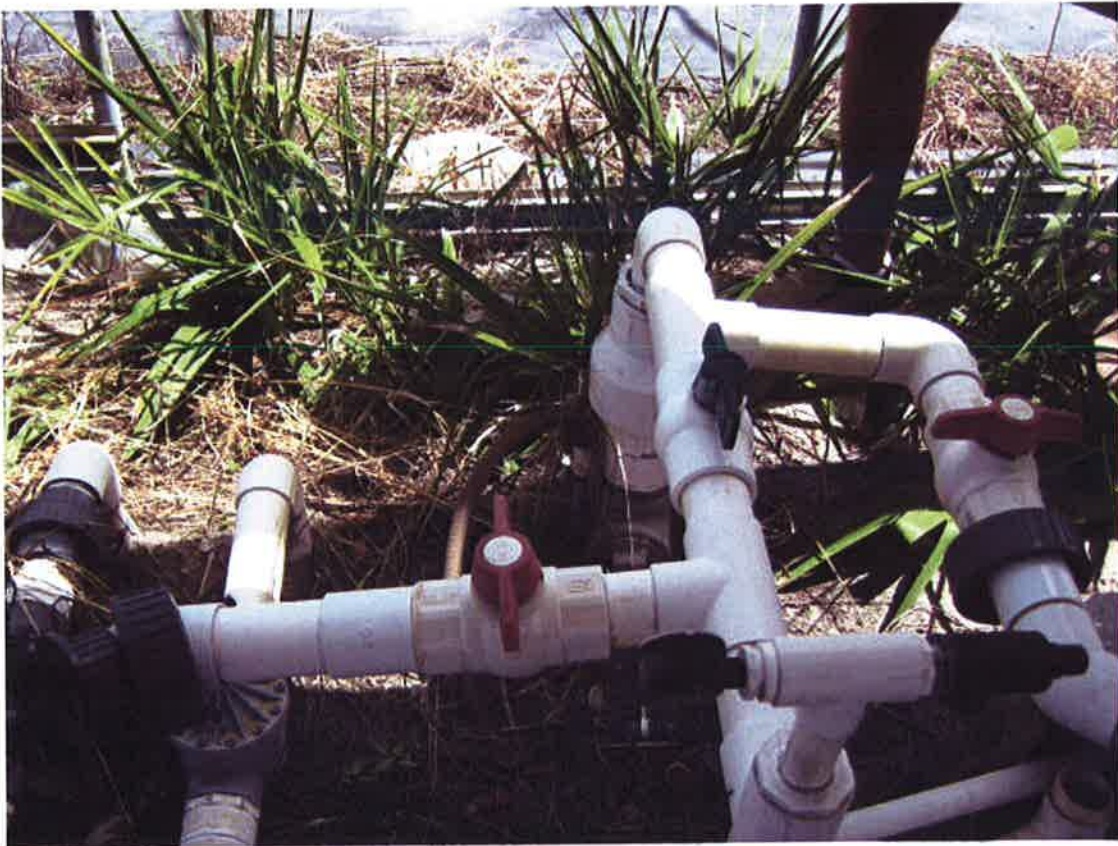
Photo B-5

Upper Photo: View of the west-central portion of the Property. Lower Photo: View of the irrigation water well located on the central portion of the Property.

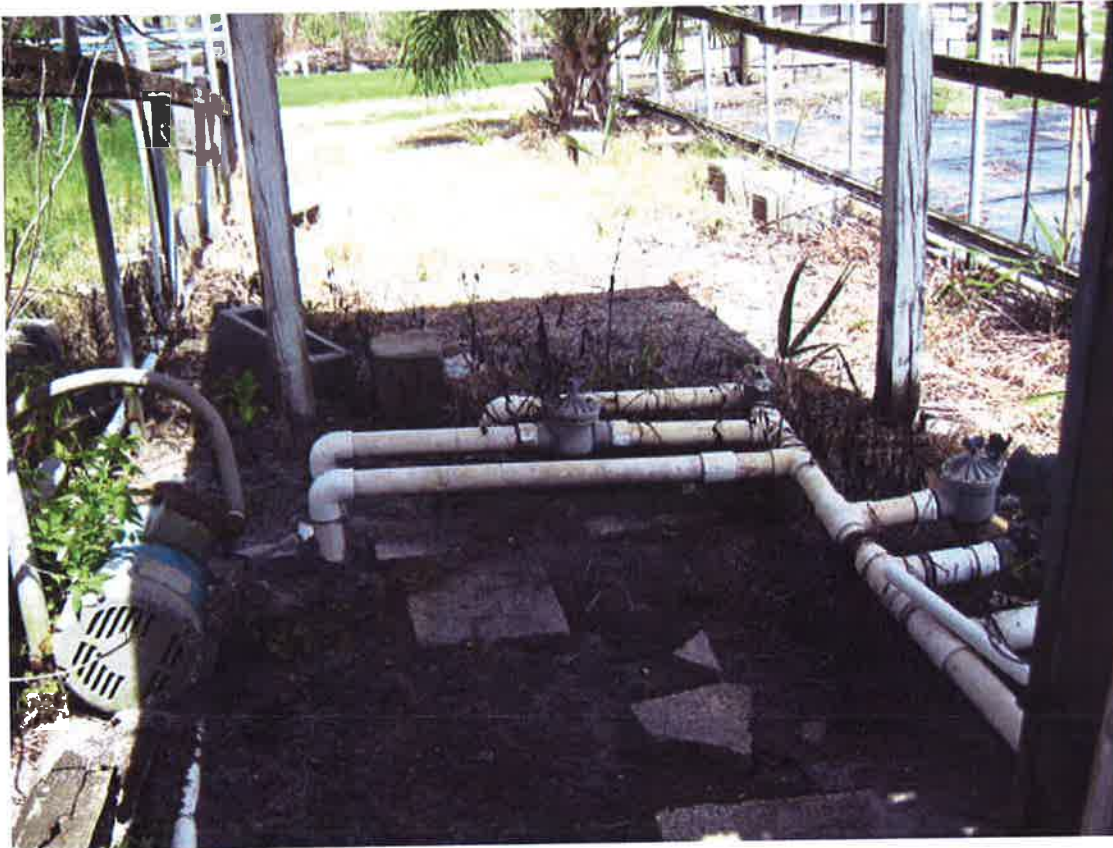
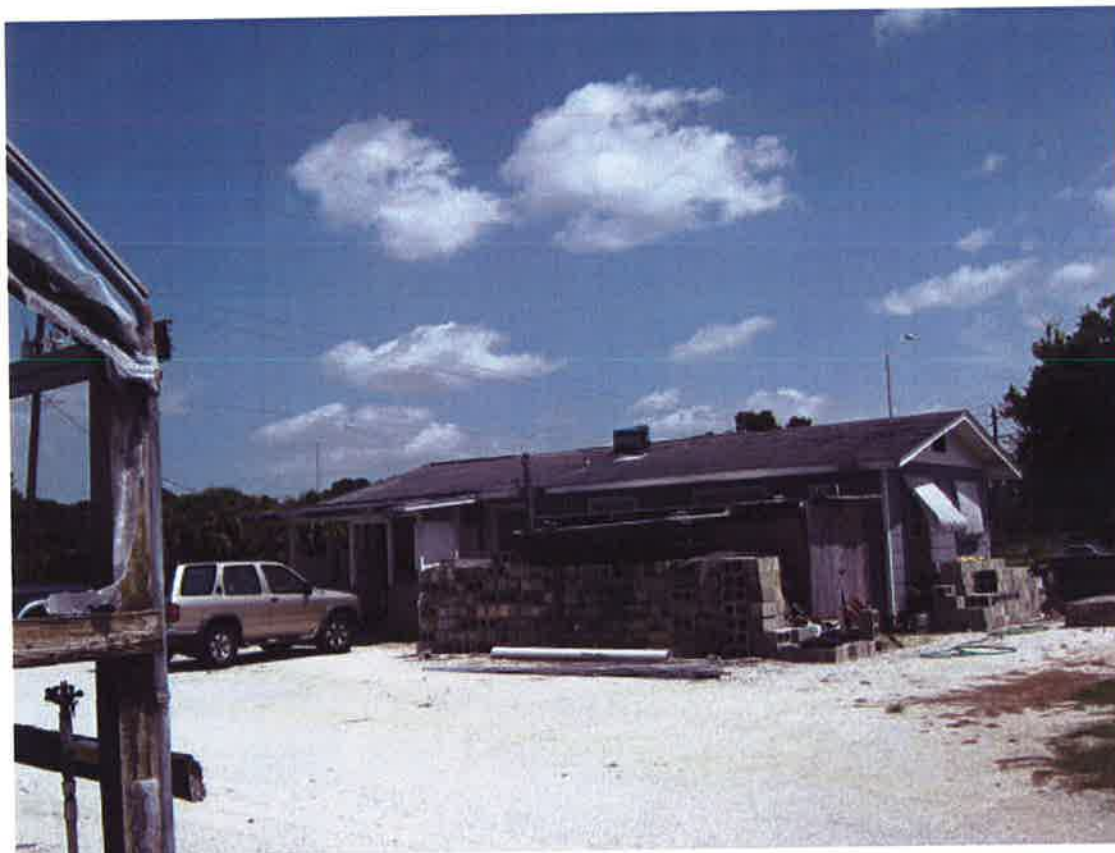
Photo B-6

Upper Photo: View of the irrigation water well located on the central portion of the Property.
Lower Photo: View of the residence/office located on the south-central portion of the Property.

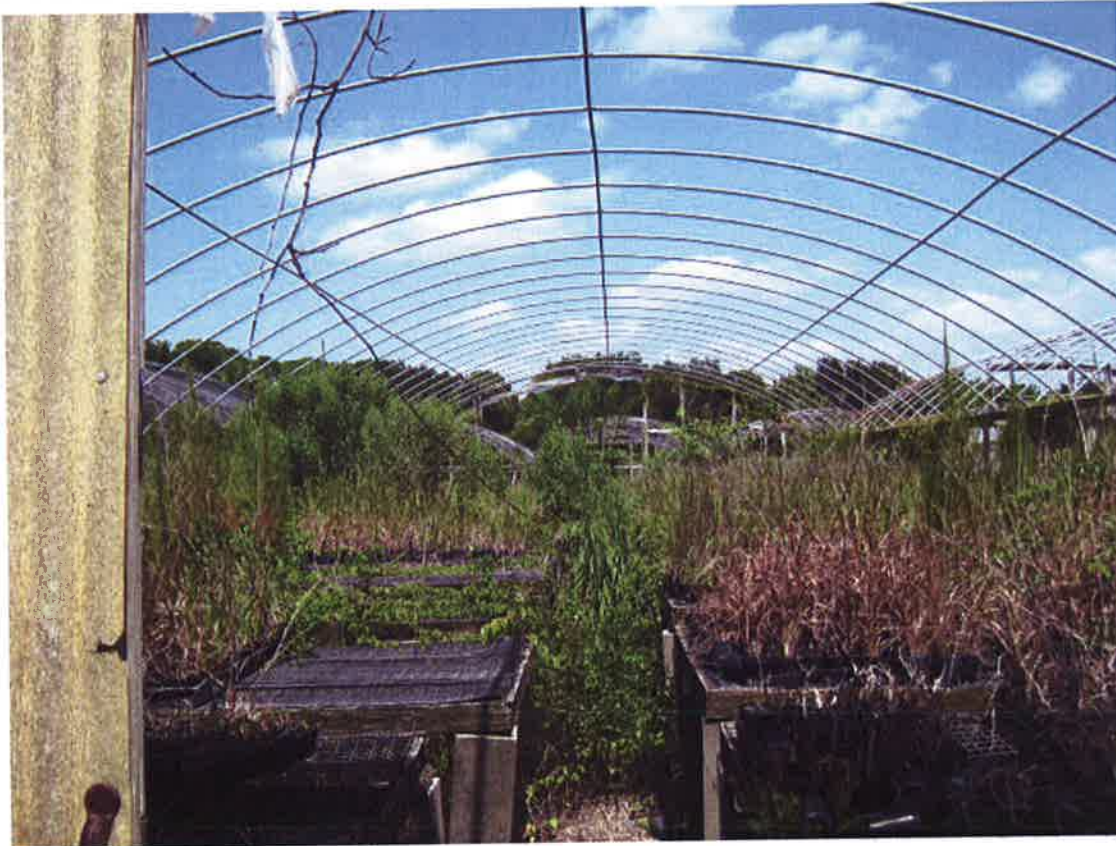
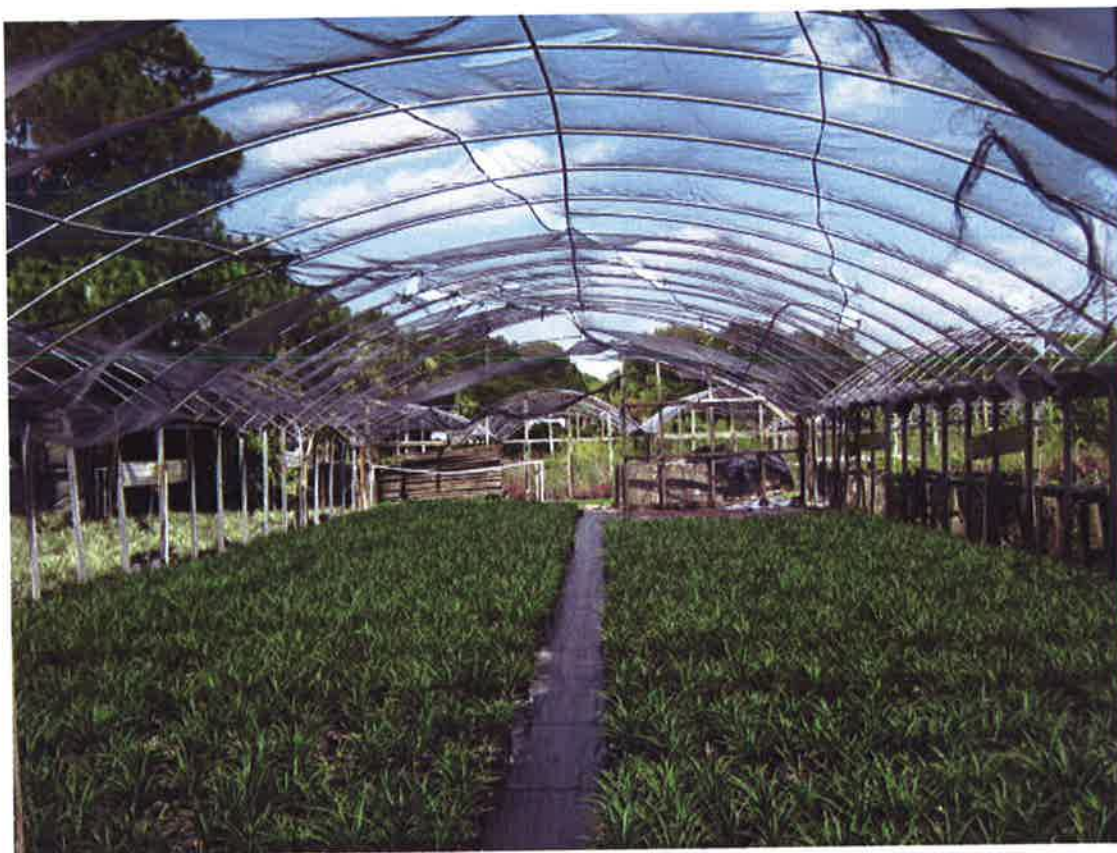
Photo B-7

The Property was historically utilized as an ornamental plant nursery from at least 1975 to the present date. According to Mr. Greg Taylor, the site contact and Property owner, throughout this time, pesticide and herbicide chemicals have been applied on plants associated with the nursery on an as needed basis. Therefore, there is a potential for the Property to have been impacted by the application of pesticide and herbicide chemicals. Based on site observations liquid and granular herbicides, and liquid pesticide products, were observed stored in the manufacturers packaging and containers. The chemical products were observed in the manufacturers supplied containers/sacks and stored within an onsite storage shed, which is located adjoining to the northwest of the onsite residence/office building and on the south-central portion of the Property. There were no apparent bulk chemical storage and/or chemical mixing tank areas observed on the Property at the time of GLE’s site visit on July 22, 2010. However, the application of pesticide and herbicide chemicals on the Property being used as a nursery since 1975 is considered a recognized environmental condition (REC) to the Property at this time, in GLE’s opinion.

Upper Photo: View of the nursery growing area, on the central portion of the Property.
Lower Photo: View of the nursery growing area, on the central portion of the Property.

Based on the historic use of the Property as a nursery facility, GLE recommends additional environmental assessment of the Property. GLE recommends that soil and groundwater samples be collected for laboratory analysis for the potential contaminants of concern. The Phase II ESA should include investigations throughout the Property and in the vicinity of the pond previously filled as well as the former fuel oil AST location.

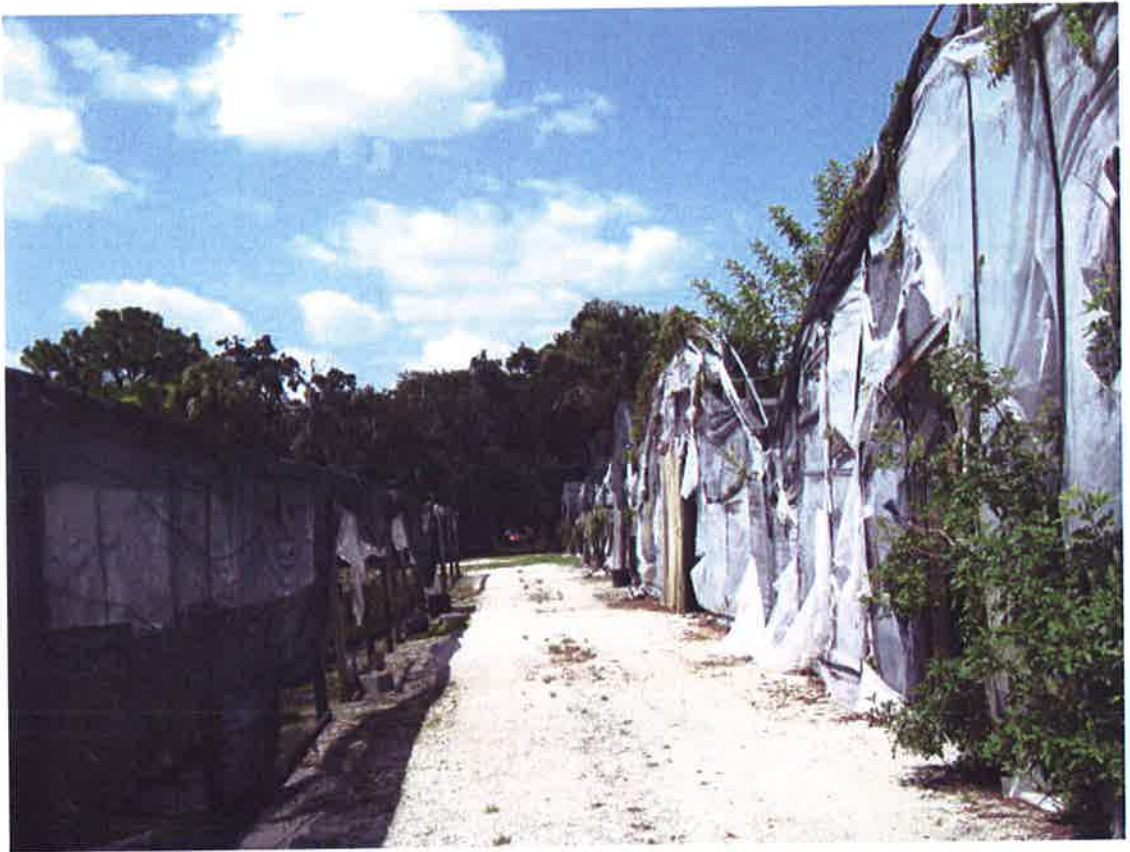
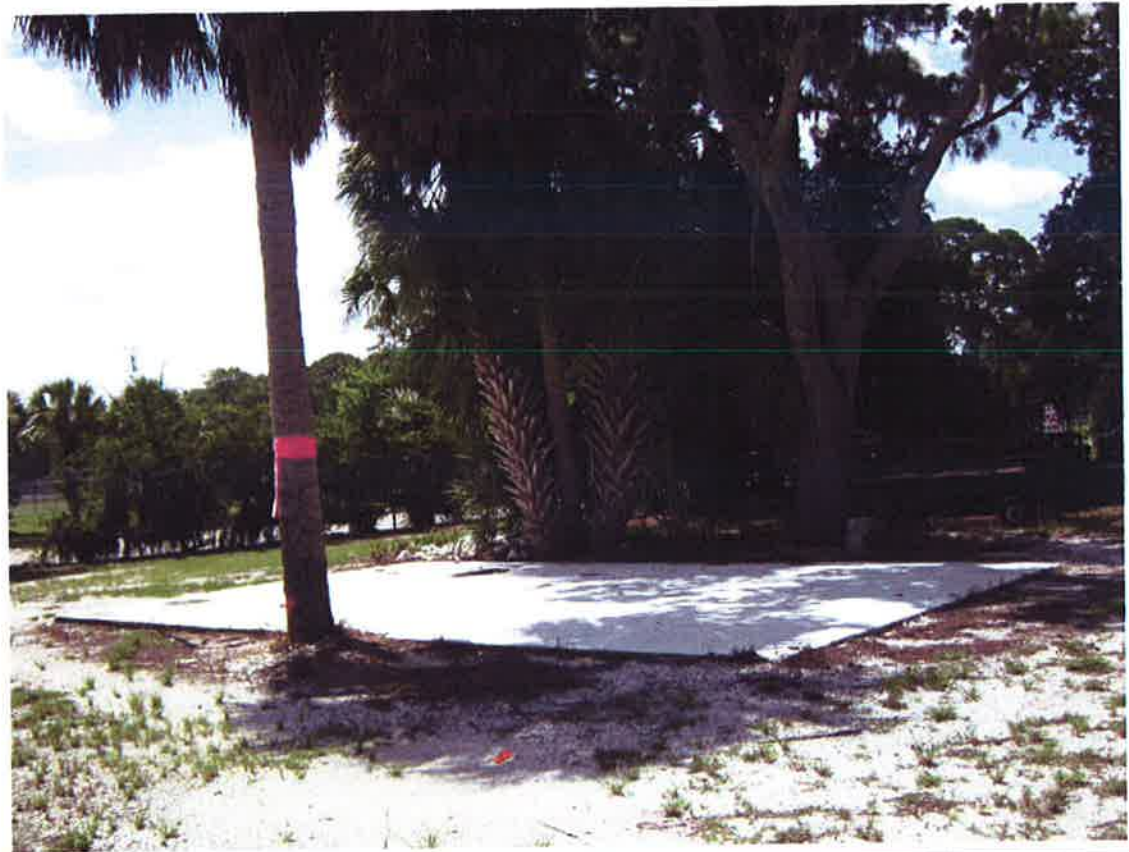
Photo B-8

Upper Photo: View of pathway on the west-central portion of the Property.
Lower Photo: View of a concrete slab on the west-central portion of the Property.

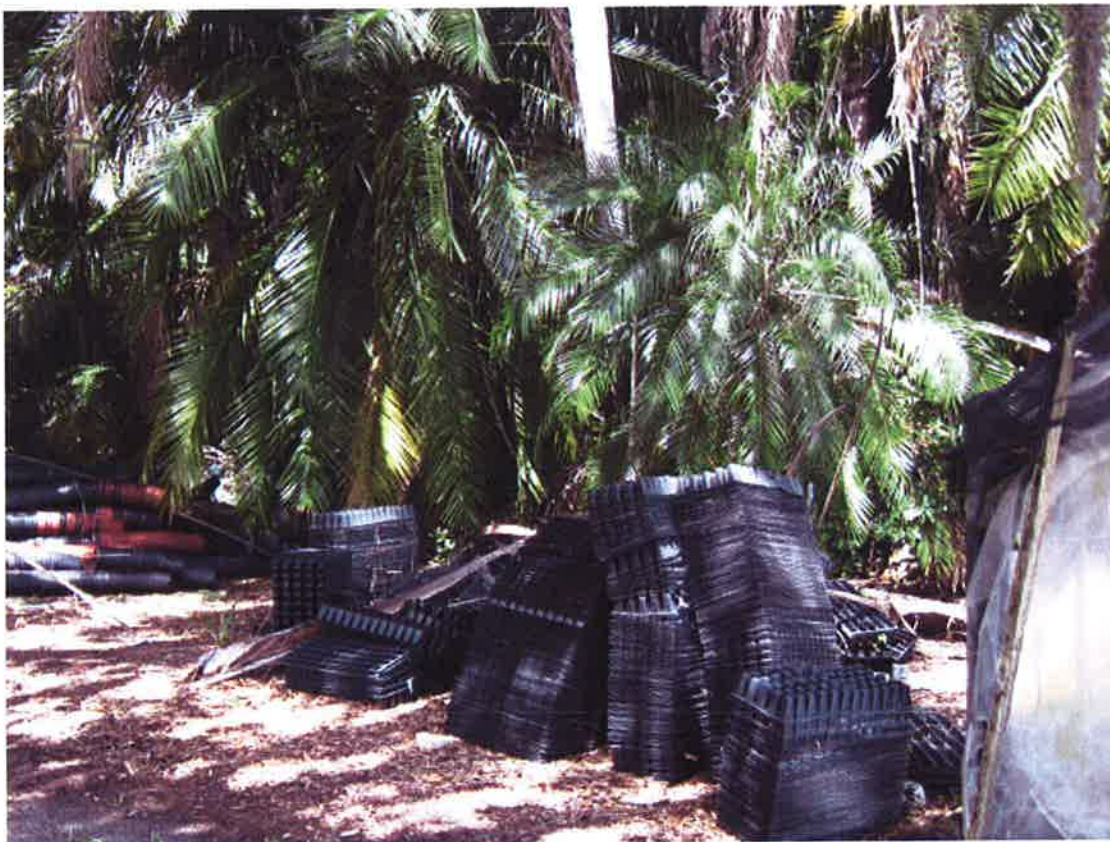
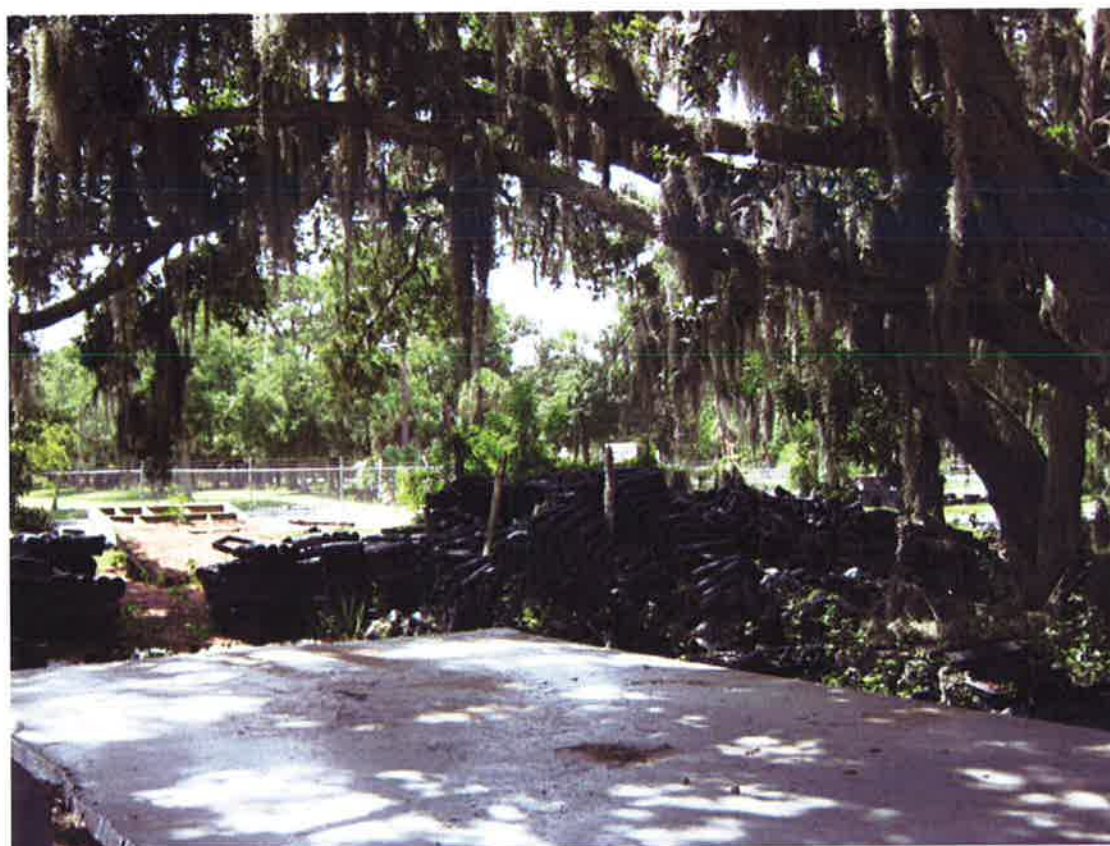
Photo B-9

Upper Photo: View of plant containers on the northwest portion of the Property.
 Lower Photo: View of plant containers on the northwest portion of the Property.

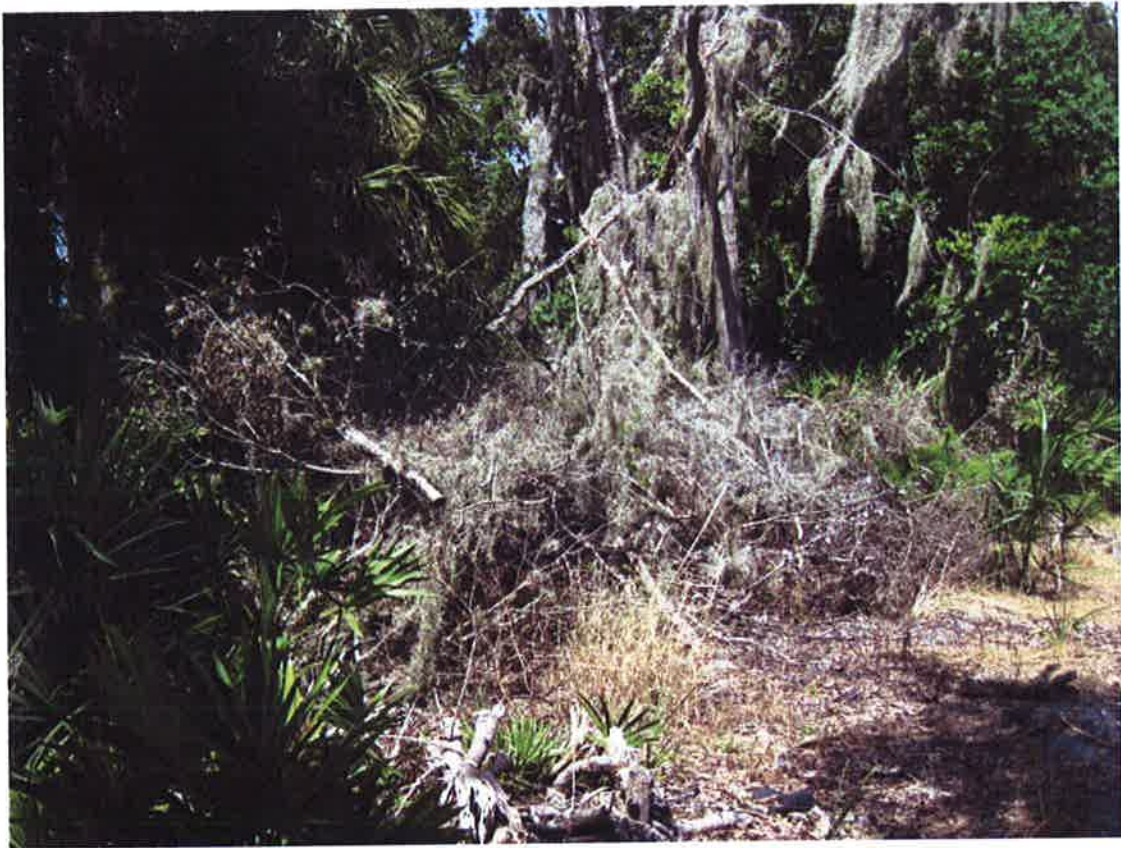
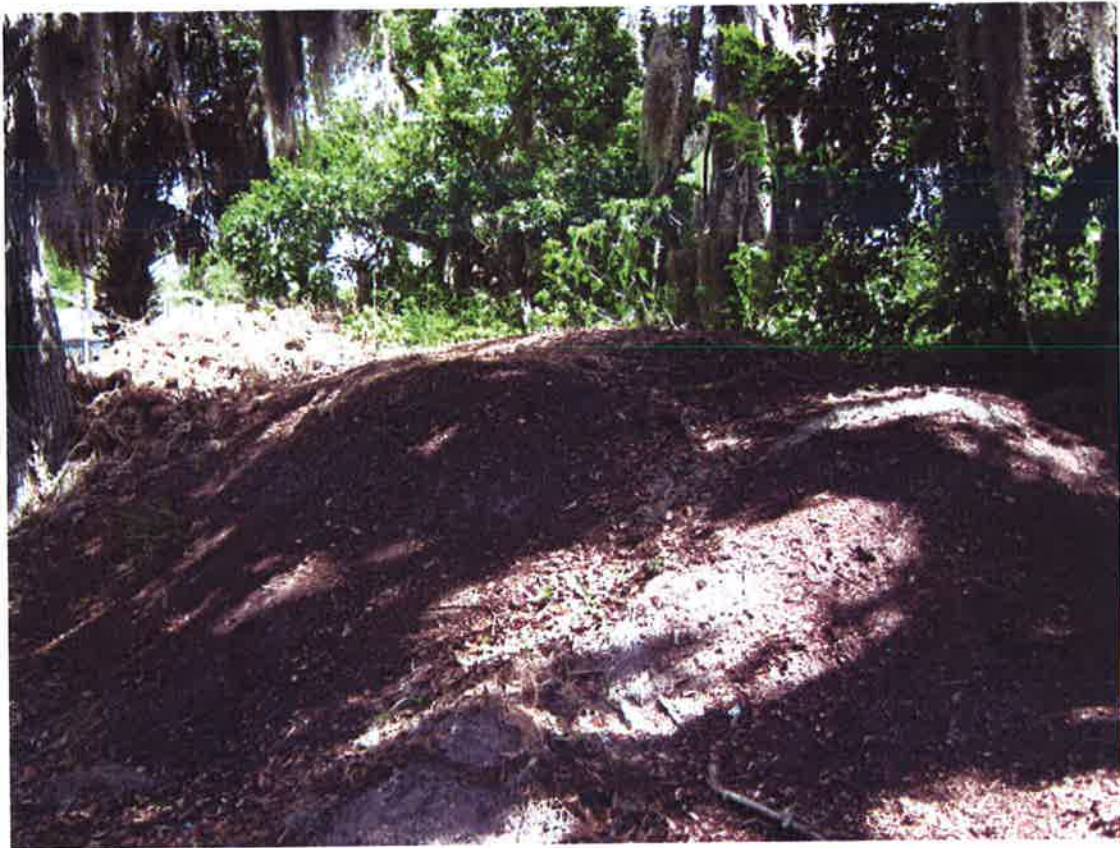
Photo B-10

At the time of the site visit, GLE was informed that a pond/depression area was previously located on the northern portion of the Property. According to Mr. Greg Taylor, site contact/Property owner, the pond/depression area was previously filled with miscellaneous horticulture debris and eventually covered with soil. In addition, it should be noted that according to Mr. Taylor, the Property was historically graded with clean fill as a means to raise the elevation of the Property. At this time, the pond/depression area previously filled with horticulture debris appears to pose a REC to the Property at this time, in GLE opinion.

Upper Photo: View of horticulture debris observed on the northern portion of the Property. Lower Photo: View of potting soil on the northern portion of the Property.

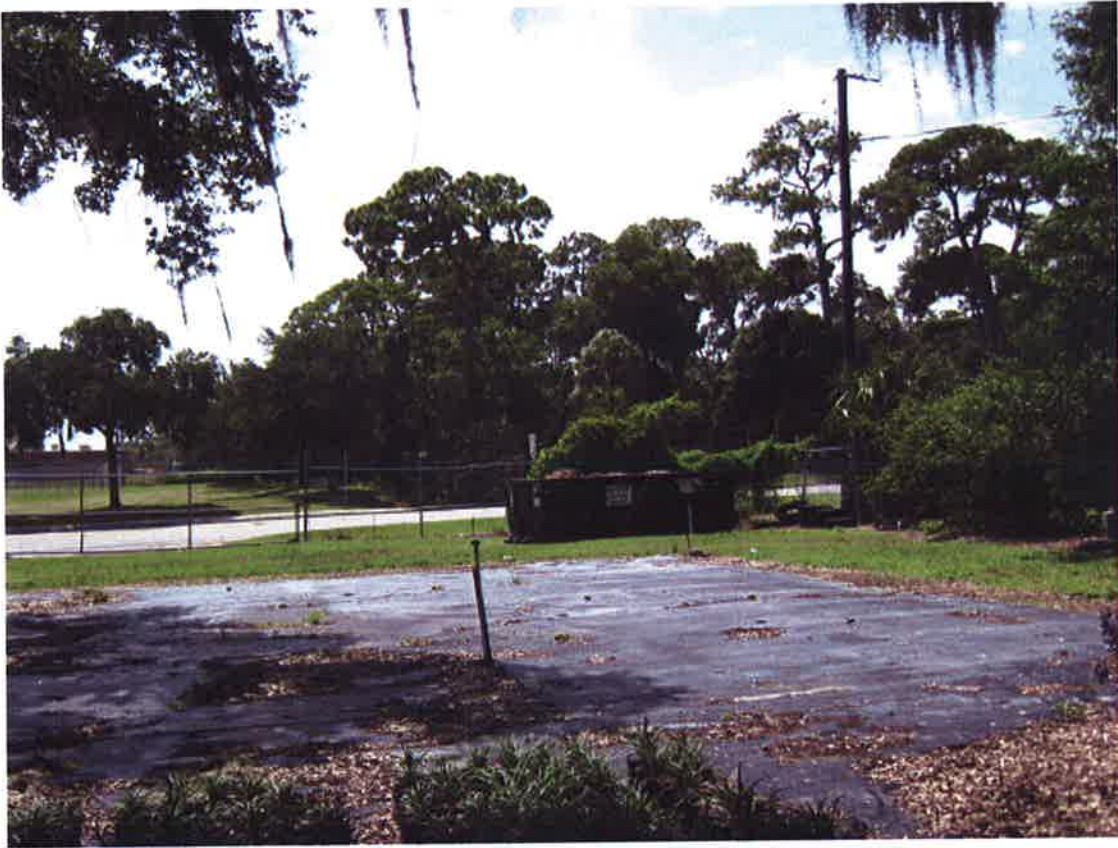
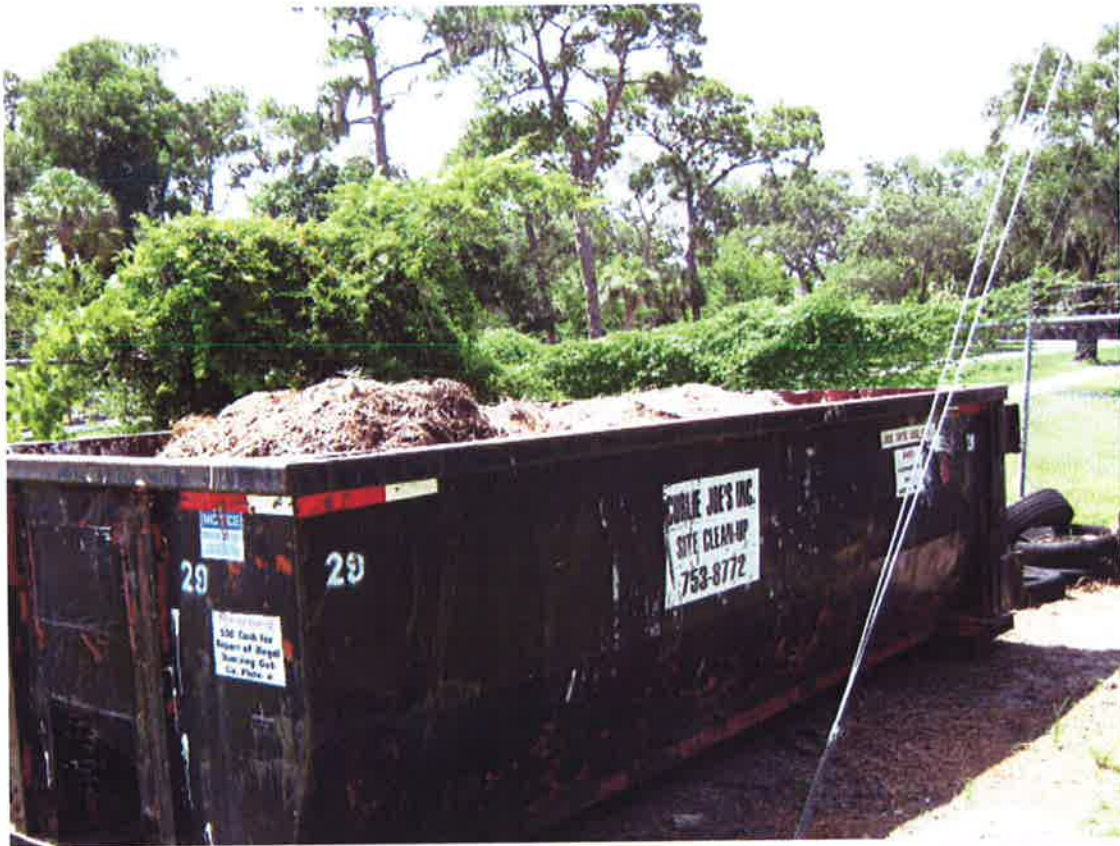
Photo B-11

Upper Photo: View of the northwest portion of the Property. Lower Photo: Roll-off with miscellaneous debris staged on the northwest portion of the Property for removal.
