PHASE I ENVIRONMENTAL SITE ASSESSMENT

**Taylor Nursery
907 63rd Avenue East
Bradenton, Manatee County, Florida**

GLE Project No. 10310-00099

July 2010

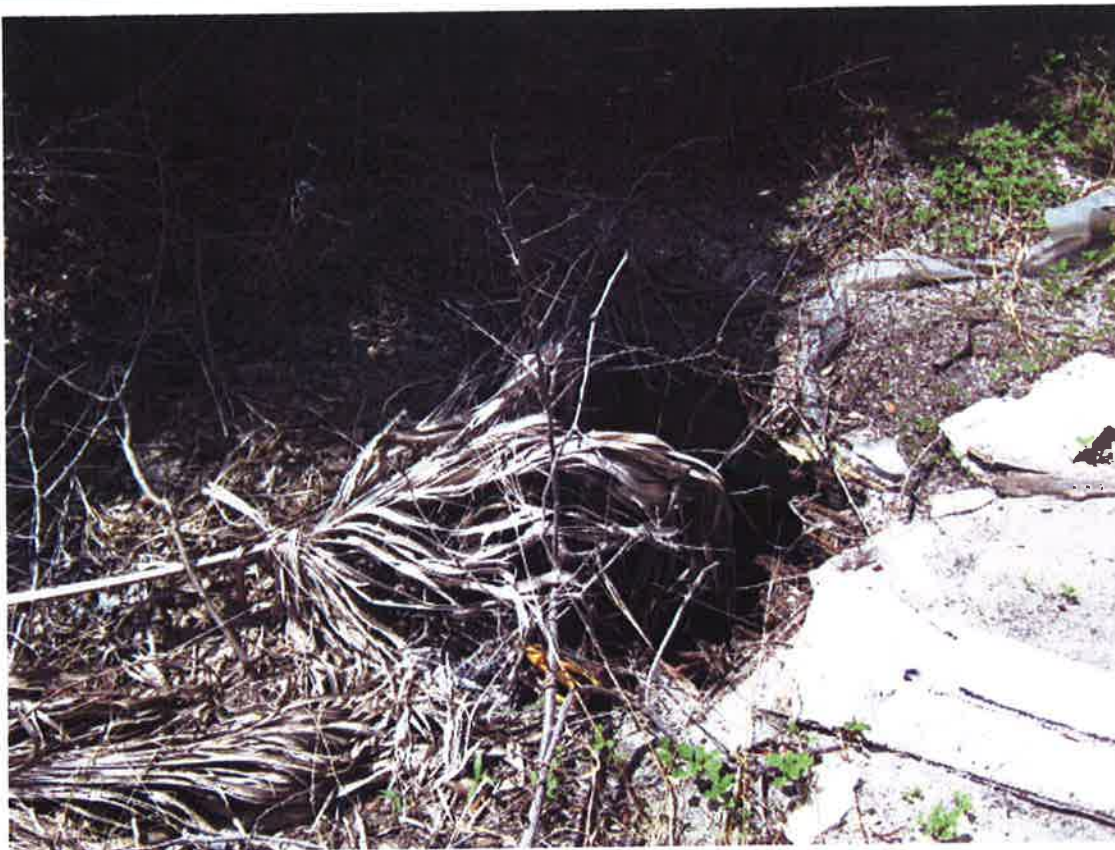
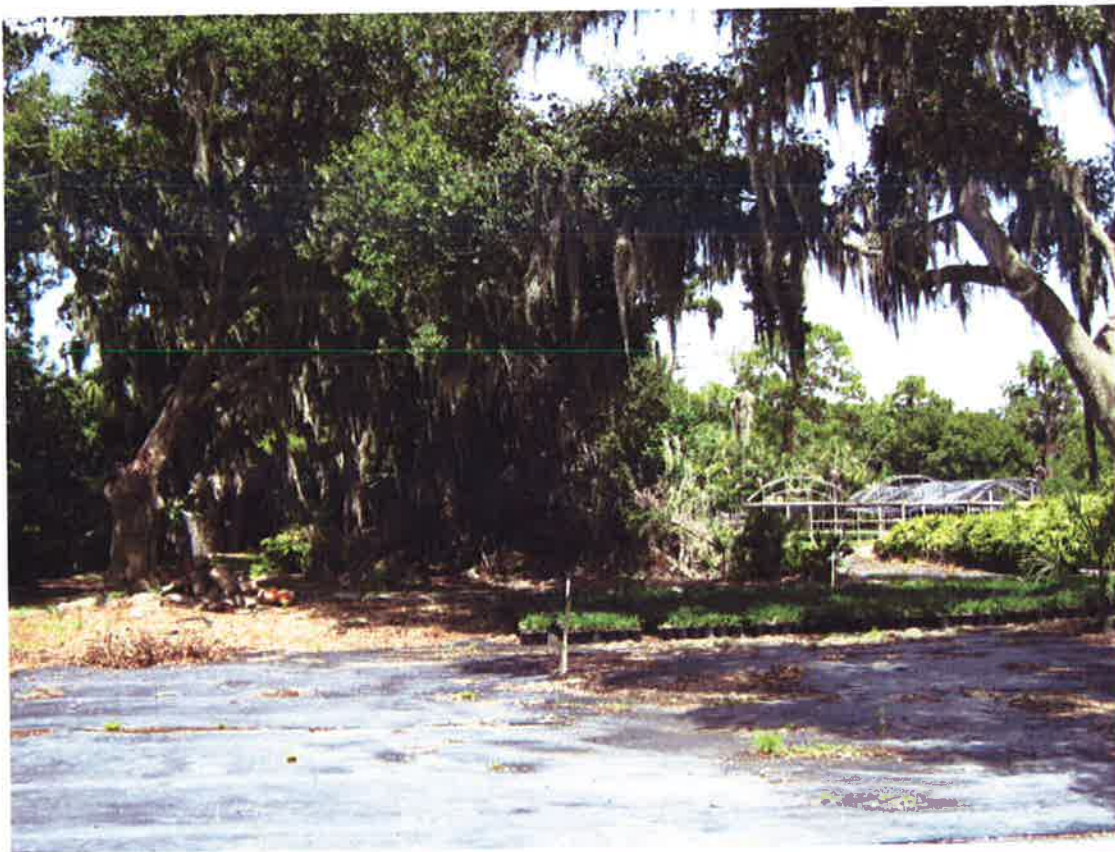
Photo B-12

Upper Photo: Stormwater drainage structure observed on the northwest portion of the Property. Lower Photo: View of the Northern portion of the Property.

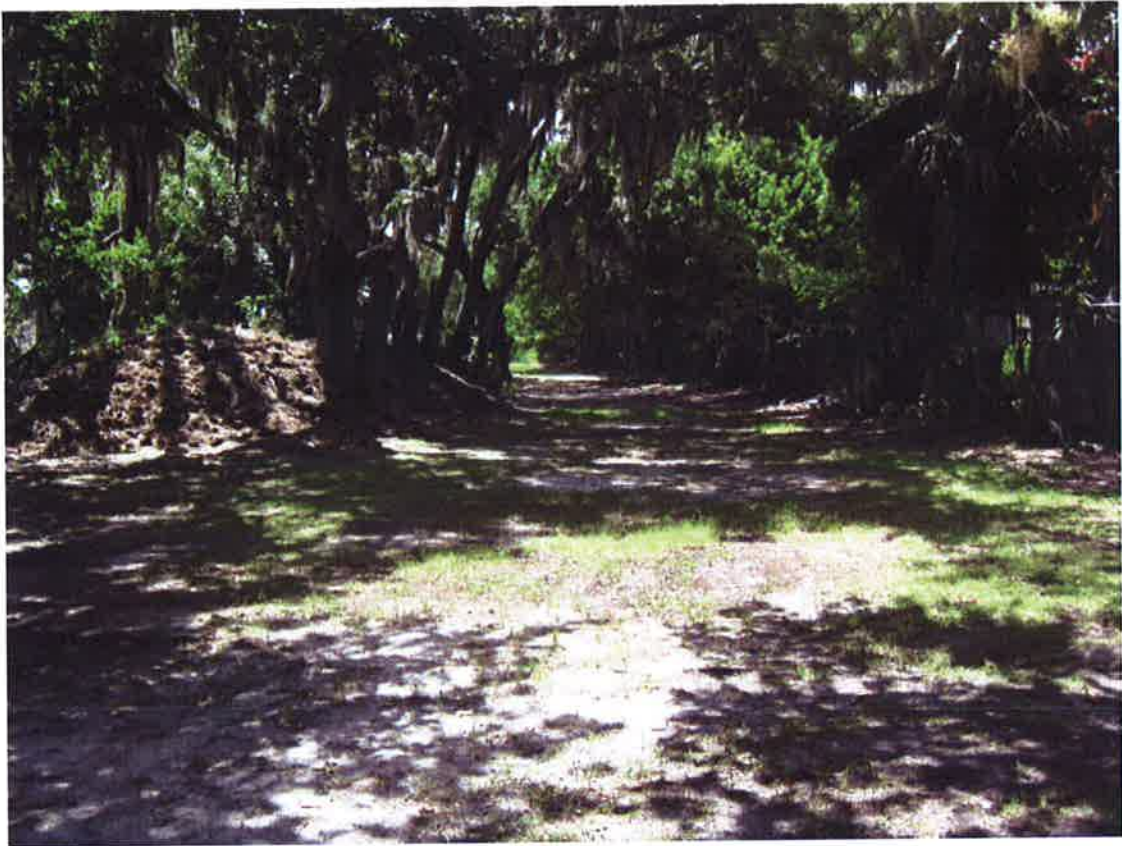
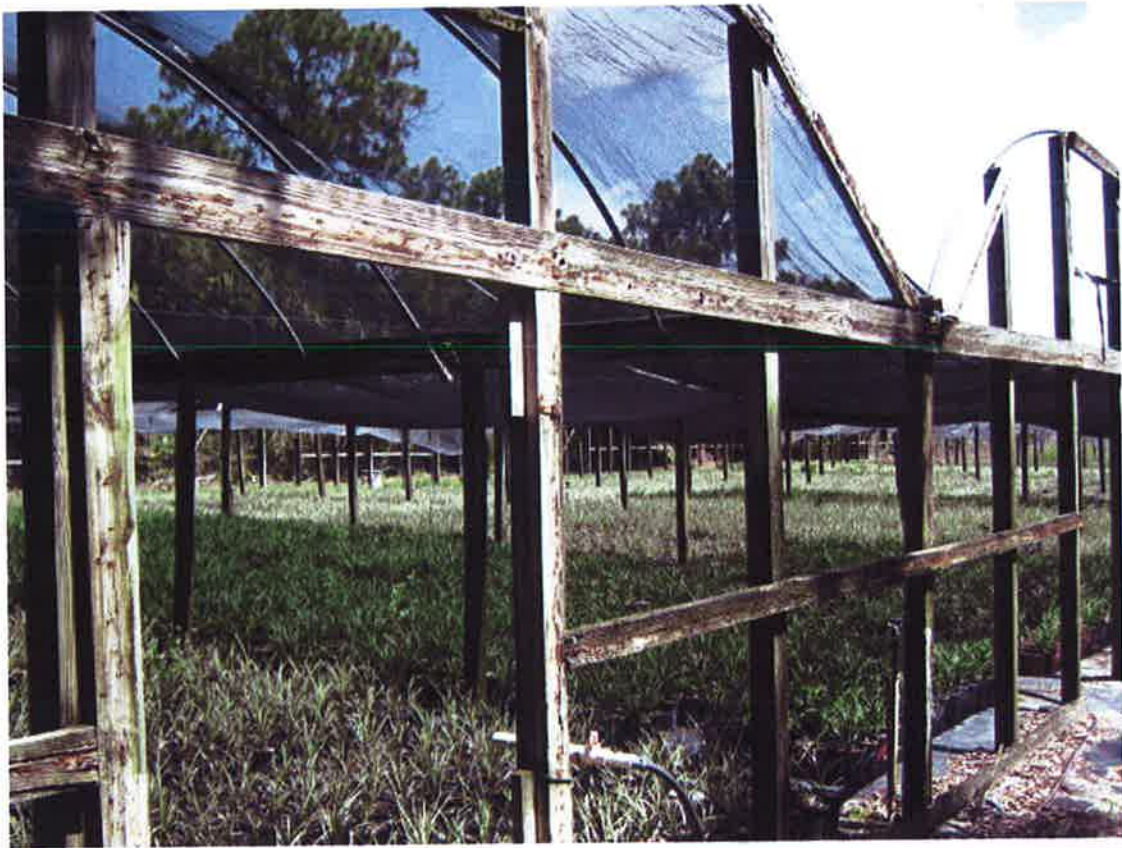
Photo B-13

At the time of the site visit, GLE was informed that a pond/depression area was previously located on the northern portion of the Property. According to Mr. Greg Taylor, site contact/Property owner, the pond/depression area was previously filled with miscellaneous horticulture debris and eventually covered with soil. In addition, it should be noted that according to Mr. Taylor, the Property was historically graded with clean fill as a means to raise the elevation of the Property. At this time, the pond/depression area previously filled with horticulture debris appears to pose a REC to the Property at this time, in GLE opinion.

Upper Photo: View of pond/depression area previously filled in with horticulture debris and soil. Lower Photo: View of the northeast portion of the Property.

Based on the historic use of the Property as a nursery facility, GLE recommends additional environmental assessment of the Property. GLE recommends that soil and groundwater samples be collected for laboratory analysis for the potential contaminants of concern. The Phase II ESA should include investigations throughout the Property and in the vicinity of the pond previously filled as well as the former fuel oil AST location.

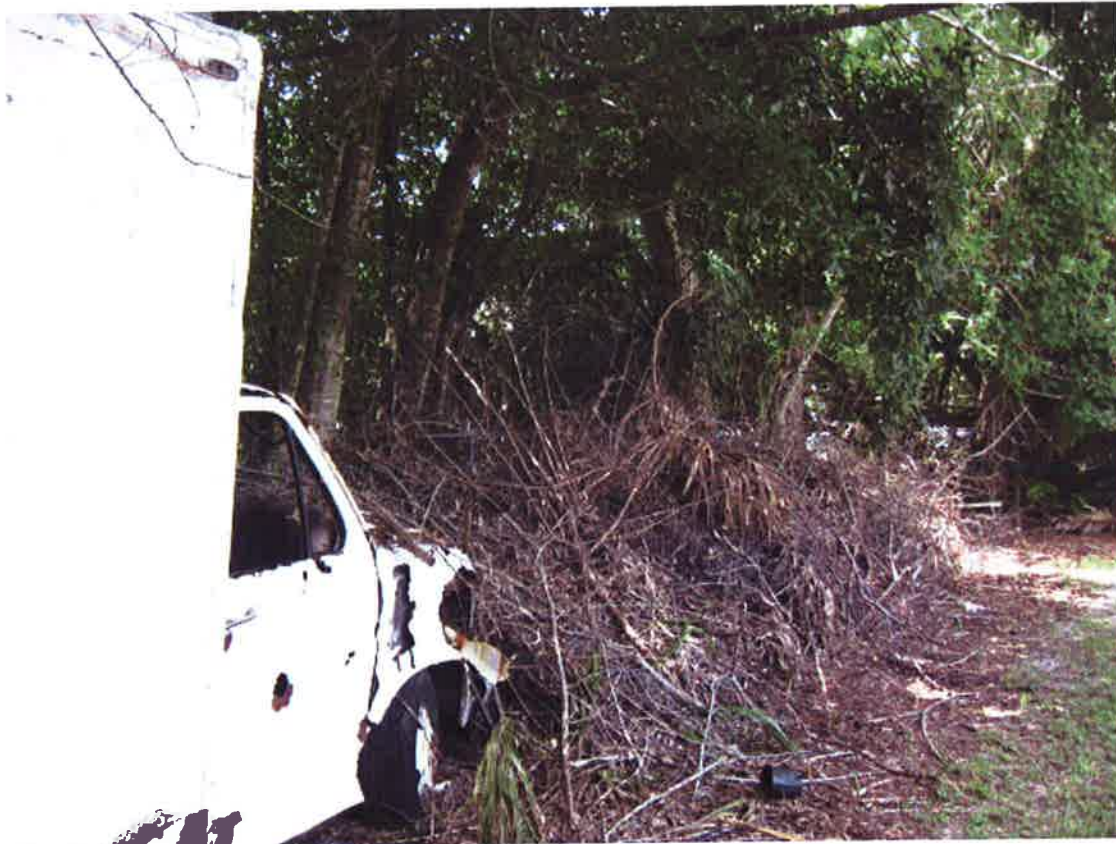
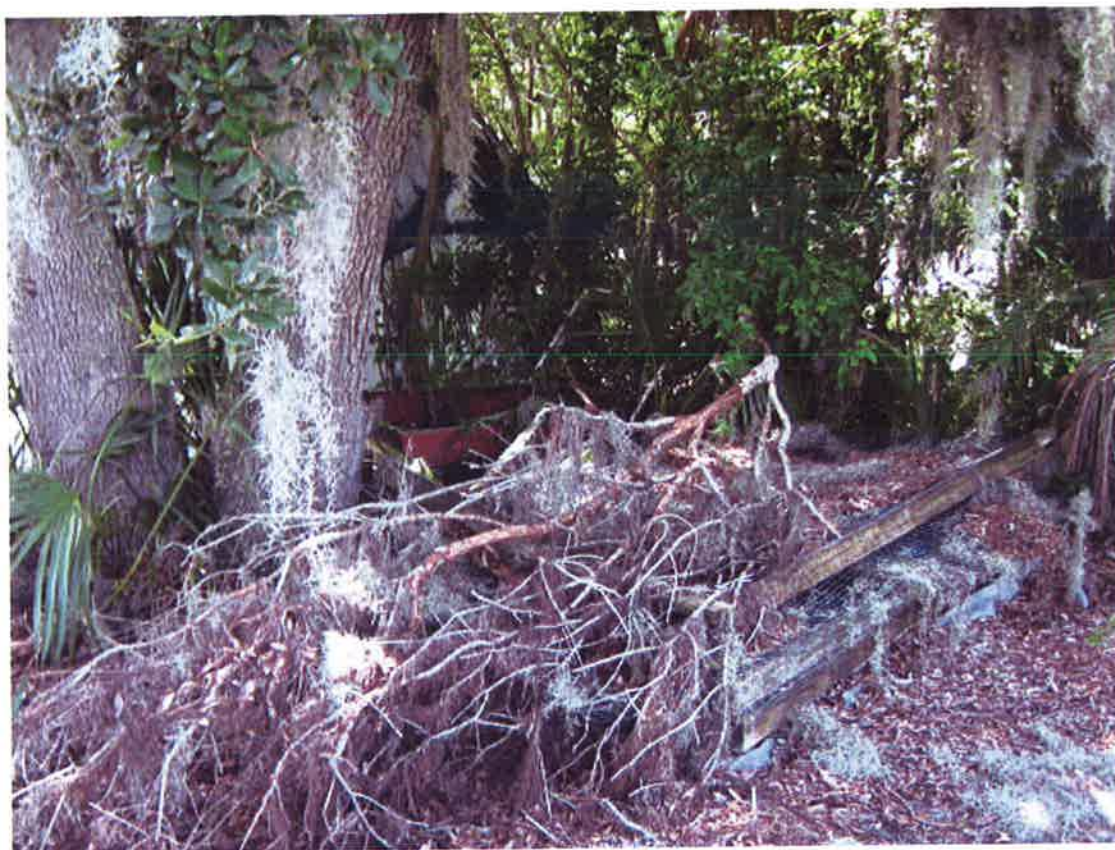
Photo B-14

Upper Photo: Horticulture debris and former delivery truck stored on the northeast portion of the Property. Lower Photo: View of debris observed on the northeast portion of the Property.

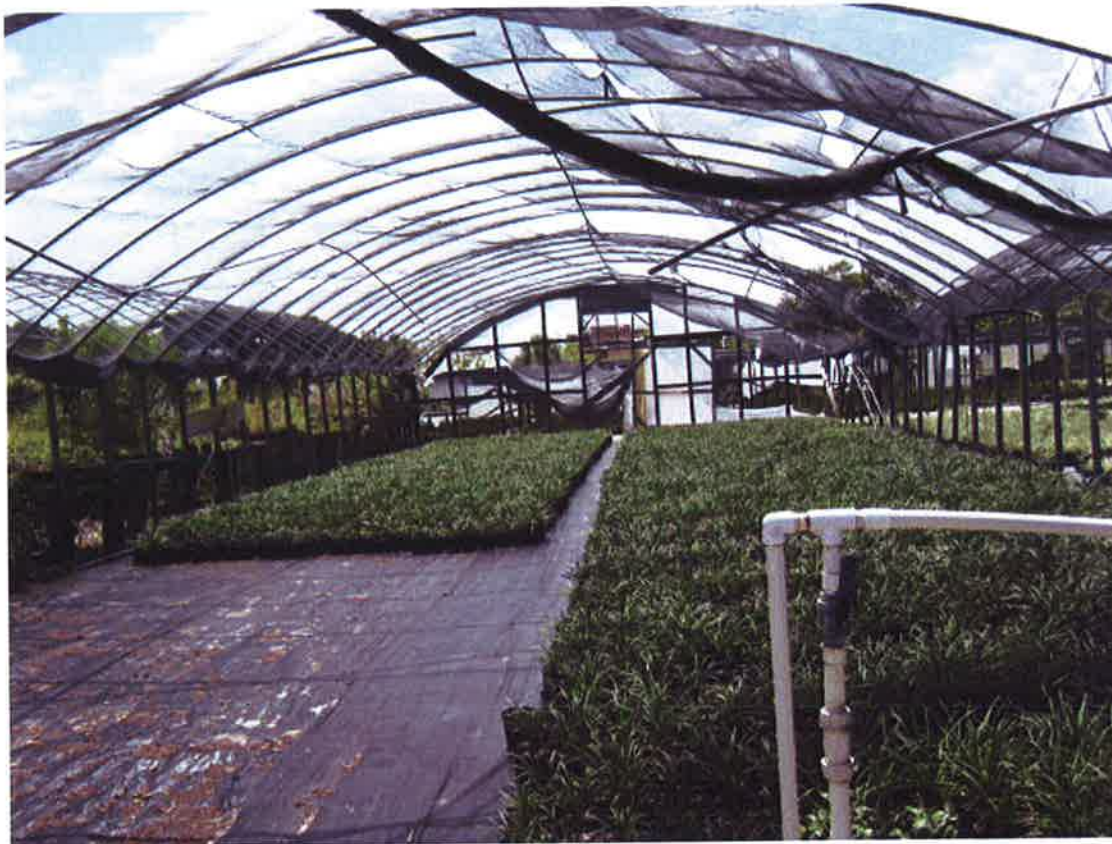
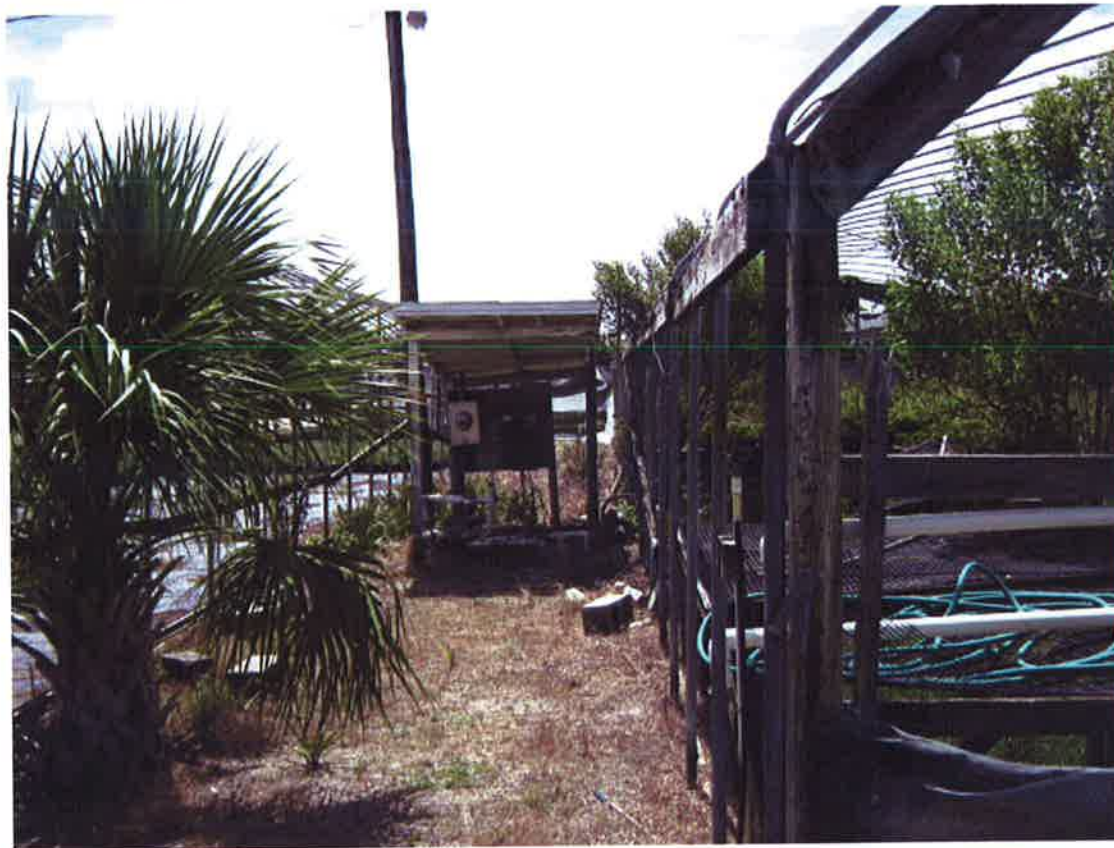
Photo B-15

Upper Photo: View of growing area on the central portion of the Property. Lower Photo: View of the irrigation water well located on the south-central portion of the Property.

GLE recommends that the onsite water wells (the former water well and the irrigation water well) should be abandoned in accordance with applicable water management district regulations if no longer intended to be utilized for this designated purpose. Special assessment activities may be required in order to locate the former water well previously associated with the onsite building structure.

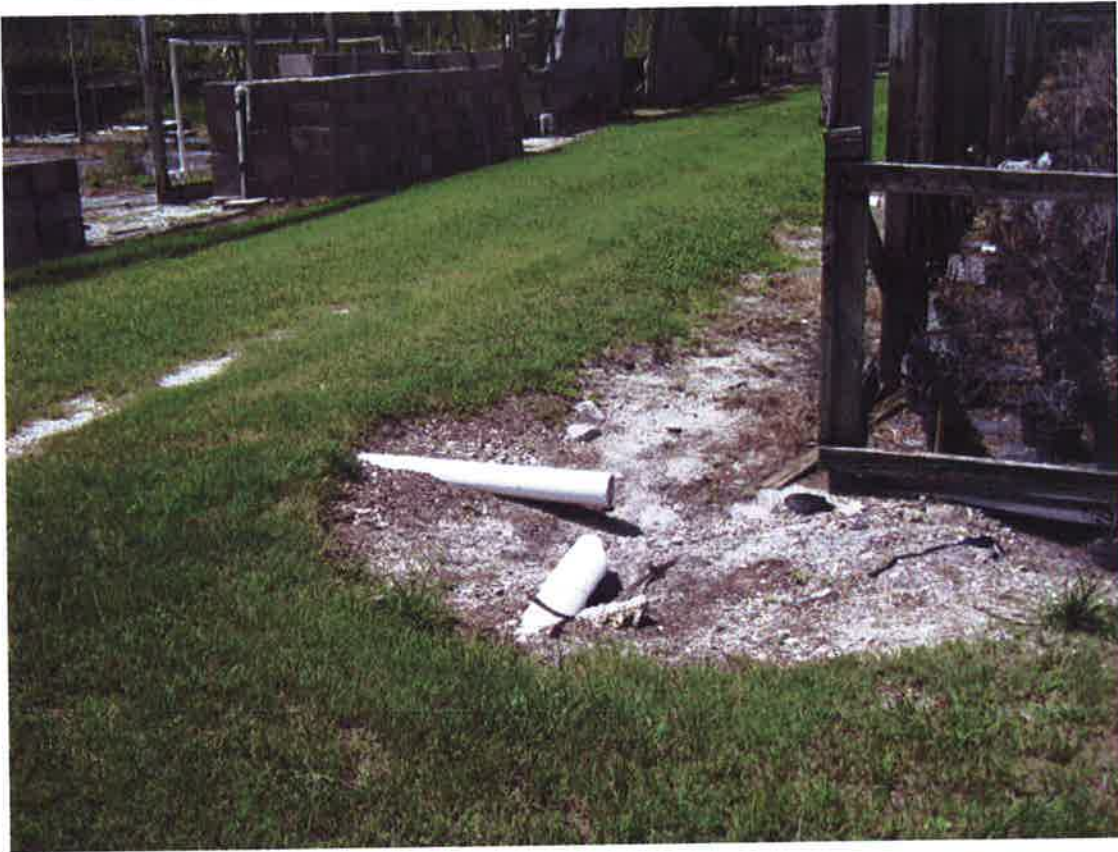
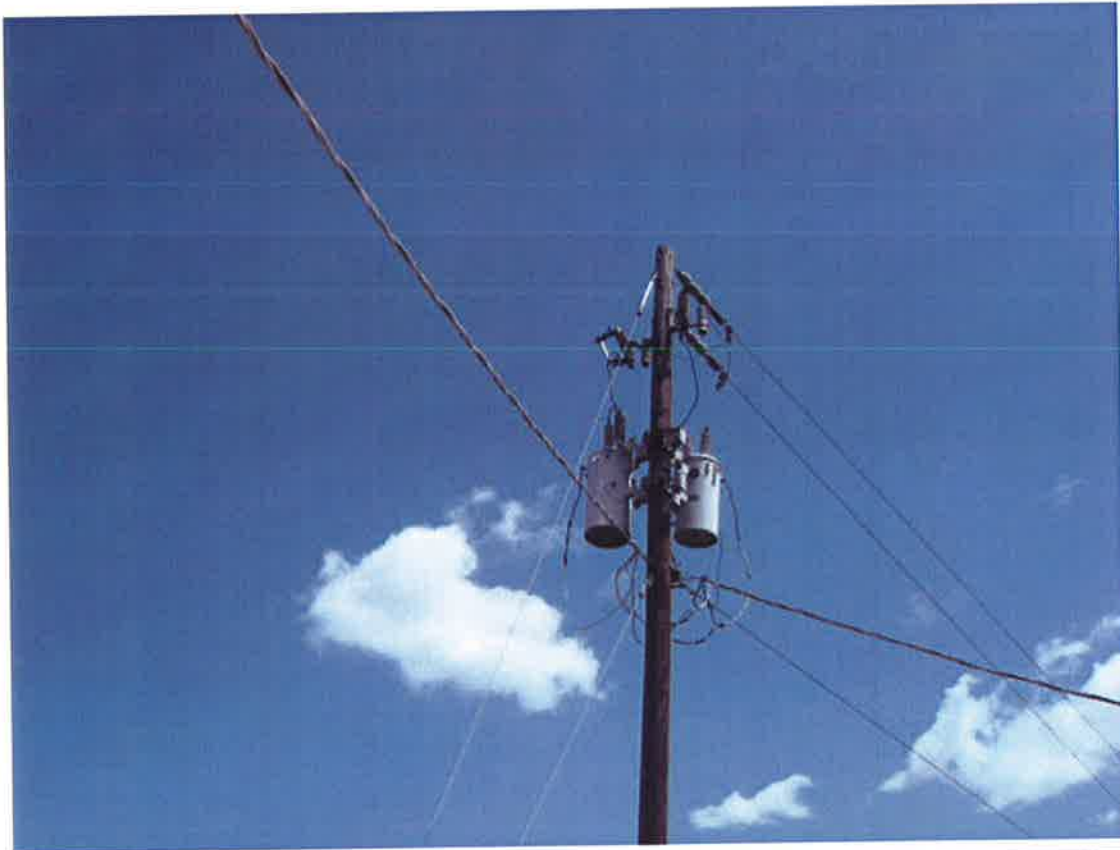
Photo B-16

Upper Photo: View of stormwater drainage system for the central portion of the Property. Lower Photo: Pole mounted transformers on the south-central portion of the Property.

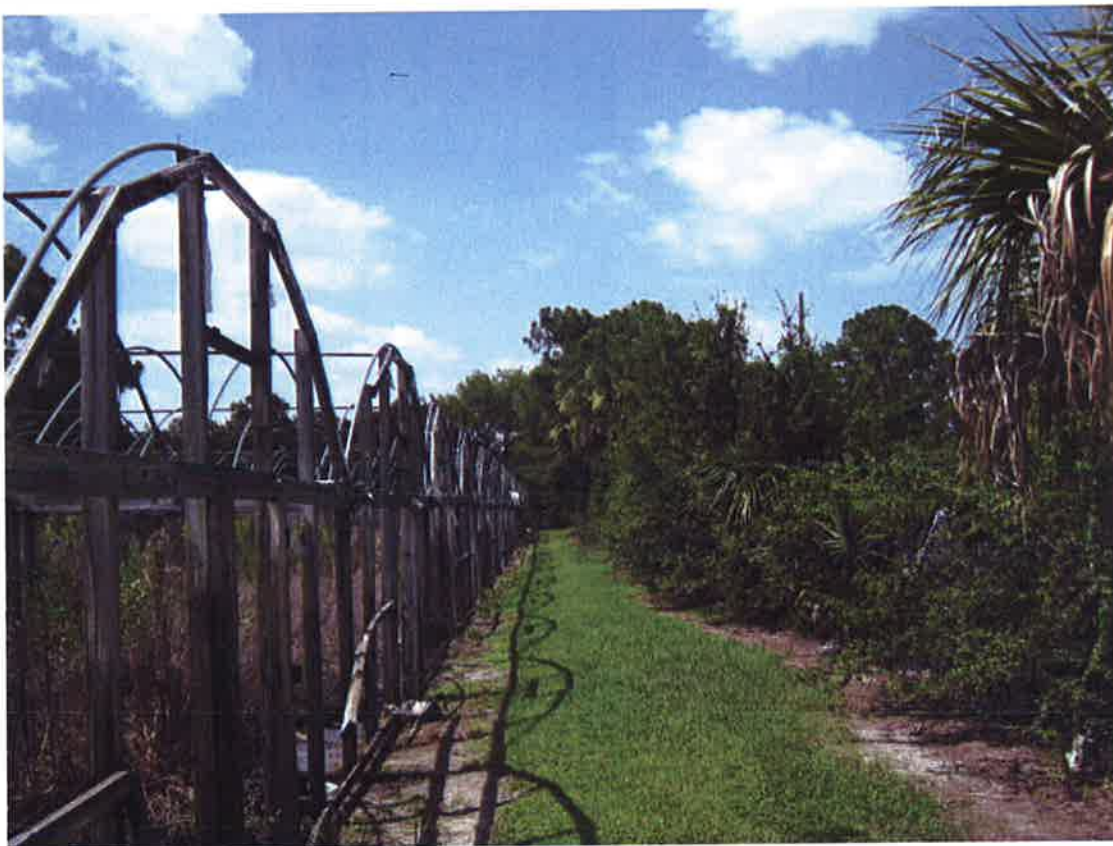
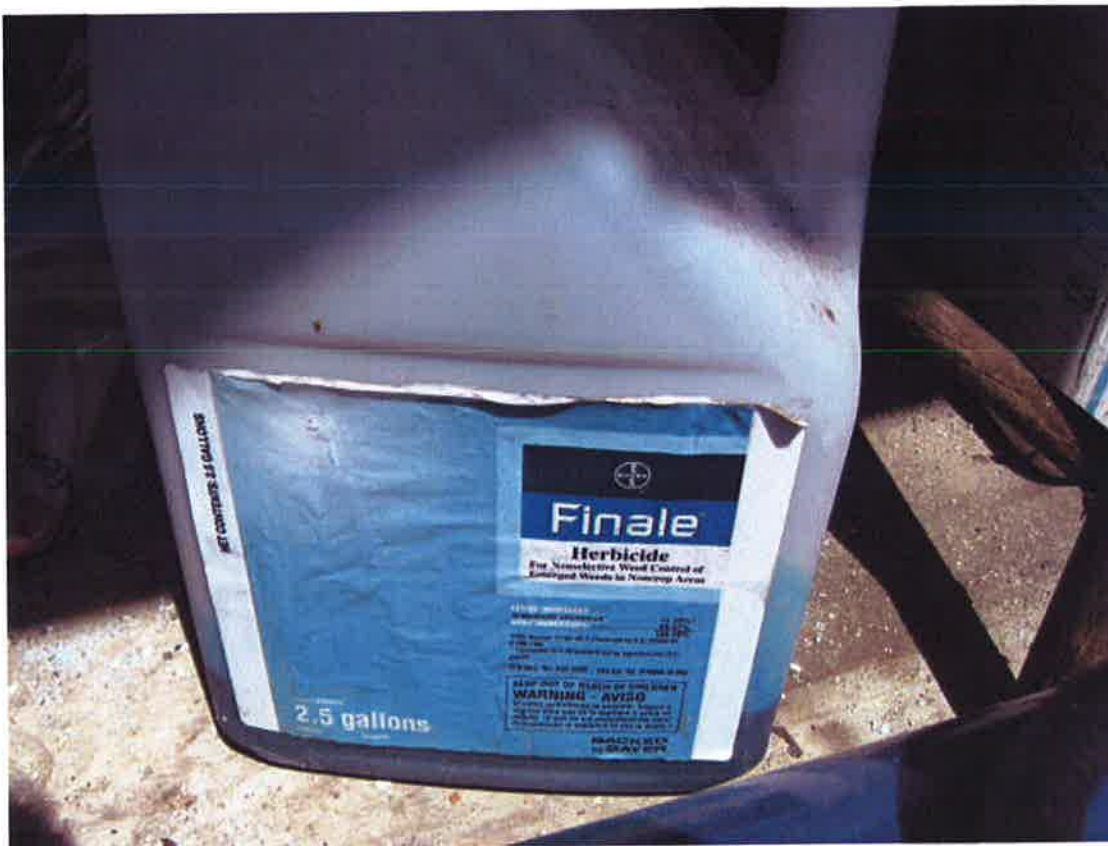
Photo B-17

The Property was historically utilized as an ornamental plant nursery from at least 1975 to the present date. According to Mr. Greg Taylor, the site contact and Property owner, throughout this time, pesticide and herbicide chemicals have been applied on plants associated with the nursery on an as needed basis. Therefore, there is a potential for the Property to have been impacted by the application of pesticide and herbicide chemicals. Based on site observations liquid and granular herbicides, and liquid pesticide products, were observed stored in the manufacturers packaging and containers. The chemical products were observed in the manufacturers supplied containers/sacks and stored within an onsite storage shed, which is located adjoining to the northwest of the onsite residence/office building and on the south-central portion of the Property. There were no apparent bulk chemical storage and/or chemical mixing tank areas observed on the Property at the time of GLE’s site visit on July 22, 2010. However, the application of pesticide and herbicide chemicals on the Property being used as a nursery since 1975 is considered a recognized environmental condition (REC) to the Property at this time, in GLE’s opinion.

Upper Photo: View looking north along the east Property boundary. Lower Photo: Herbicide container observed within the storage shed adjacent to the northeast of the onsite residence/office

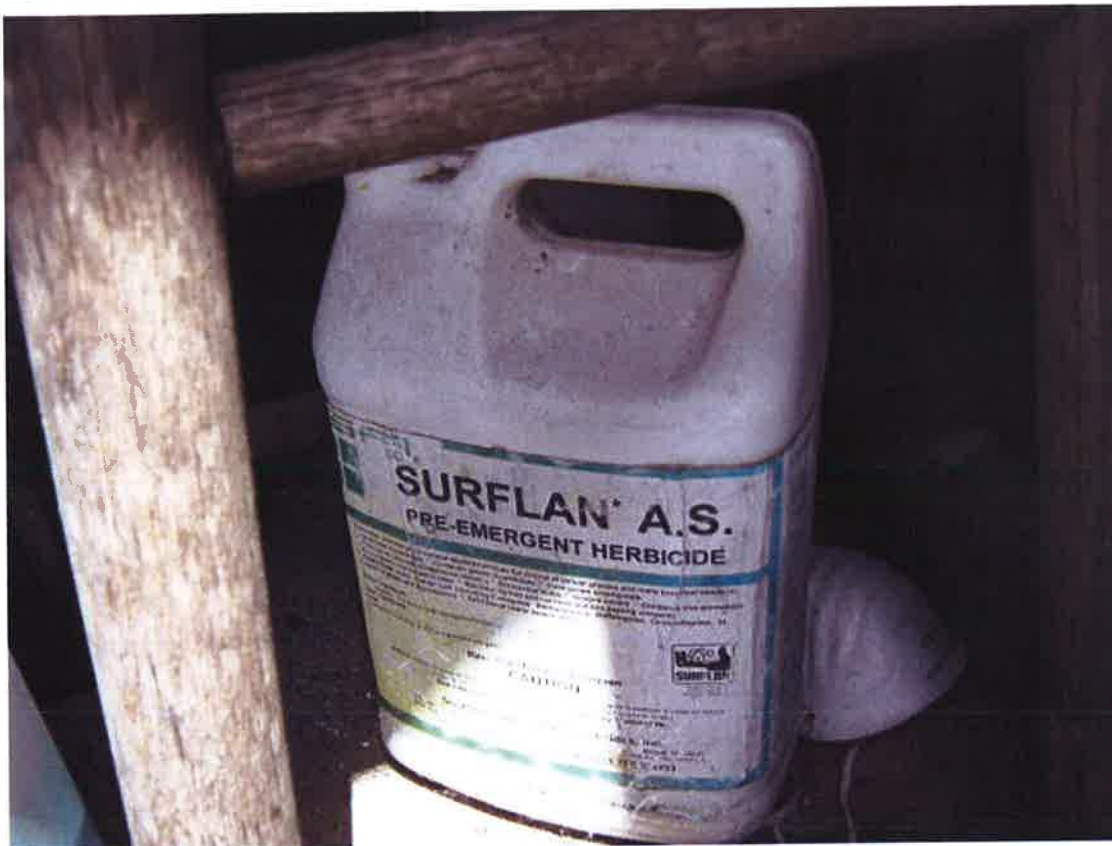
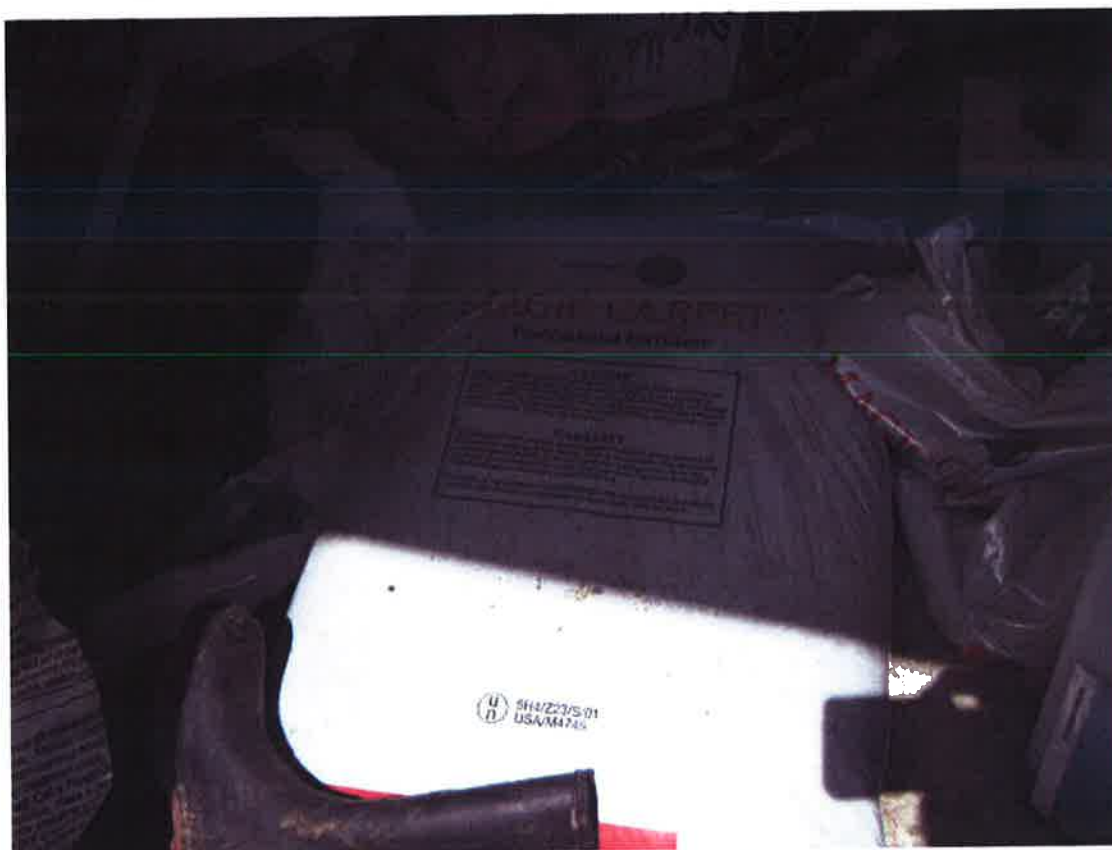
Photo B-18

Upper Photo: View of herbicide container observed within the storage shed adjacent to the northwest of the residence/office. Lower Photo: View of fertilizer observed within the onsite shed.

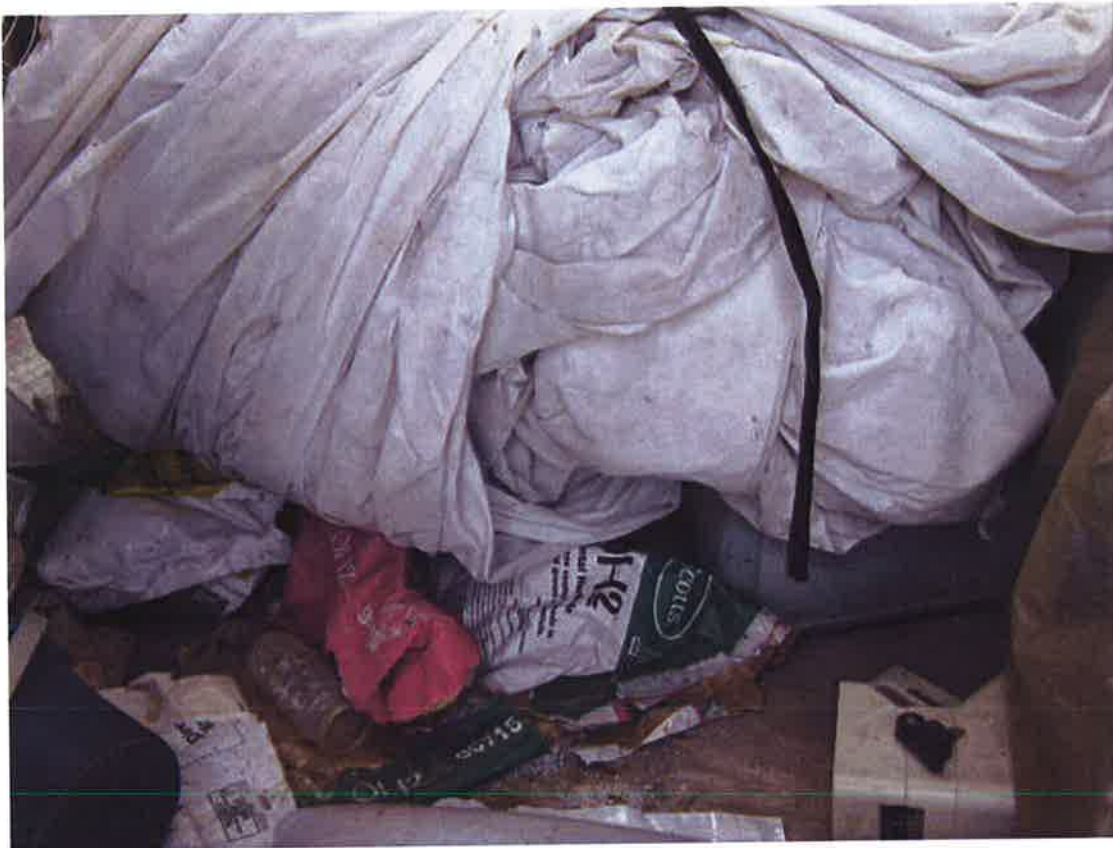
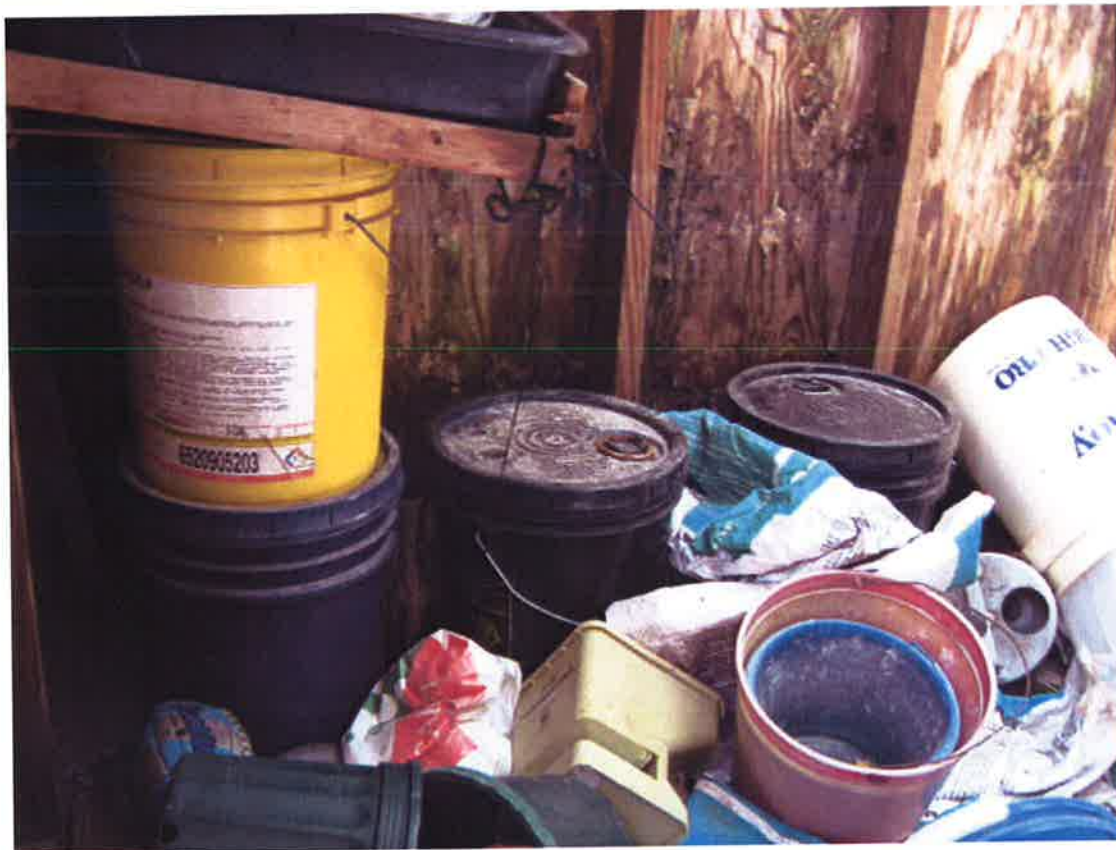
Photo B-19

Upper Photo: Granular herbicide observed stored within the onsite storage shed.

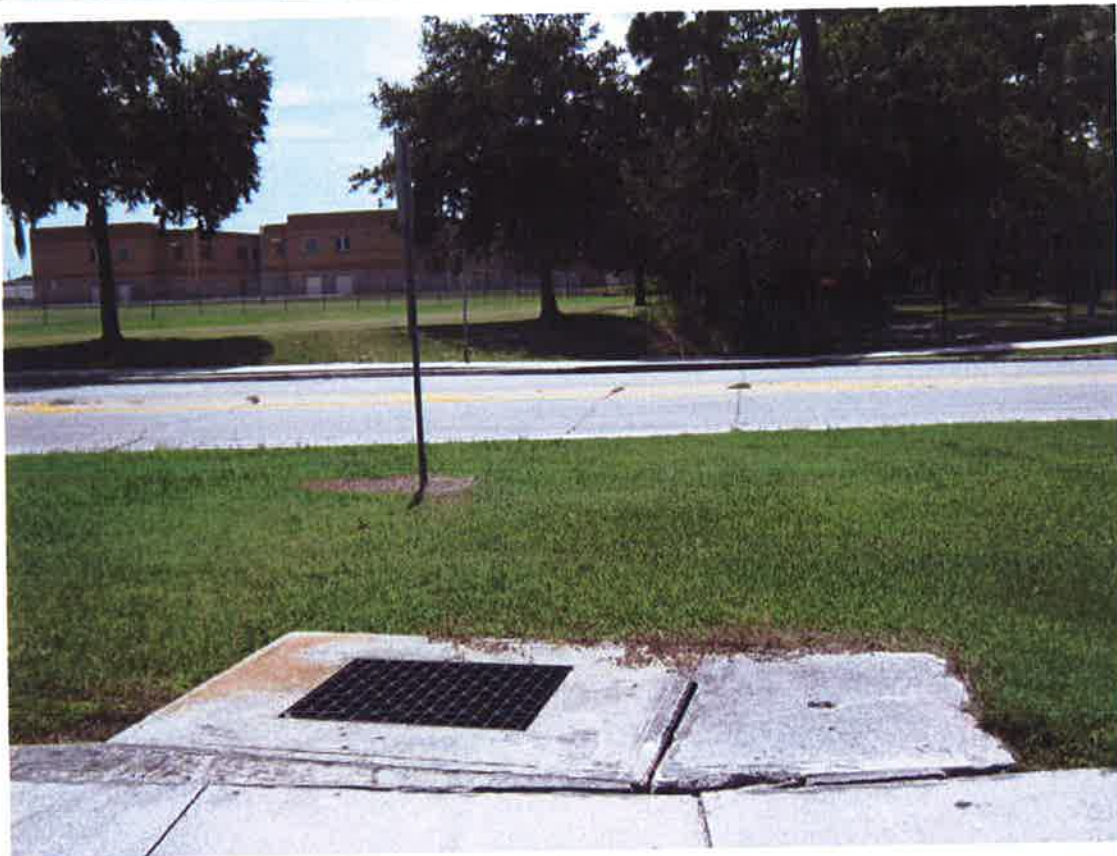
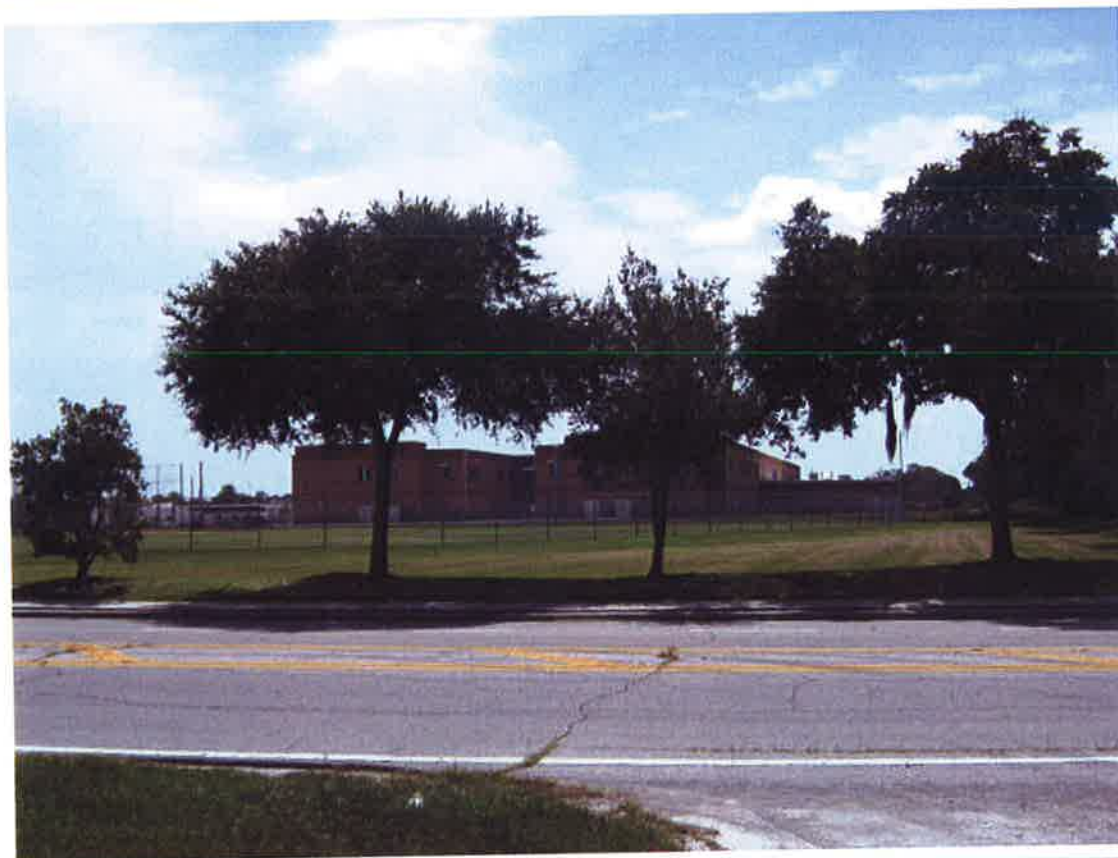
Photo B-24

Upper Photo: View of drainage structure and outfall adjoining to the northwest of the Property.
 Lower Photo: View of the school located adjoining to the west of the Property across 9th Street East.
