- **Rye Road Alternative** – This build alternative consists of a new two-lane crossing the Manatee River adjacent to the existing Rye Road Bridge and the expansion of Rye Road from two to four lanes from SR 64 north to Golf Course Road, Golf Course Road from two to four lanes from Rye Road to Fort Hamer Road, and Fort Hamer Road from two to four lanes from Golf Course Road to US 301, a total of 10.2 miles.

FIGURE 1-1
PROJECT AREA MAP

ASSESSMENT METHODOLOGY

FIGURE 4-1
POTENTIALLY CONTAMINATED SITE LOCATION MAP – BOTH BUILD ALTERNATIVES

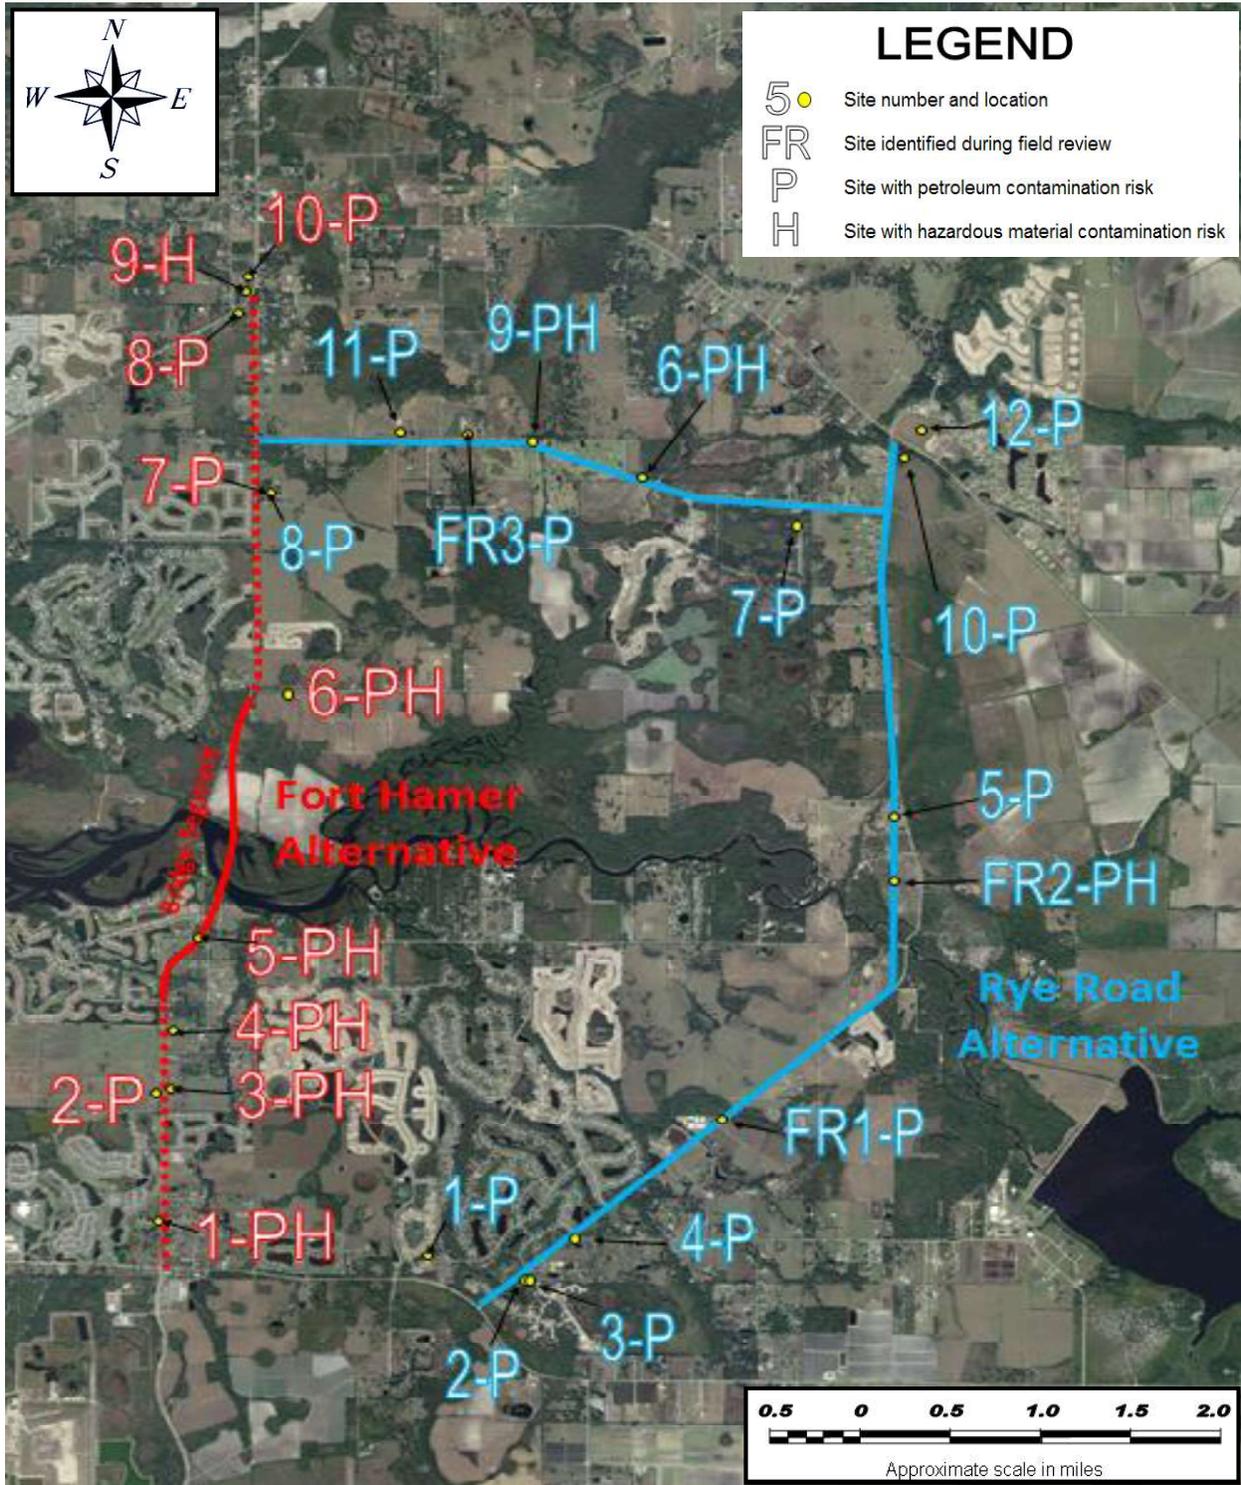
A total of 10 sites have been identified within this alternative as having the potential for hazardous materials and/or petroleum contamination as defined by regulatory agencies. The location of each site in the Fort Hamer Alternative and Rye Road Alternative is shown on **Figure 4-1** and the summary of potentially contaminated sites for the Fort Hamer Alternative is provided in **Table 4-1**. The risk potentials for this alternative are as follows: six “Low” risk sites, three “Medium” risk sites, and one “High” risk site. Each of the “Low,” “Medium,” and “High” ranked sites are discussed more thoroughly in the sections that follow. Note that of these 10 sites, only one (Site No. 5) is located within or adjacent to the construction limits of the Fort Hamer Alternative.

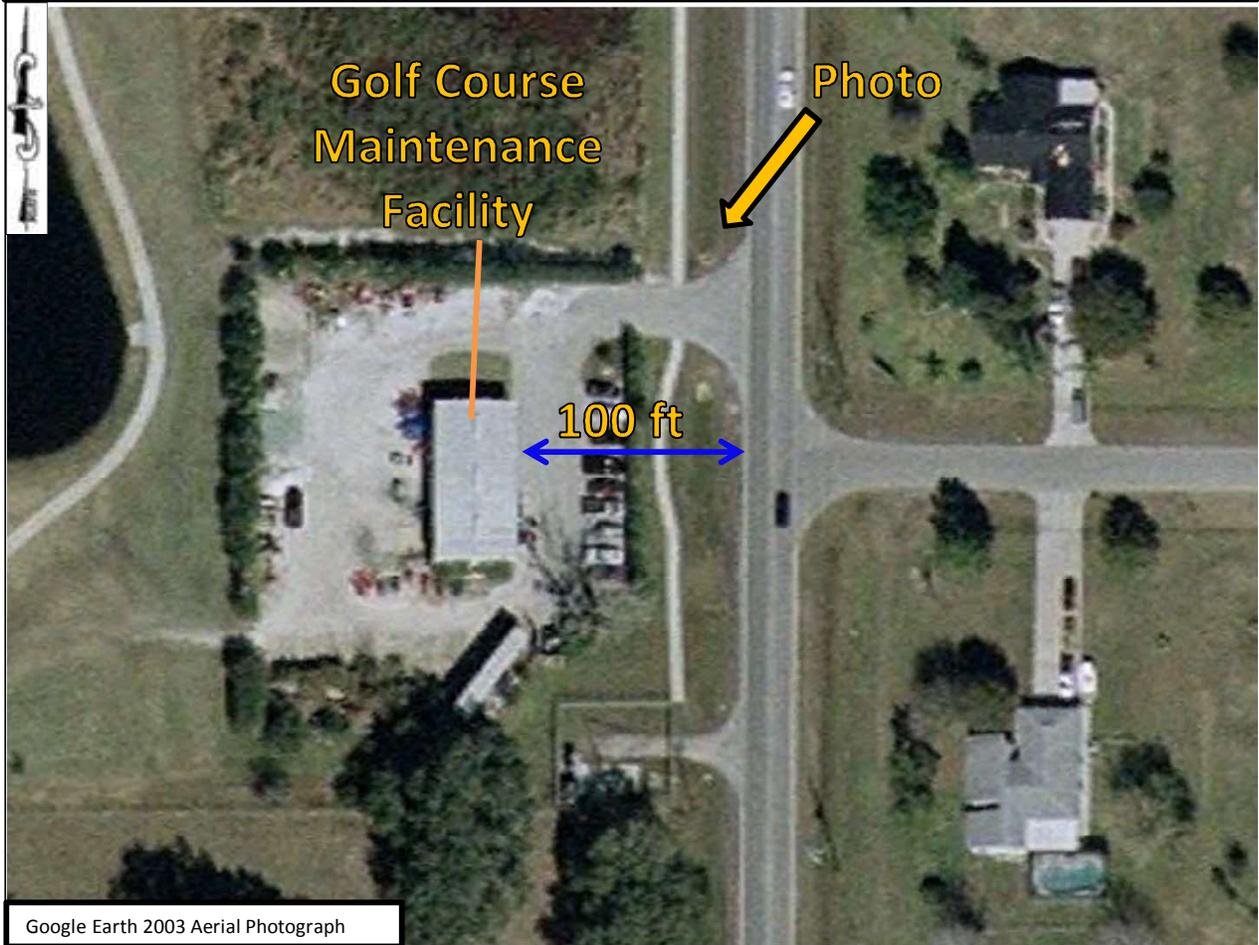
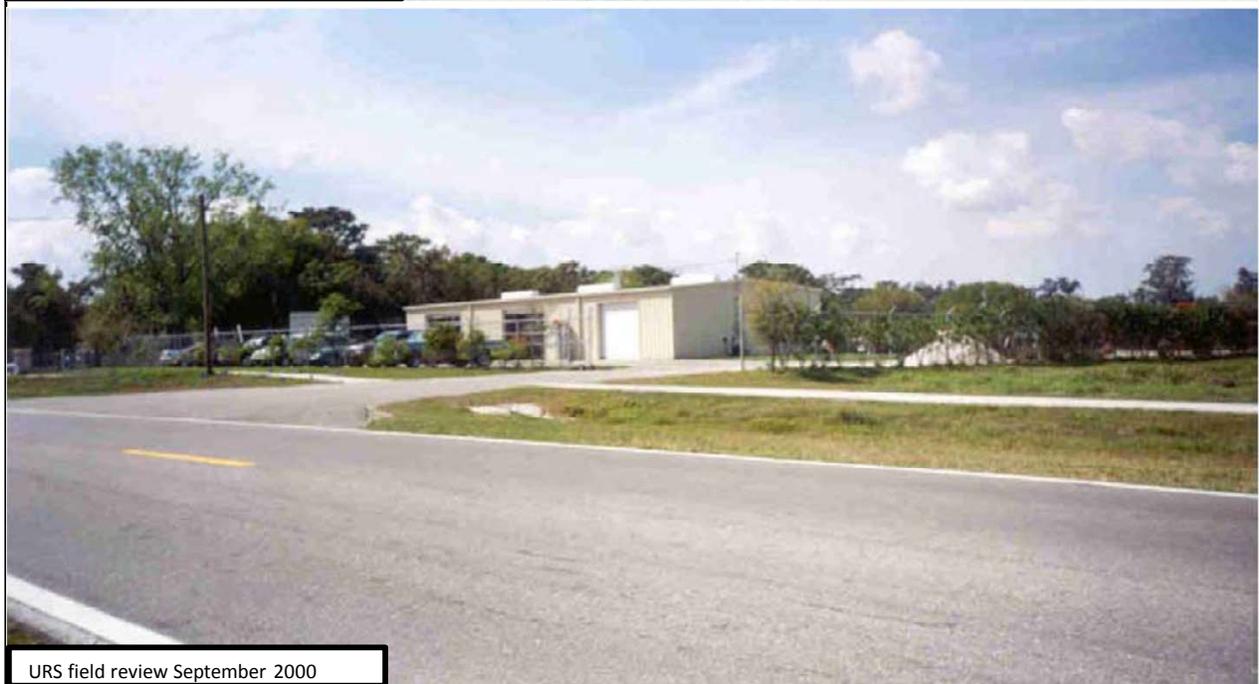
Site 1

- **Site No. 1 (Greenfield Plantation Golf Course Maintenance Facility - Upper Manatee River Road)** - This site is an existing golf course maintenance facility located adjacent and west of the existing ROW. A site photograph and location map with photograph direction is provided on **Page B-1** in **Appendix B**. This facility is not registered with FDEP but typically could be involved with petroleum products, solvents, metals (arsenic), pesticides, and herbicides. A review of the historical aerial photographs indicates that this site has only been in existence since after 1998. No violations were found associated with this site. Based on this information and the fact that this facility is only two to three years old, the risk rating is “Low” for this alternative.

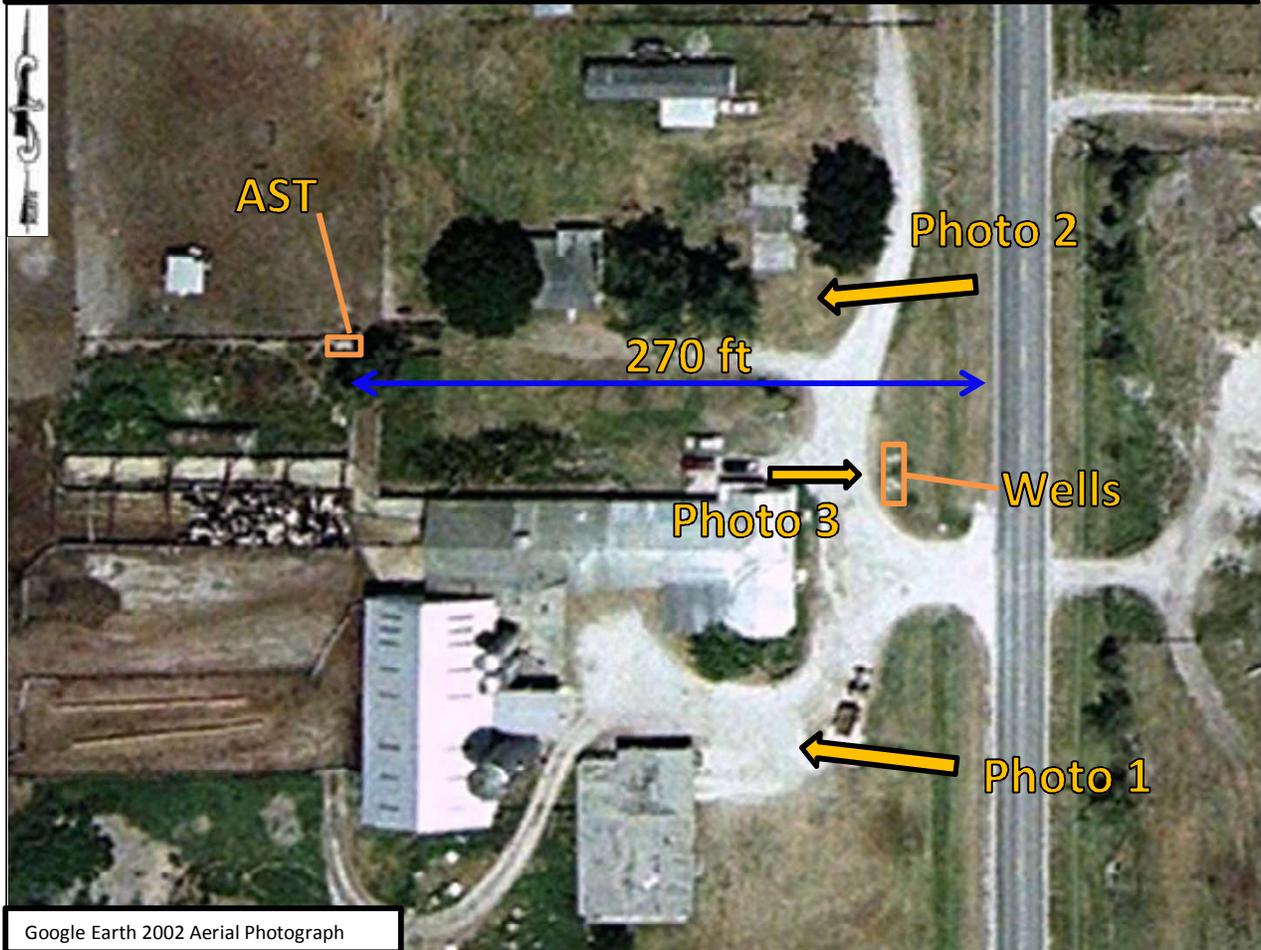
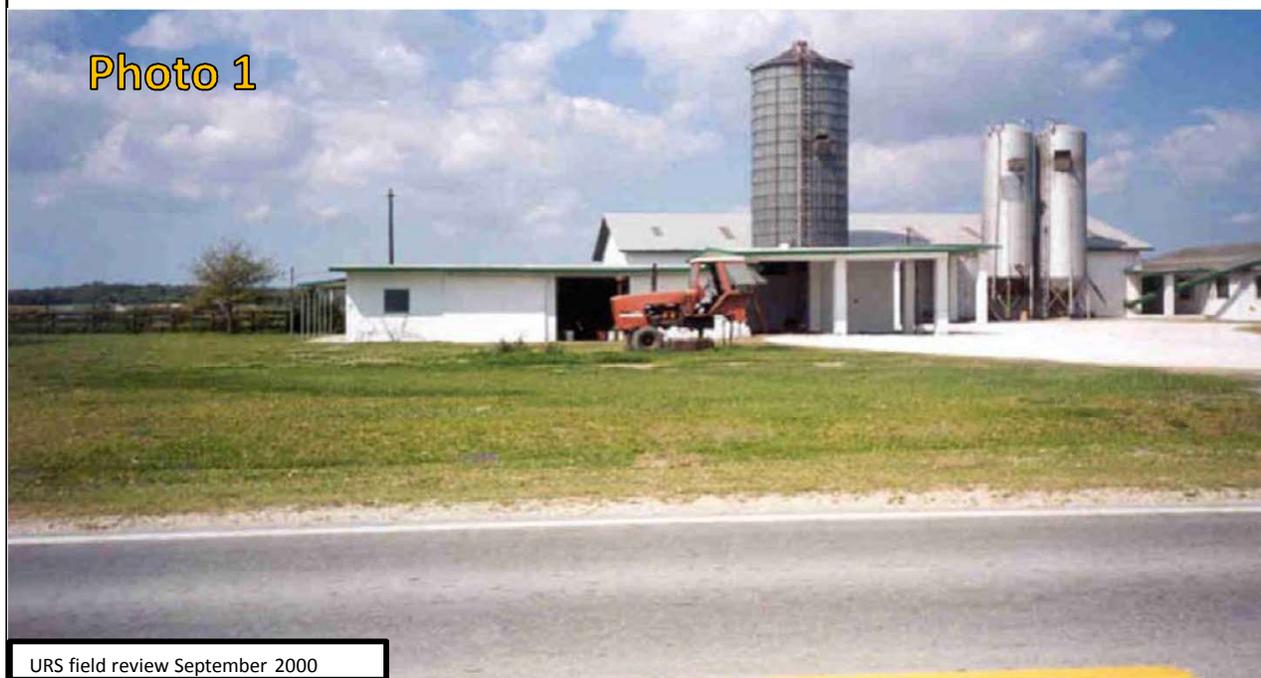
Site 2

- **Site No. 2 (Moore Property Agricultural Facility - 108 Upper Manatee River Road)** - This site is an existing agricultural facility located adjacent and west of the existing ROW. A site photograph and location map with photograph direction is provided on **Pages B-2 and 3** in **Appendix B**. This facility is registered with FDEP (ID# 9700838) as having had one 2,000-gallon gasoline underground storage tank (UST), which was removed in 1997. A Discharge Notification Report (DNR) was filed in 1997 and cleanup is listed as active. The site is also listed as eligible for state assisted cleanup in the Petroleum Contamination Participation Program (PCPP) with a score of 45. Based on this information and the site’s distance from the ROW, the risk rating is “Medium” for this alternative. However, no roadway improvements are anticipated for areas adjacent to this site.

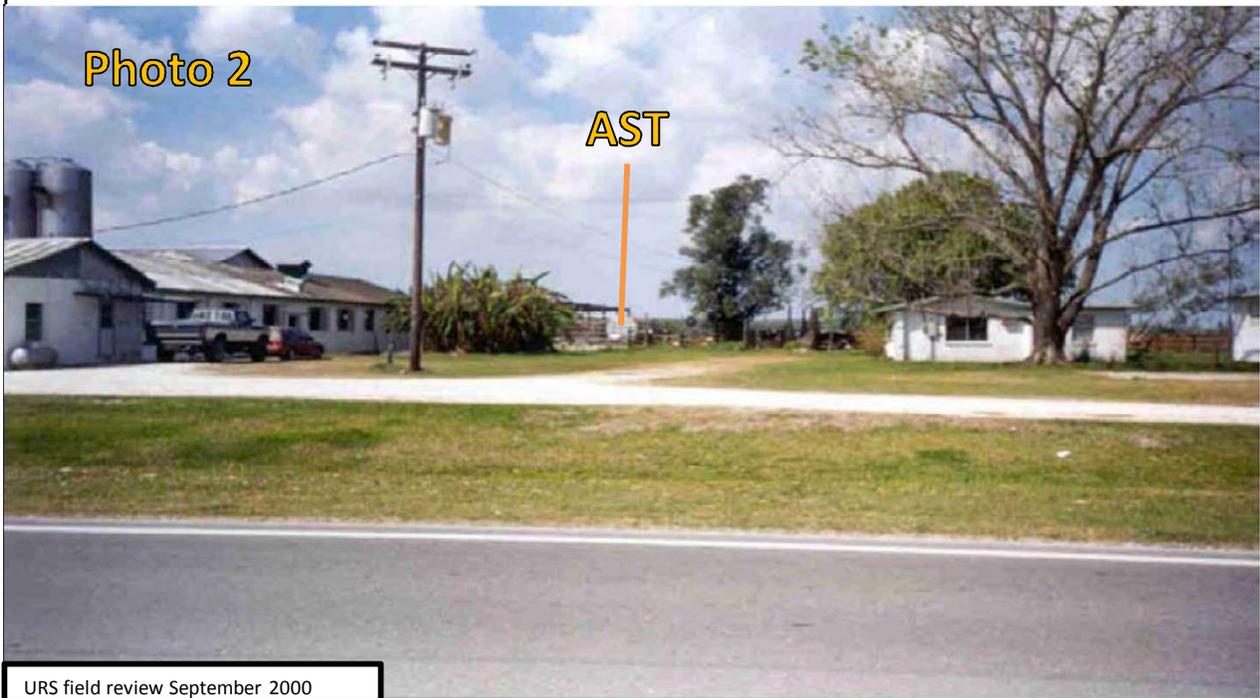
Photo 2

AST

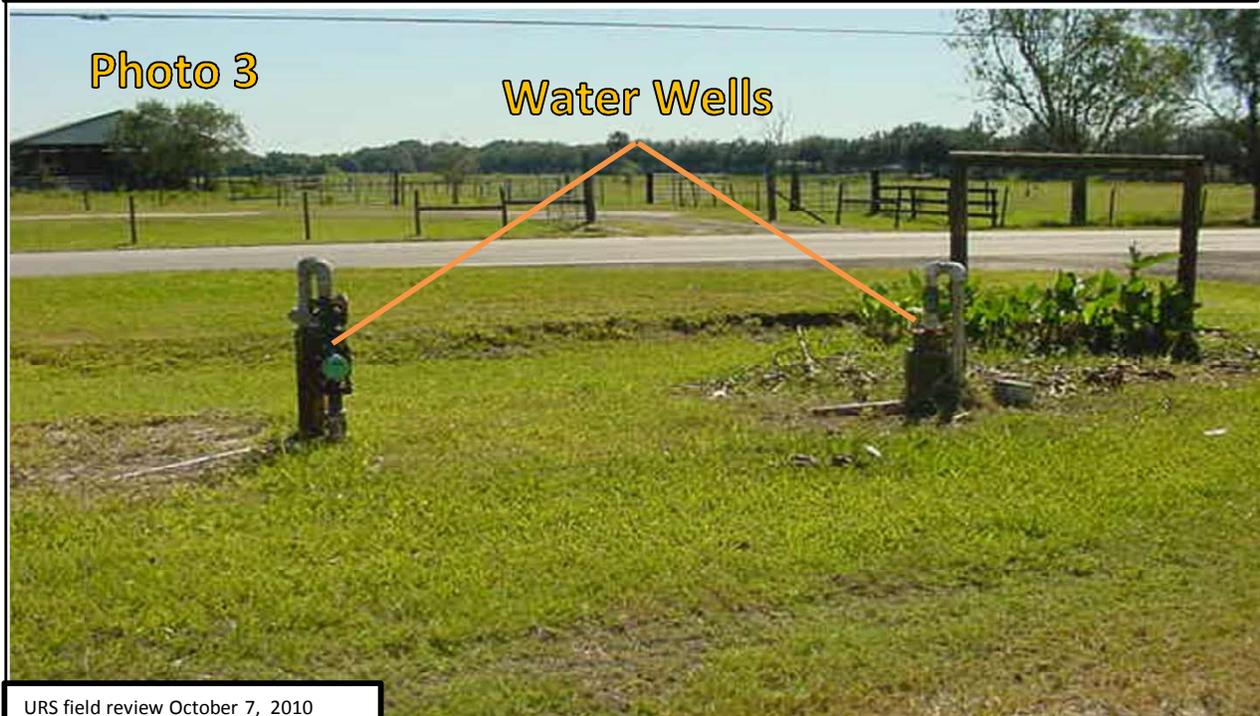
Photo 3

Water Wells

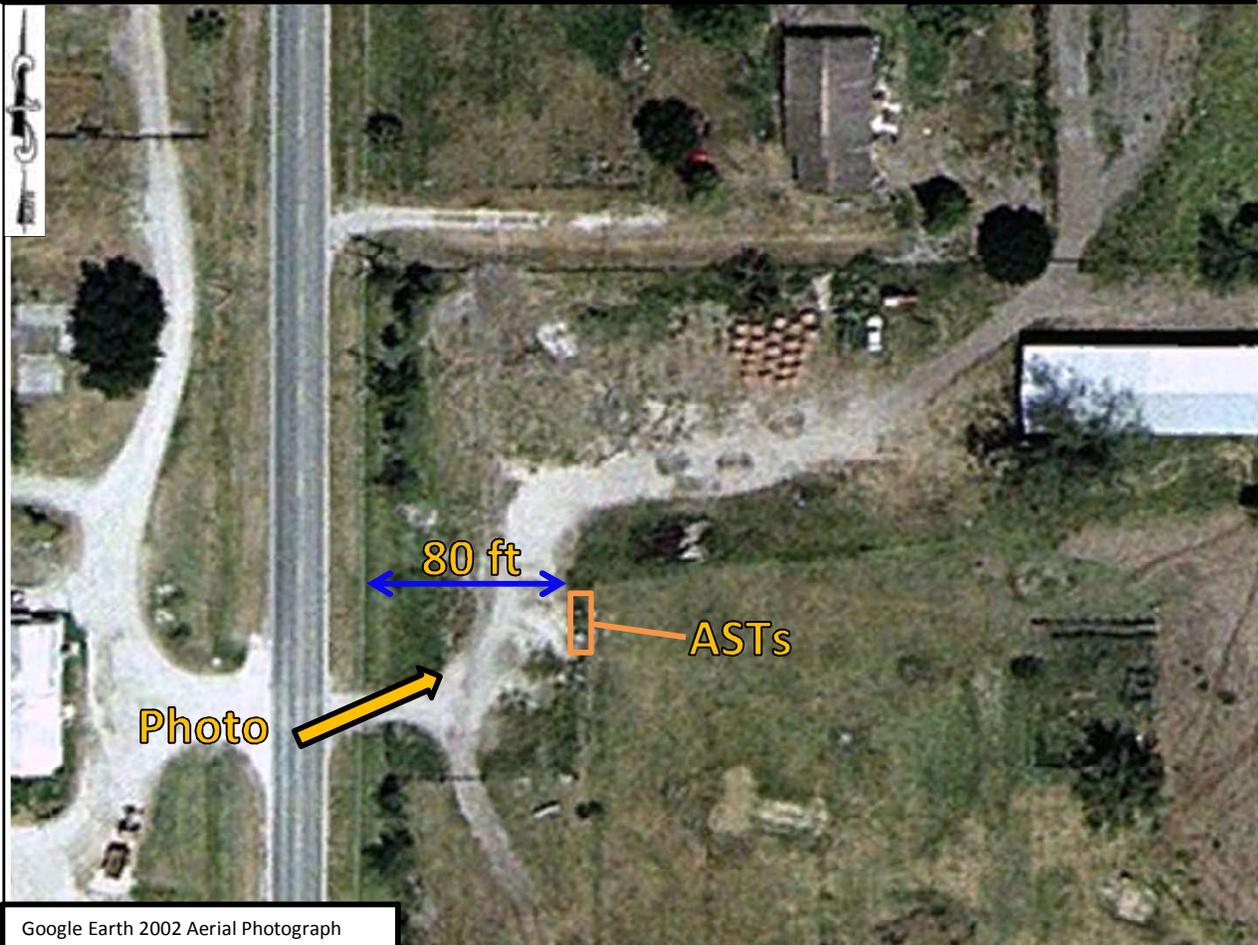
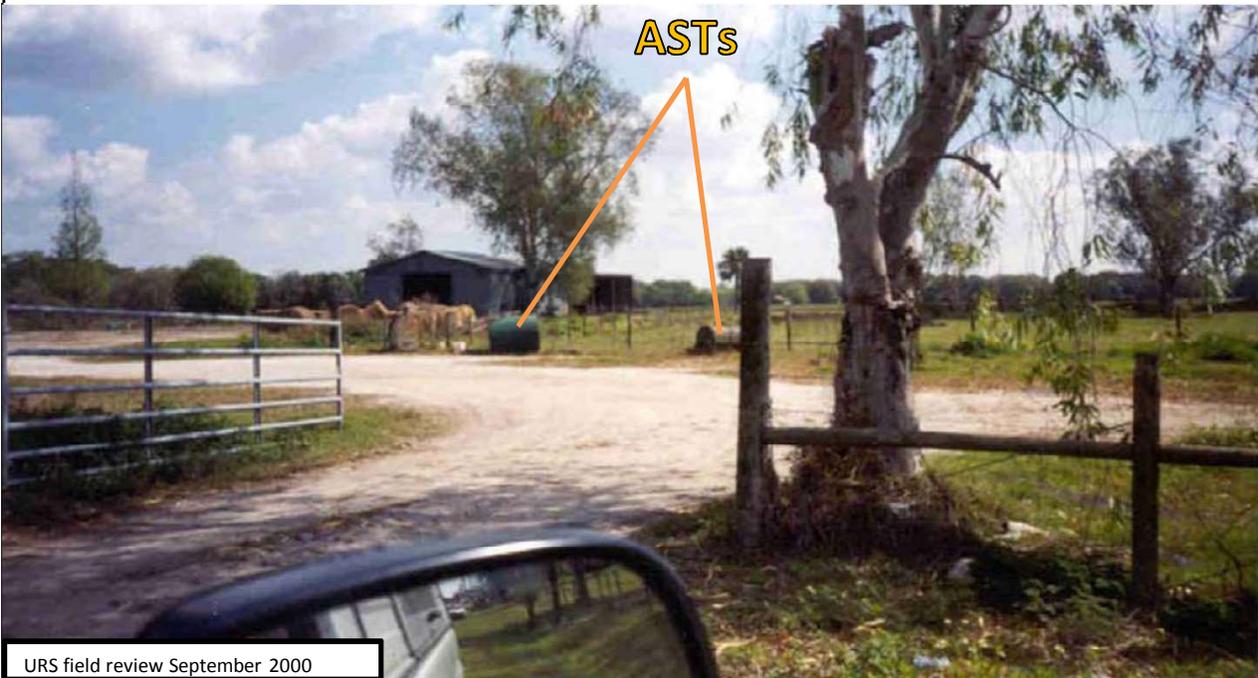
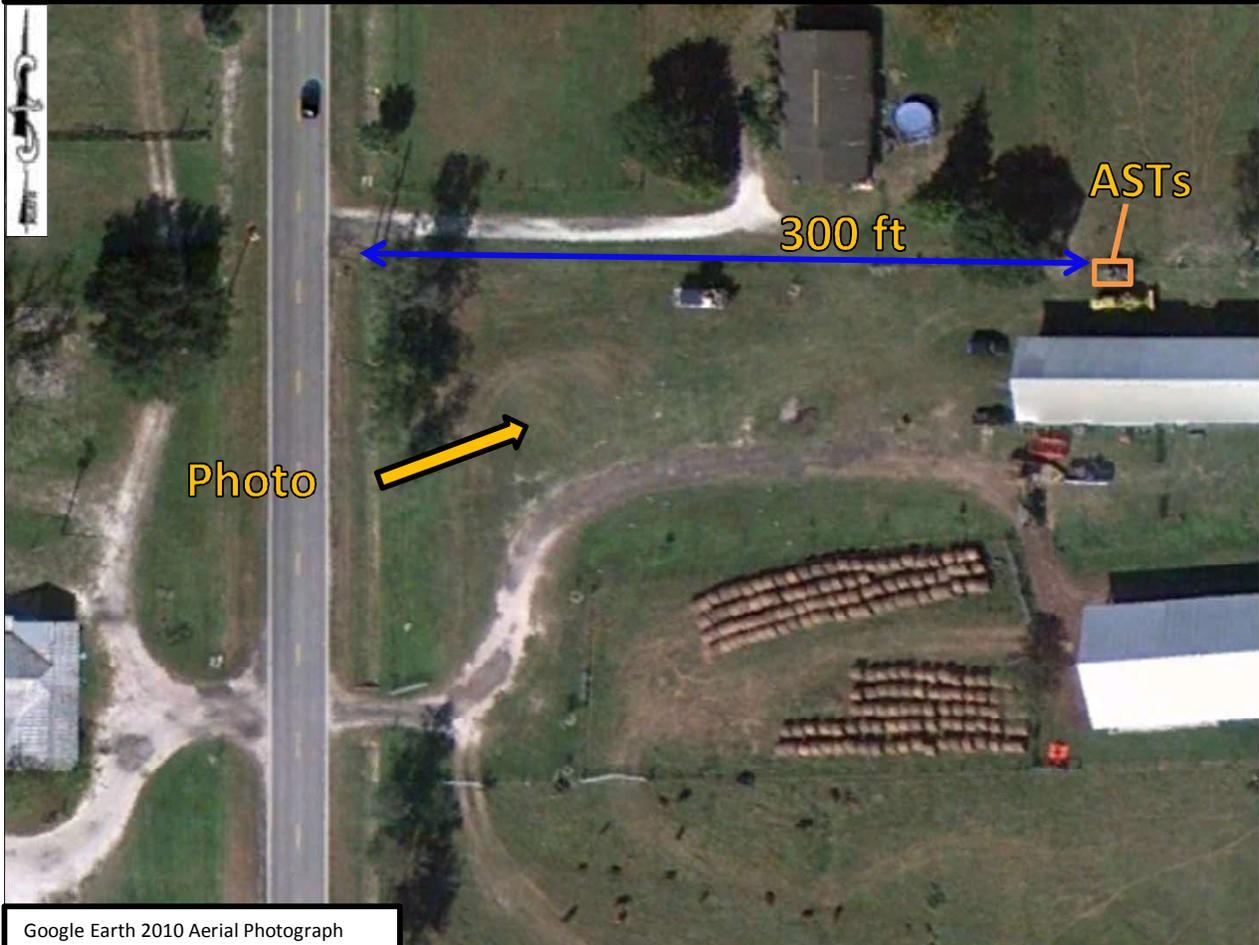
Site 3

- **Site No. 3 (Moore Property Agricultural Facility - 131 Upper Manatee River Road)** - This site is an existing agricultural facility located adjacent and east of the existing ROW. A site photograph and location map with photograph direction is provided on **Pages B-4 and B-5** in **Appendix B**. This facility is not registered with FDEP, but during field reconnaissance, three 300-gallon skid-mounted aboveground storage tanks (ASTs) were noted on site. No violations were found associated with this site. Based on this information, the risk rating is “Low” for this alternative.

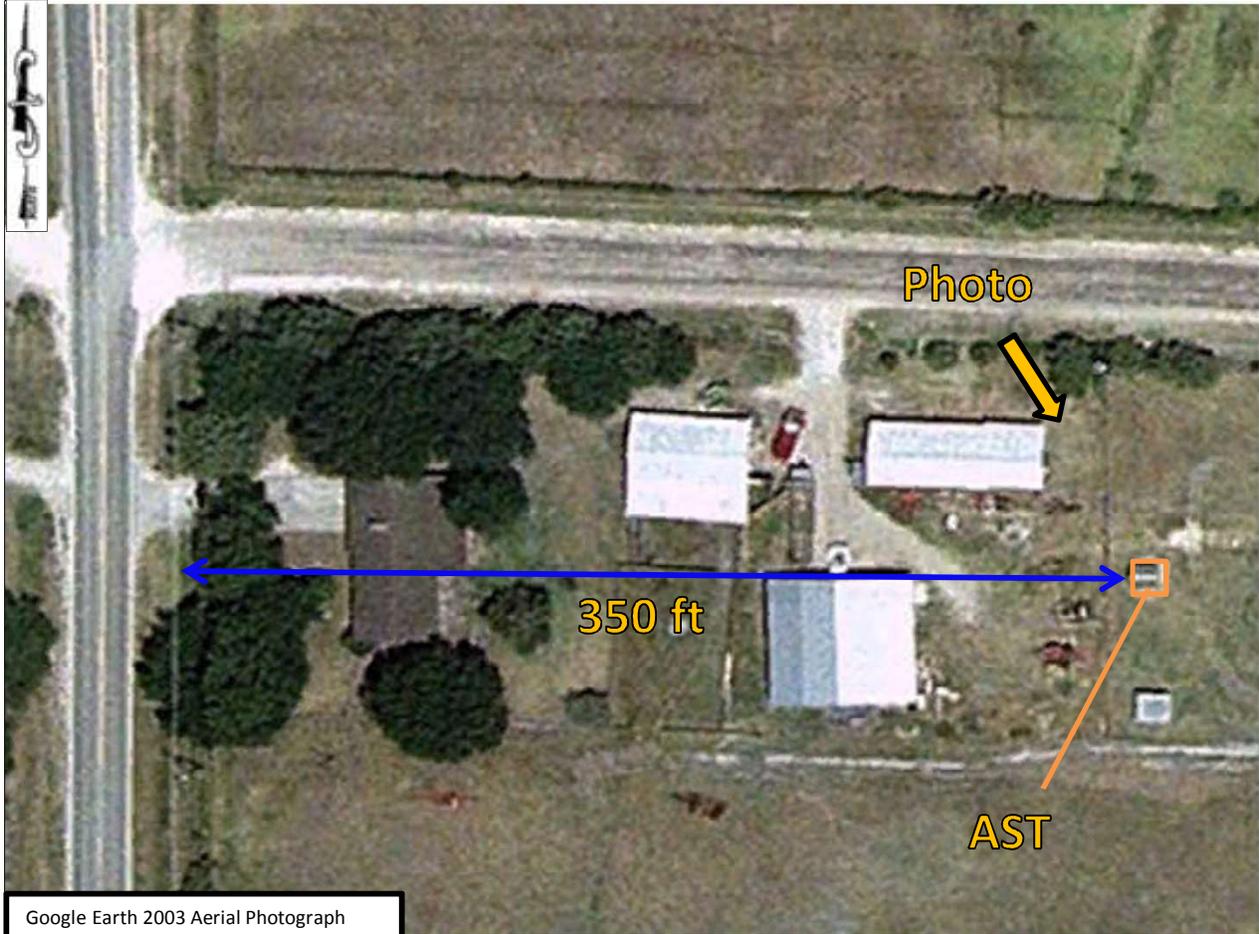
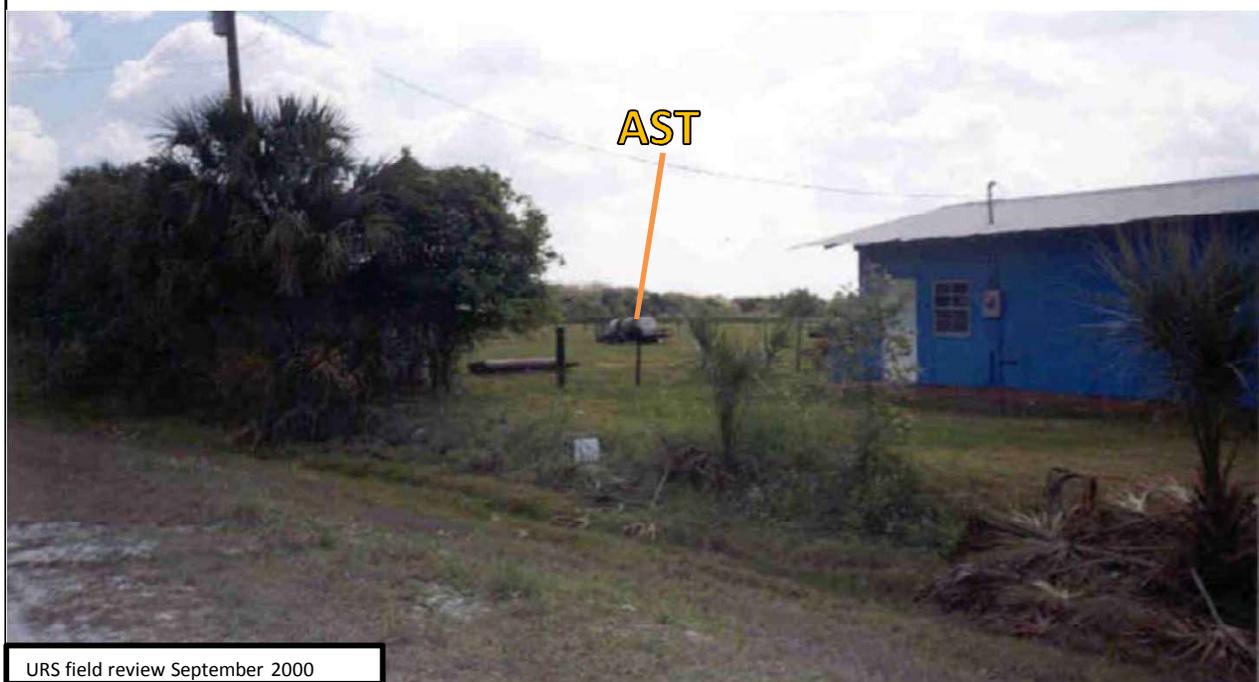
Site 4

- **Site No. 4 (Dave Ballard Property - 257 Upper Manatee River Road)** - This site is an existing agricultural facility located 350 feet to the west of the existing ROW. A site photograph and location map with photograph direction is provided on **Page B-6** in **Appendix B**. This facility is not registered with FDEP but has a 500-gallon trailer-mounted AST, which could contain petroleum fuel or pesticides. No violations were found associated with this site. Based on this information, the risk rating is “Low” for this alternative.

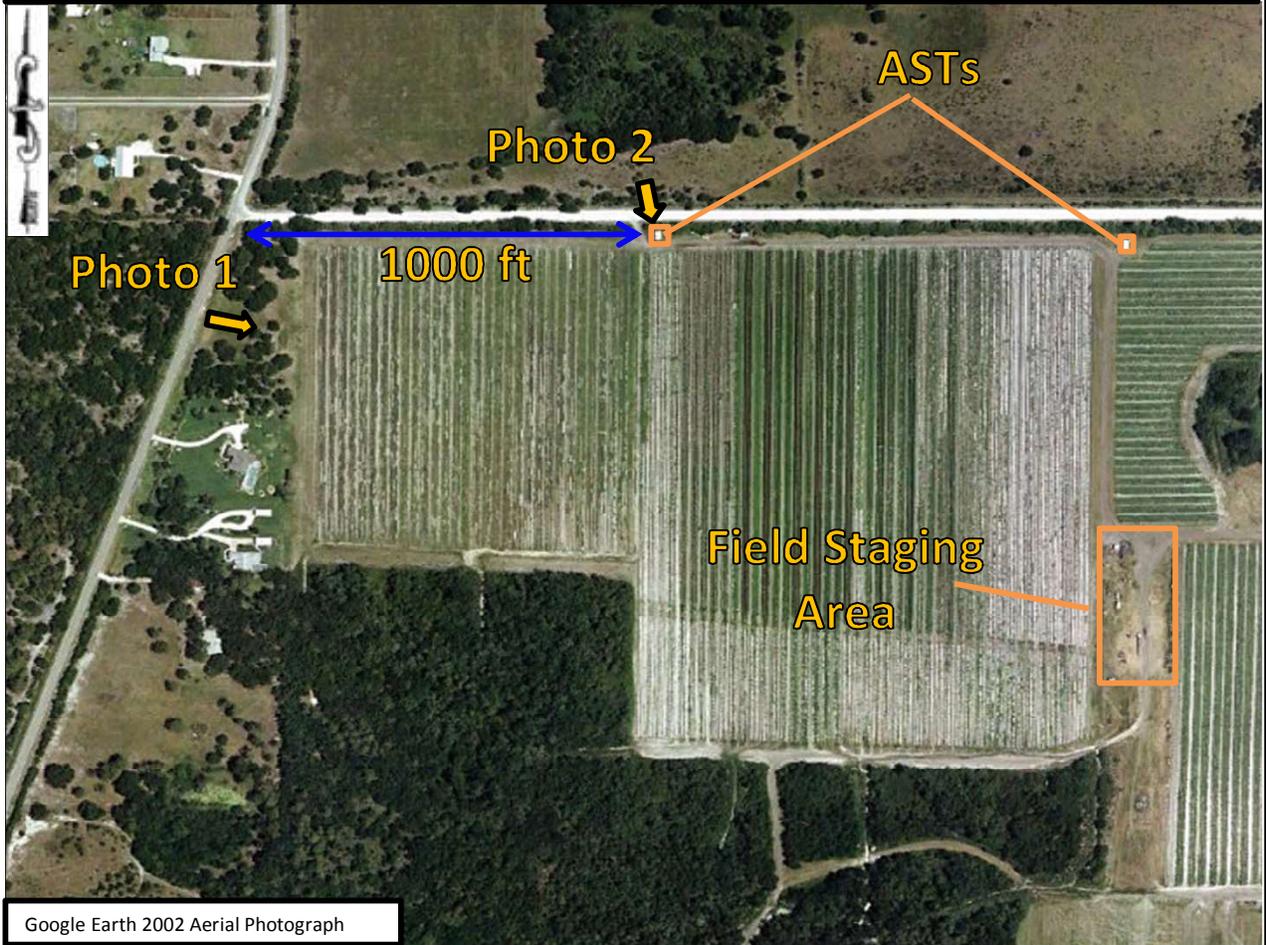
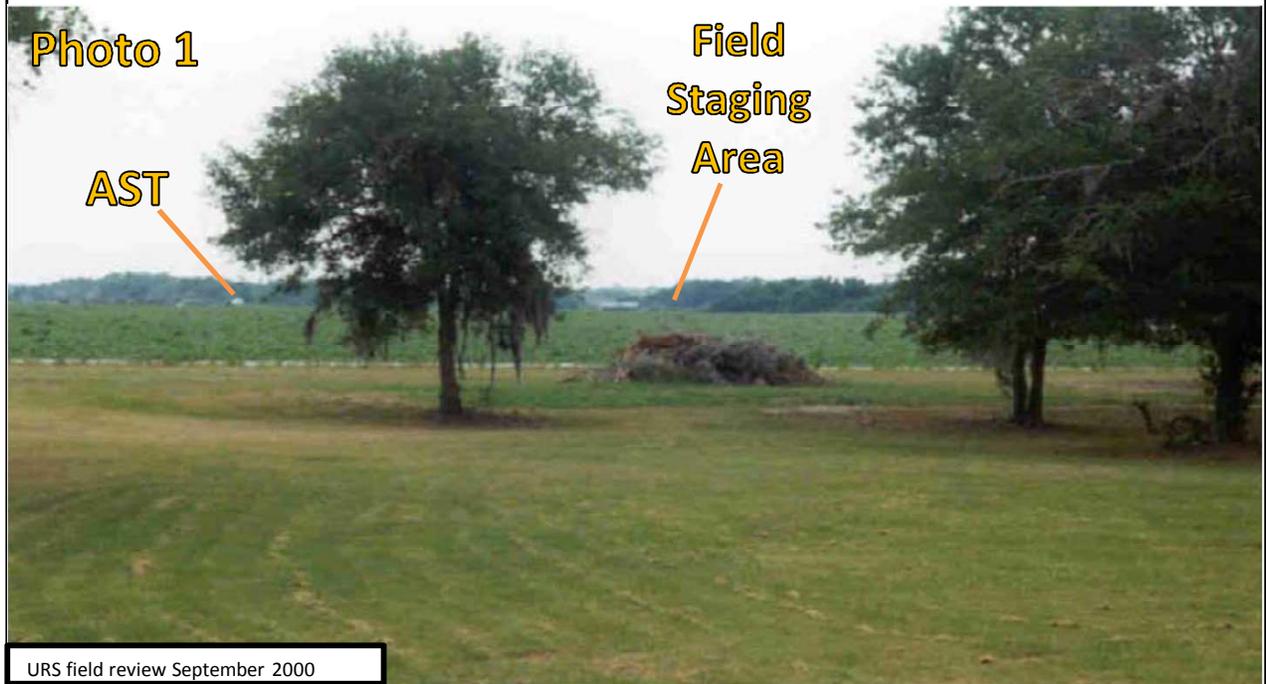
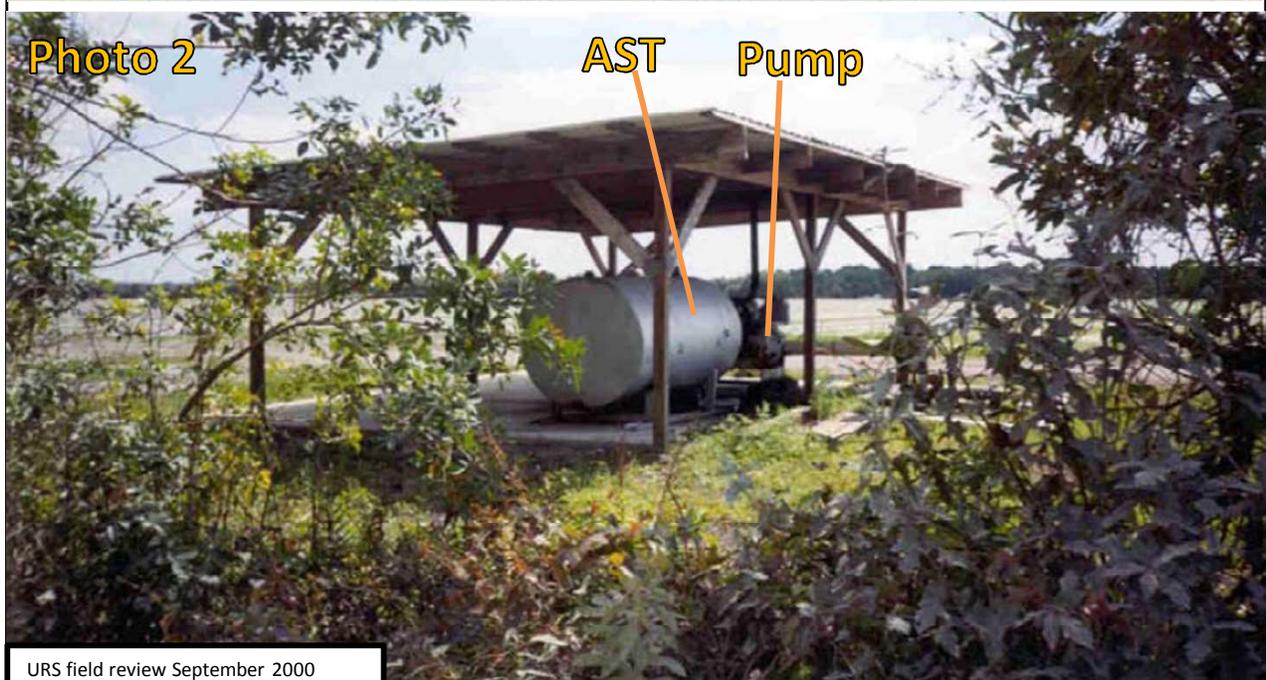
Site 6

- **Site No. 6 (Mulholland Road Farm - Mulholland Road and Fort Hamer Road)** - This site is an existing agricultural facility who’s tanks are located 450 feet to the east of the existing ROW. A site photograph and location map with photograph direction is provided on **Pages B-9 and B-10** in **Appendix B**. This facility is registered with FDEP (ID# 9300757) as having one 1,000-gallon diesel AST associated with a back-up generator. However, during field reconnaissance, at least three additional 550-gallon diesel ASTs were noted. No reported discharges or violations were found associated with this site. Based on this information and the fact that the observed ASTs are at least 450 feet from the existing ROW, the risk rating is “Low” for this alternative.

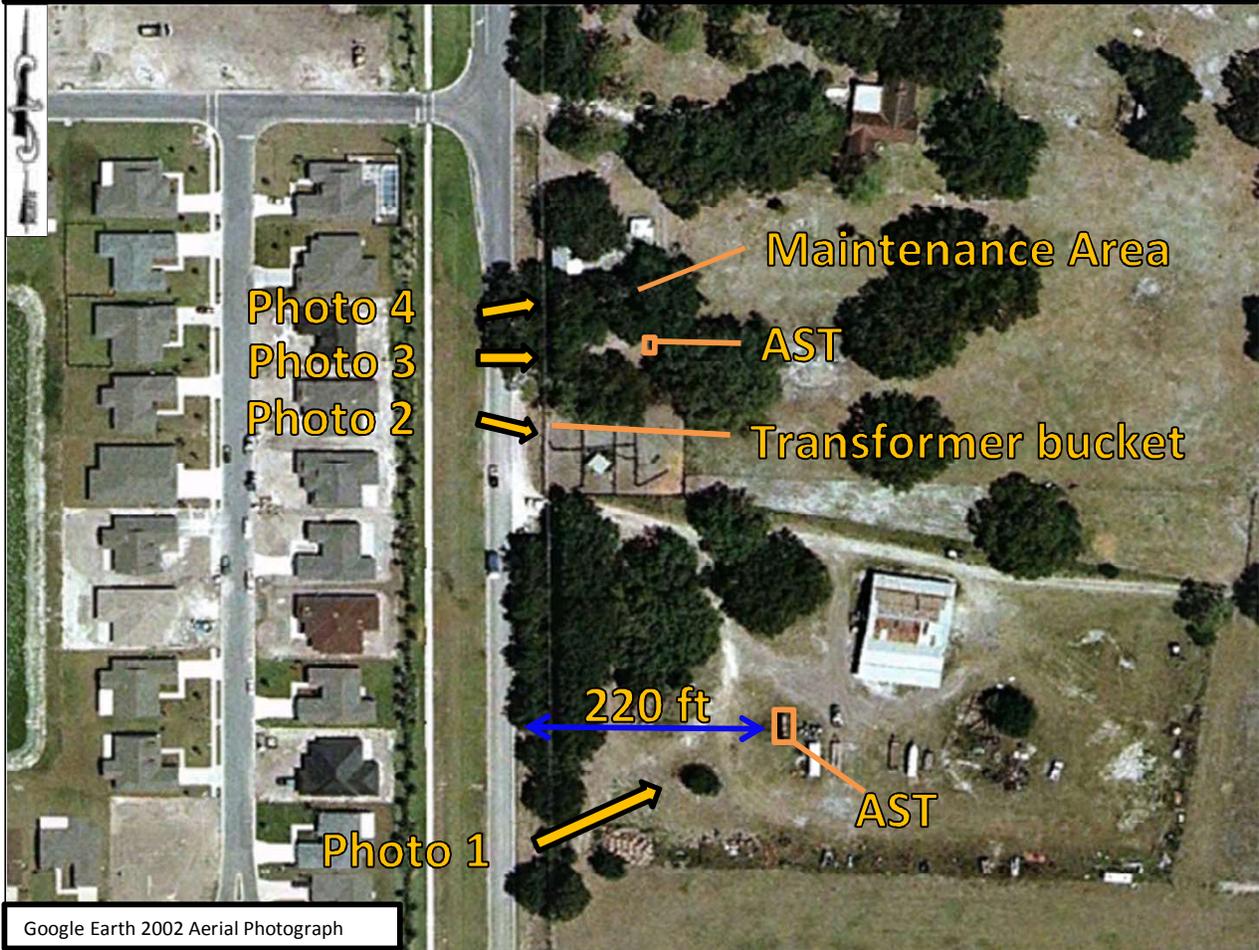
Site 7

- **Site No. 7 [Cross Creek Homes (formerly Fort Hamer Farms, a.k.a. Rawl's Custom Cutting & Wrapping) - 4402 Fort Hamer Road]** - This site is a former agricultural facility being developed as the Cross Creek residential community. A site photograph and location map with photograph direction is provided on **Pages B-11 and B-12 in Appendix B**. This facility is registered with FDEP (ID# 8623998) as having one 550-gallon diesel AST. During field reconnaissance, numerous derelict ASTs of unknown contents, an old transformer, and a maintenance area were noted. No reported discharges or violations were found associated with this site. The entire site has been cleared and is being developed as part of the Cross Creek development. Based on this information, the risk rating is “Medium” for this alternative. However, no roadway improvements are anticipated for areas adjacent to this site.

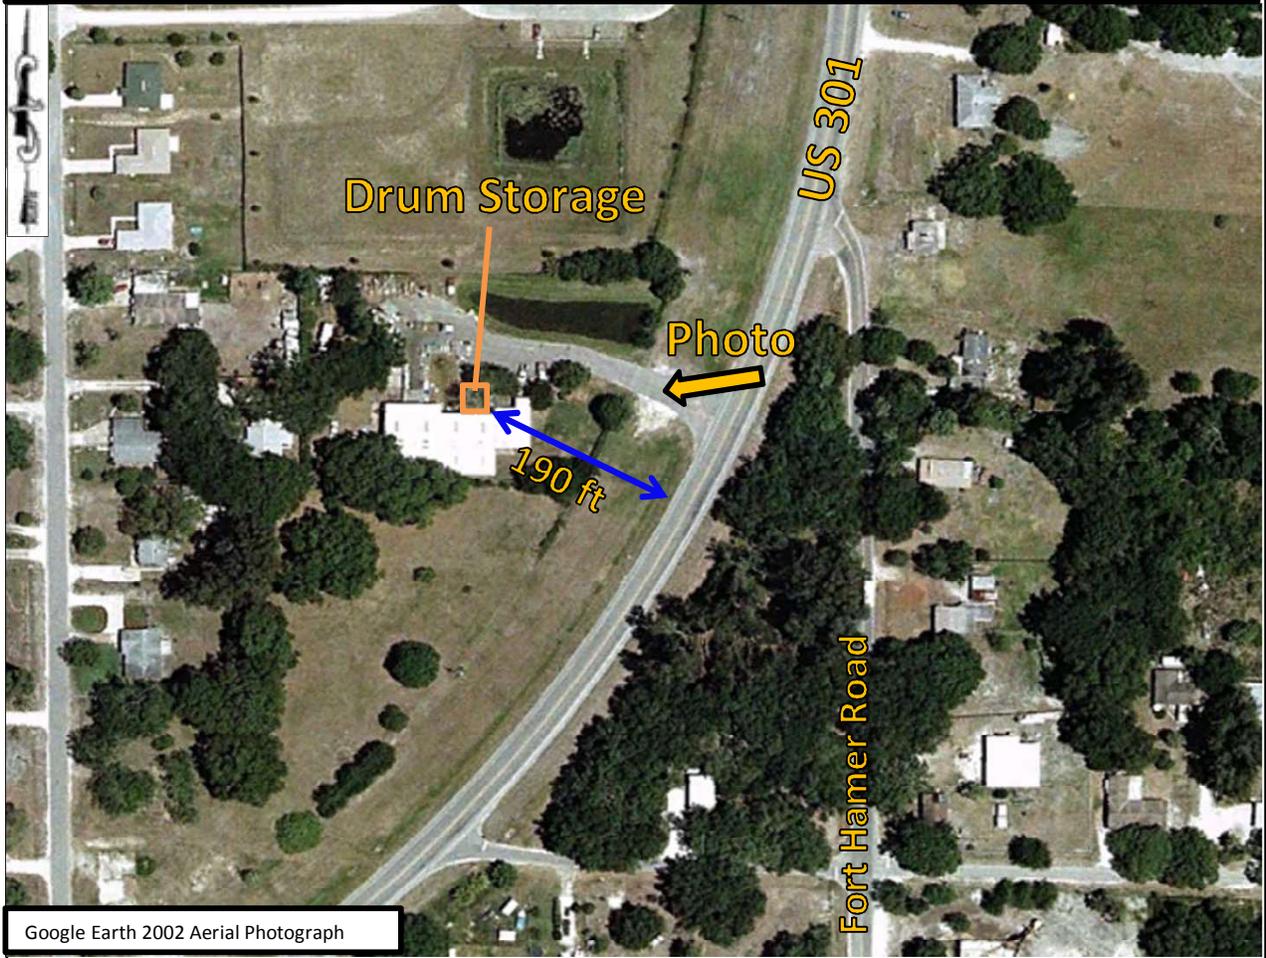
Site 9

- **Site No. 9 (United Agri Products - 12120 US 301)** - This site is an existing agricultural supply facility located 150 feet to the northeast of a former proposed roadway improvement area on US 301. A site photograph and location map with photograph direction is provided on **Page B-14 in Appendix B**. This facility is registered with FDEP (ID# 9401161) as having one 4,500-gallon pesticide AST and is listed in the EPA’s FINDS list as a pesticide storage facility. No reported discharges or violations were found associated with this site. Based on this information, the risk rating is “Low” for this alternative.

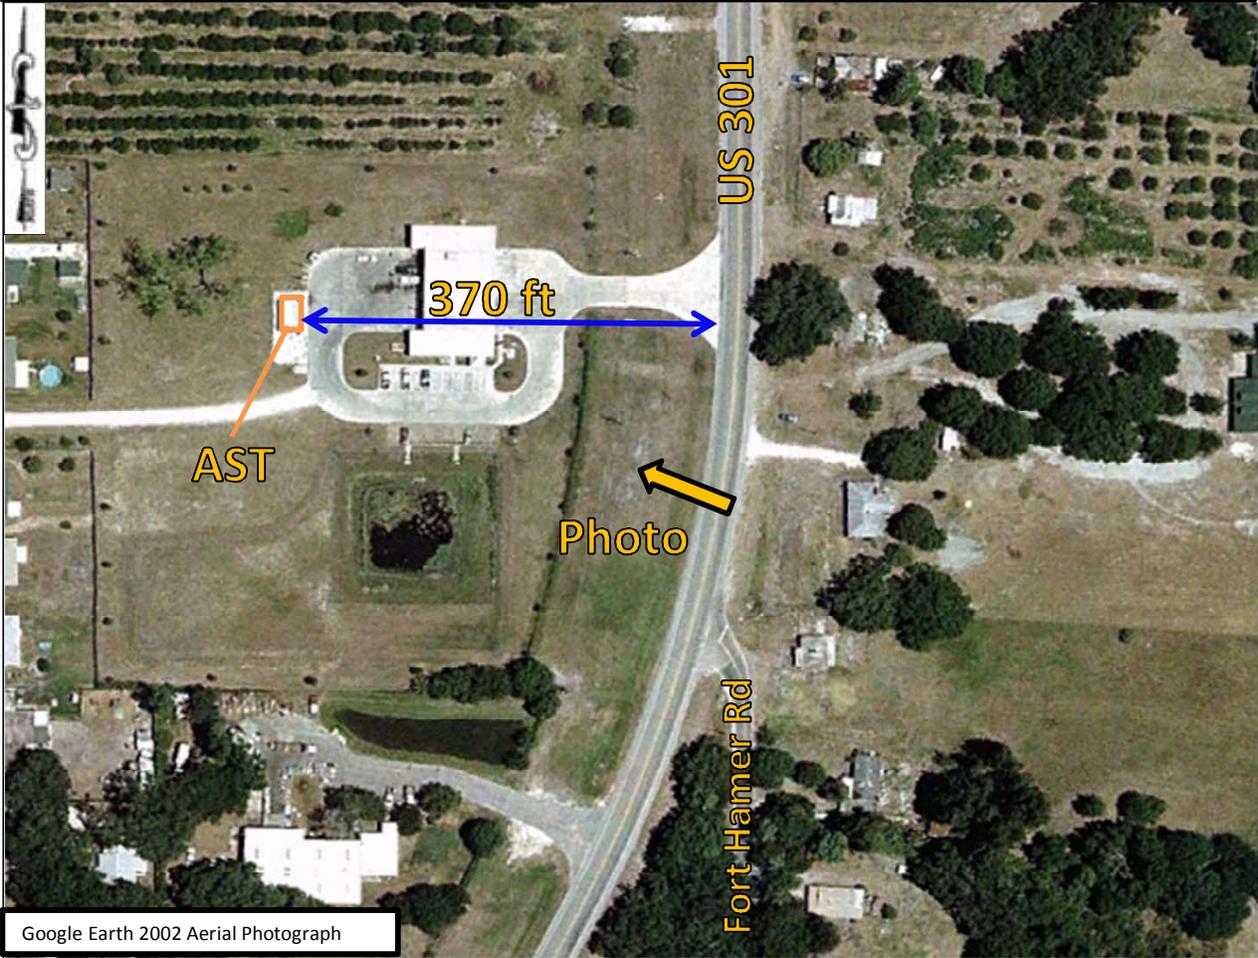
Site 10

- **Site No. 10 (Manatee County Parrish Fire Station Fuel Site - 12132 US 301)** - This site is an existing fire station with fueling capabilities located 150 feet to the north of the proposed roadway improvement area. A site photograph and location map with photograph direction is provided on **Page B-15 in Appendix B**. This facility is registered with FDEP (ID# 9801702) as having one 15,000-gallon diesel AST. No reported discharges or violations were found associated with this site. Based on this information, the risk rating is “Low” for this alternative.

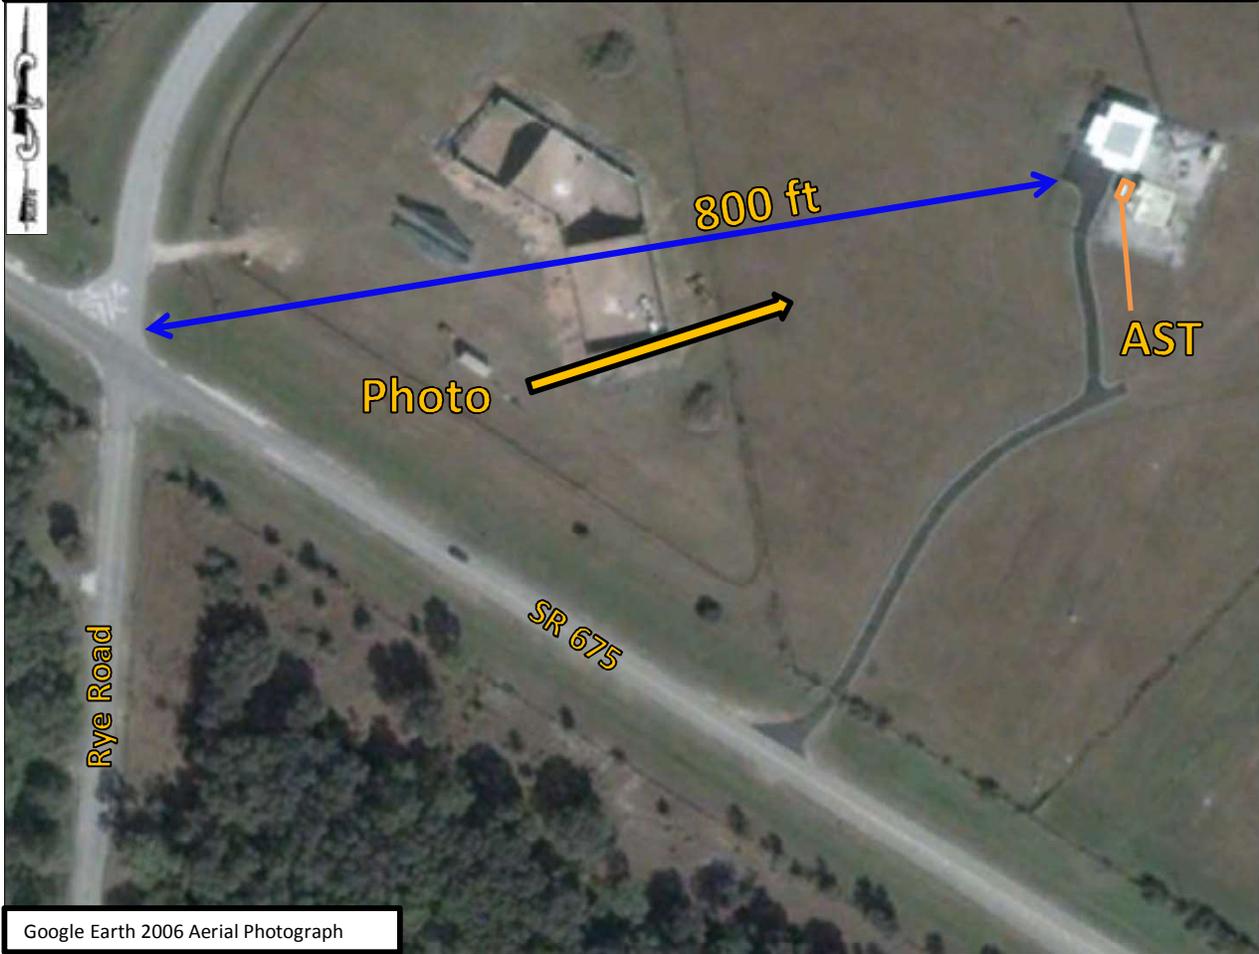
Site 12

- **Site No. 12 (Southern Broadcast Corporation WWSB - 17020 SR 675) -** This site is an existing transmission tower located 800 feet northeast of the existing Rye Road ROW. A site photograph and location map with photograph direction is provided on **Page B-19 in Appendix B**. This facility is registered with FDEP (ID# 9601127) as having one 800-gallon diesel AST installed in 1996, which was replaced with a 2,000-gallon AST in 2000. The currently in service AST is used to fuel an emergency backup generator. No violations were found associated with this site. Based on distance the risk rating is “Low” for this alternative.
