- **Rye Road Alternative** – This build alternative consists of a new two-lane crossing the Manatee River adjacent to the existing Rye Road Bridge and the expansion of Rye Road from two to four lanes from SR 64 north to Golf Course Road, Golf Course Road from two to four lanes from Rye Road to Fort Hamer Road, and Fort Hamer Road from two to four lanes from Golf Course Road to US 301, a total of 10.2 miles.

FIGURE 1-1
PROJECT AREA MAP

ASSESSMENT METHODOLOGY

FIGURE 4-1
POTENTIALLY CONTAMINATED SITE LOCATION MAP – BOTH BUILD ALTERNATIVES

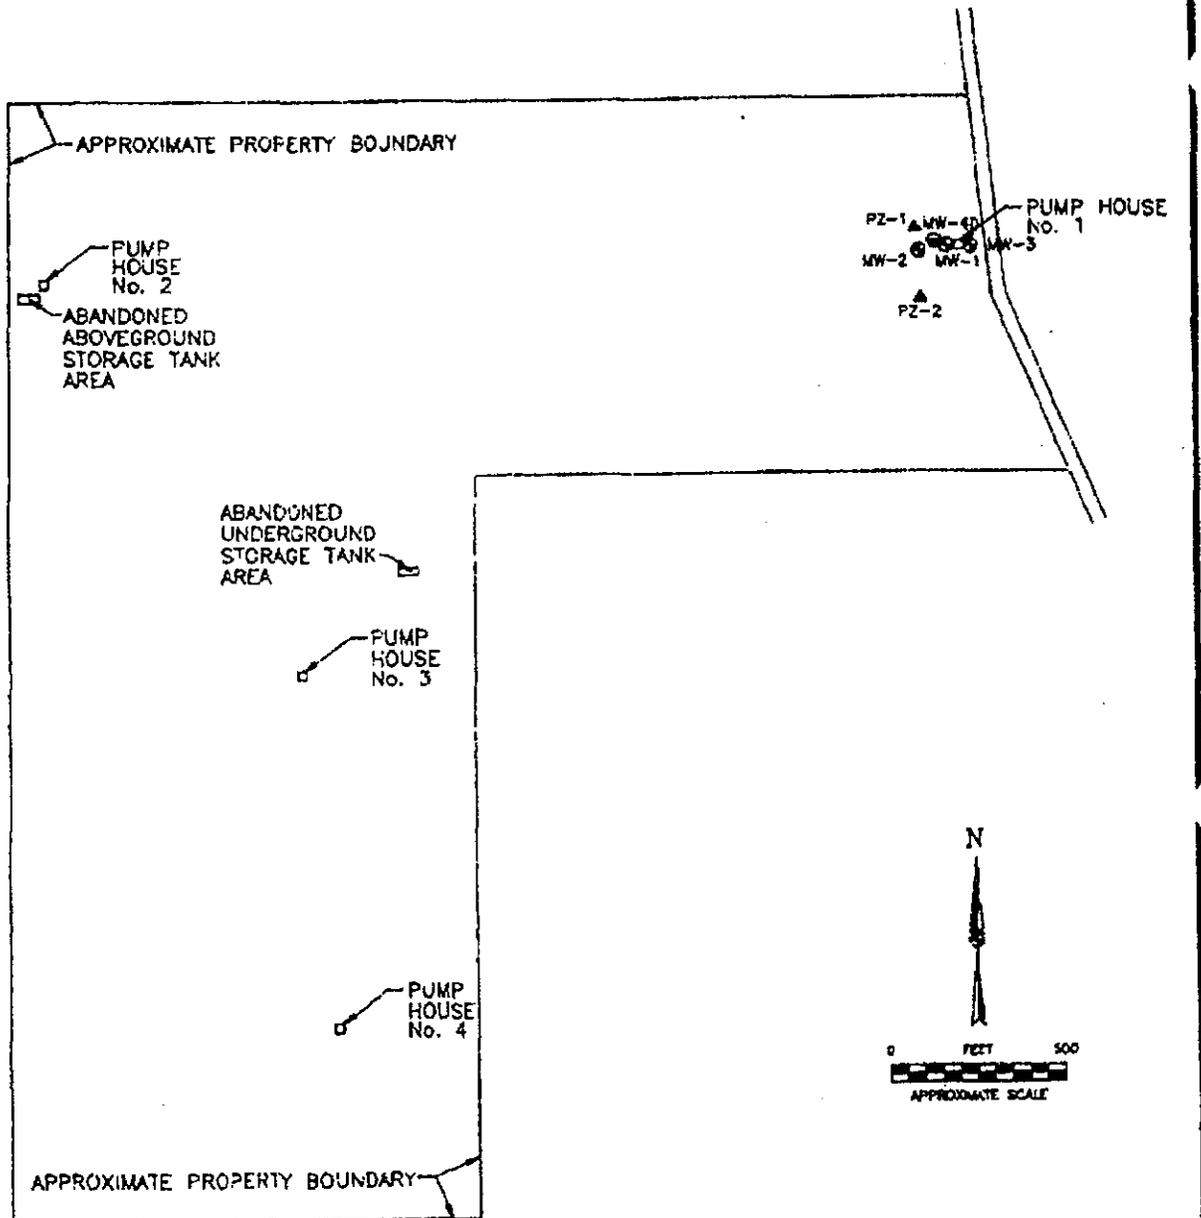
LEGEND	
	MW-1 MONITORING WELL
	MW-4D DEEP MONITORING WELL
	PZ-1 PIEZOMETER LOCATION

<p>TRI-STATE ENVIRONMENTAL INC.</p>	<p align="center">FIGURE 1 SITE MAP BLUEBIRD RANCH • PARRISH, FLORIDA MONITORING ONLY REPORT - 1st QUARTER</p>	<p>PROJECT NO: J96-0007</p>	<p>DRAFTED BY: D.W.</p>
--	---	---------------------------------	-----------------------------

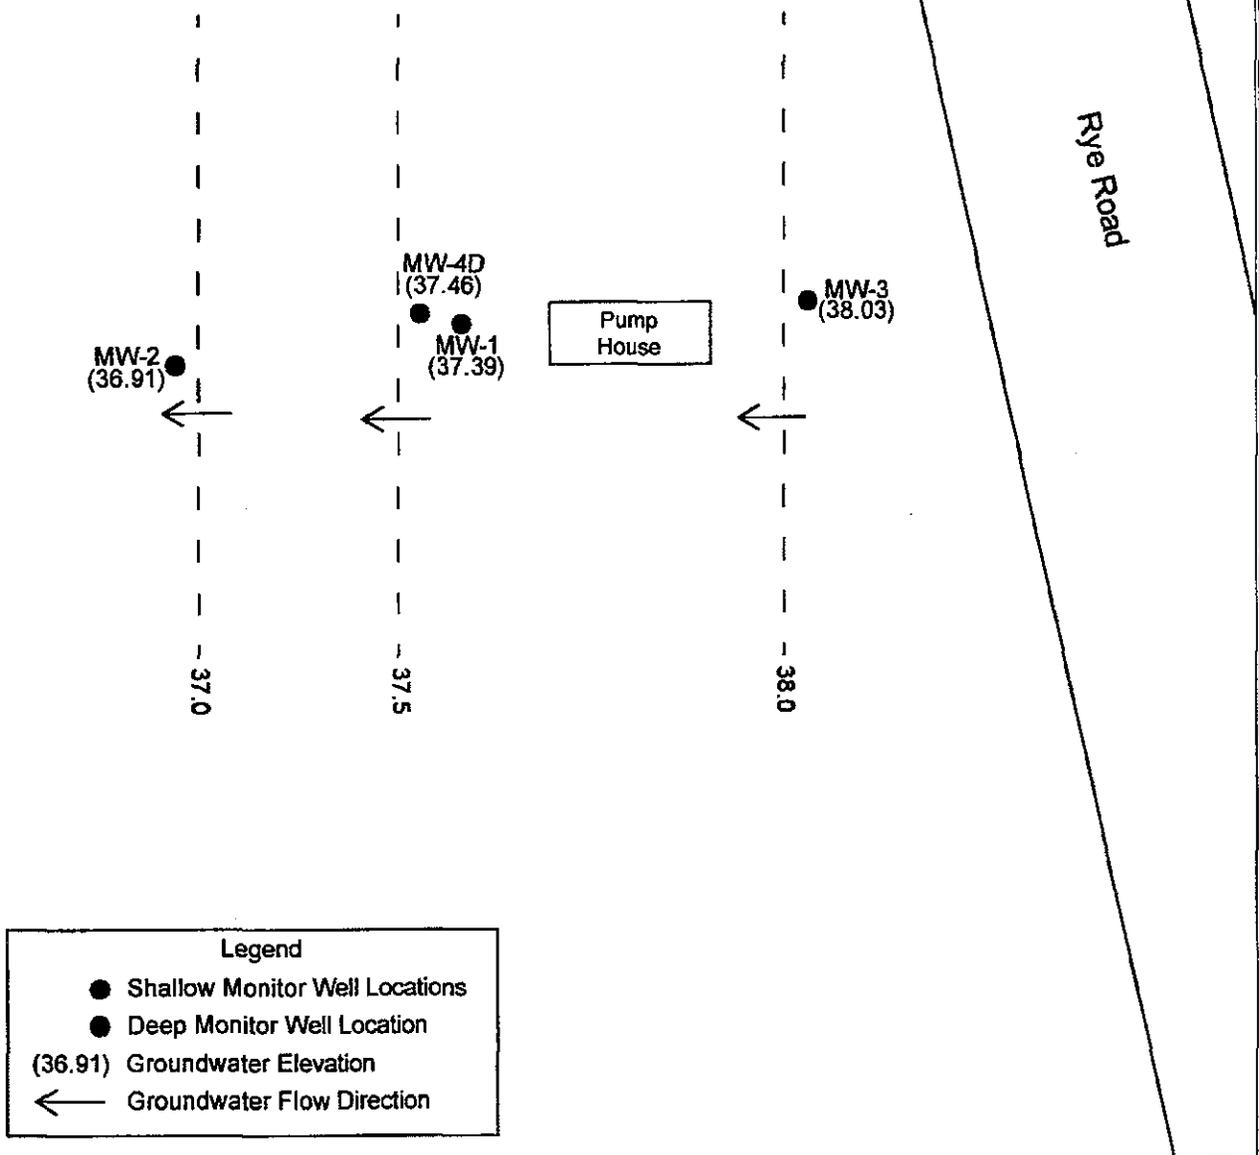
Site 5

- Shallow Monitor Well Locations
- Deep Monitor Well Location
- (36.91) Groundwater Elevation
- ← Groundwater Flow Direction
