TECHNICAL MEMORANDUM FOR BRIDGE REPLACEMENT FOUR-LANE ALTERNATIVES

Bridge Replacement at Upper Manatee River Road over Gates Creek

Upper Manatee River Road over Gates Creek
(Existing Bridge No. 134024)

Draft Report
October, 2021

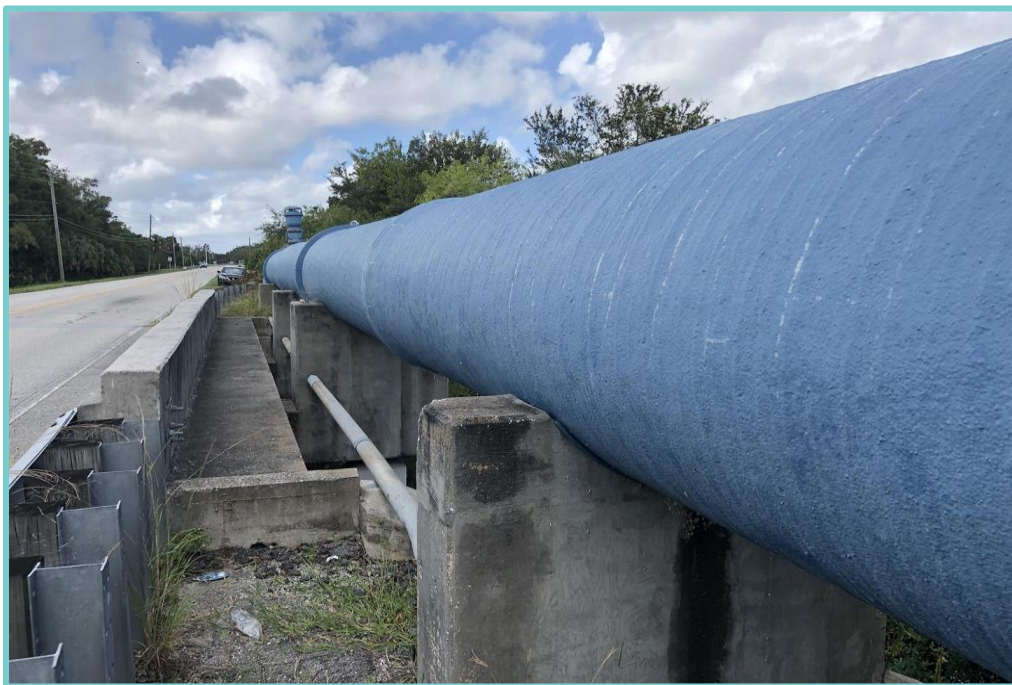
Photo 2-1 – 42" PWM Spanning Gates Creek North of Bridge No. 134024

Constructed in 1995, the 42" PWM aerial crossings over Gates Creek is part of a water transmission main that conveys potable water from the Lake Manatee Water Treatment Plant to the intersection of SR 64 and Upper Manatee River Road. The aerial crossing is supported on the north side of the bridge by concrete piles with reinforced concrete caps. Lateral support is provided for the utility by connection to the bridge bent caps. The PWM extends 85' over Gate Creek, with 45 degree bends at either channel bank, which return the utility underground. Based on a review of photos taken during a site visit in October 2020 by KCA, the aerial crossings are constructed of prestressed concrete cylinder pipe (PCCP) which consists of a concrete core, a thin steel cylinder, high tensile prestressing wire and an exterior concrete mortar. Refer to **Photo 2-1** for photographic representation of the 42" PWM.

PCCP is known for its resistance to corrosion, high internal pressures and external loadings, and its ability to be rapidly and economically installed. There are two types of PCCP. Lined-cylinder Pipe (LCP) was first manufactured in 1942 and Embedded-Cylinder Pipe (ECP) in 1953. The main difference between the two is how they are constructed. The cross section of the LCP is layered from the inside out as follows: concrete core, steel cylinder, prestressing wires, cement mortar. With the ECP, the steel cylinder is embedded in the concrete core and the prestressing wires wrap around the concrete core instead of the steel cylinder. Based on the photos, the aerial crossings at Gates Creek uses LCP.

The 42" PWM appears to be in good condition, approaching 30 years of service. No leaking or settling was observed. Joint repairs have been performed at some point (Refer to **Photo 2-2**) and the concrete mortar does show signs of distress from the elements (Refer to **Photo 2-3**). The hairline cracks in the mortar allow rainwater to pull calcium out of the mortar to form the stalagmites, both of which are

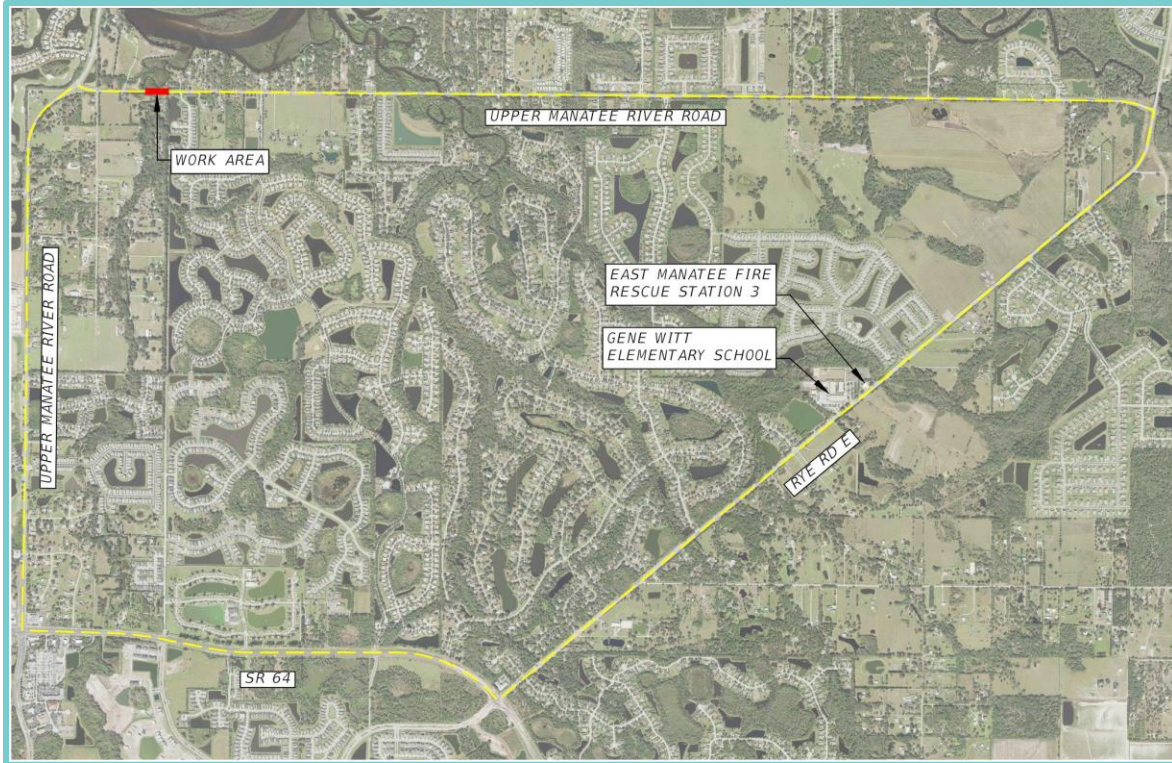
Figure 4-4 – Upper Manatee River Road Detour

A traffic detour route was considered that would eliminate any ability for the motorist to traverse West to East along the Upper Manatee River Road across the bridge construction site. Detour routes were evaluated to ensure the local residential roadways won't be overwhelmed with the addition of the re-routed traffic. Considering the constraints, the shortest available detour route is depicted in **Figure 4-4** below.

Detour length is the total additional travel along equivalent service roadways for a vehicle which would result from closing a bridge. The distance along Upper Manatee River Road from Fort Hamer Road to North Rye Road is approximately 3.9 miles. The shortest equivalent detour route includes traveling south on Upper Manatee River Road from Fort Hamer Road to SR-64, traveling east on SR-64 to Rye Road East, then traveling northeast on Rye Road East to Upper Manatee River Road. The total distance of this route is approximately 7.1 miles. The standard total detour length is therefore 3.2 miles.

The “Worst Case” detour route, beginning at the nearest side street to the work area and ending at the nearest side street on the opposite side, is approximately 10.8 miles in length. Gene Witt Elementary School and East Manatee Fire Rescue Station 3 are located on Rye Road East, which is used in the detour route. The increase in traffic volume from the detour is expected to have a negative impact on operational effectiveness of both facilities but not on the overall safety of the roadway. The closure itself may marginally increase response times from Fire Rescue Station 3 to locations on the opposite side of the work area. In the “worst case” scenario of an incident immediately west of the work area, the distance traveled from Fire Rescue Station 3 would increase from 5.1 miles using Rye Road East and approaching from the east to 5.9 miles using Rye Road East/SR 64 and approaching from the west. The additional 0.8 miles of travel could potentially add several minutes to response times.

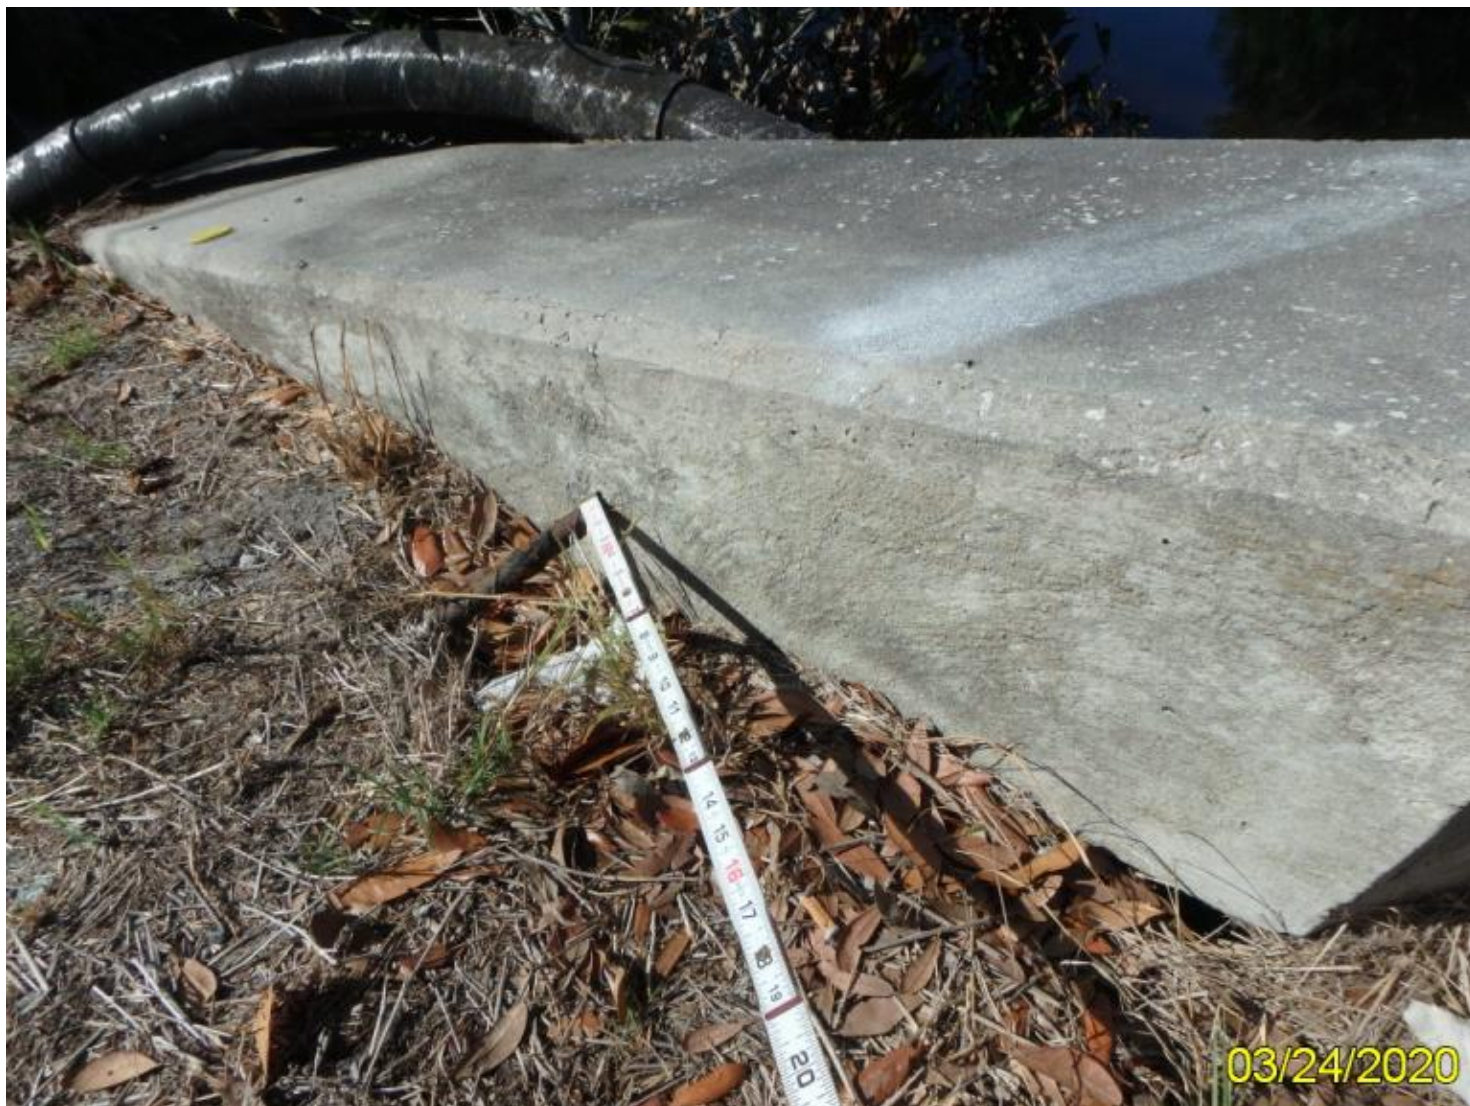
Photo 1 - Element 8475 R/Conc Walls

Exposed tie back due to erosion along the southeast wingwall

REPAIR RECOMMENDATION:

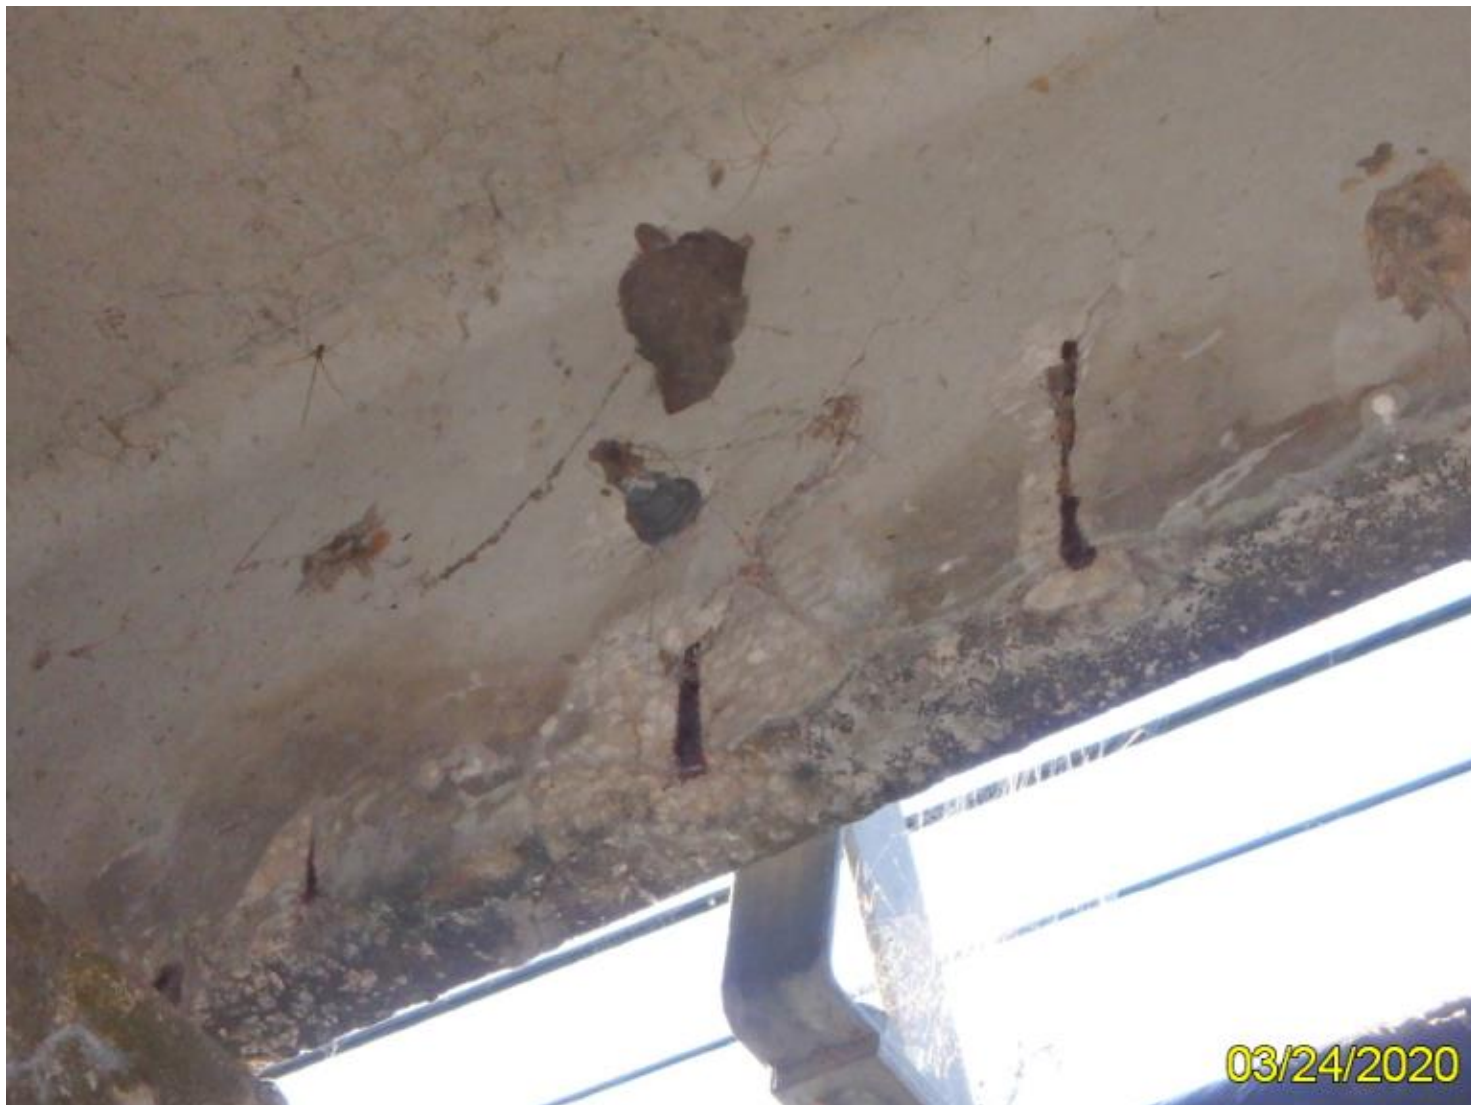
Photo 2 - Element 109 Pre opn Conc Girder/Beam

Beam 2-2 right leg spall with exposed prestress strands

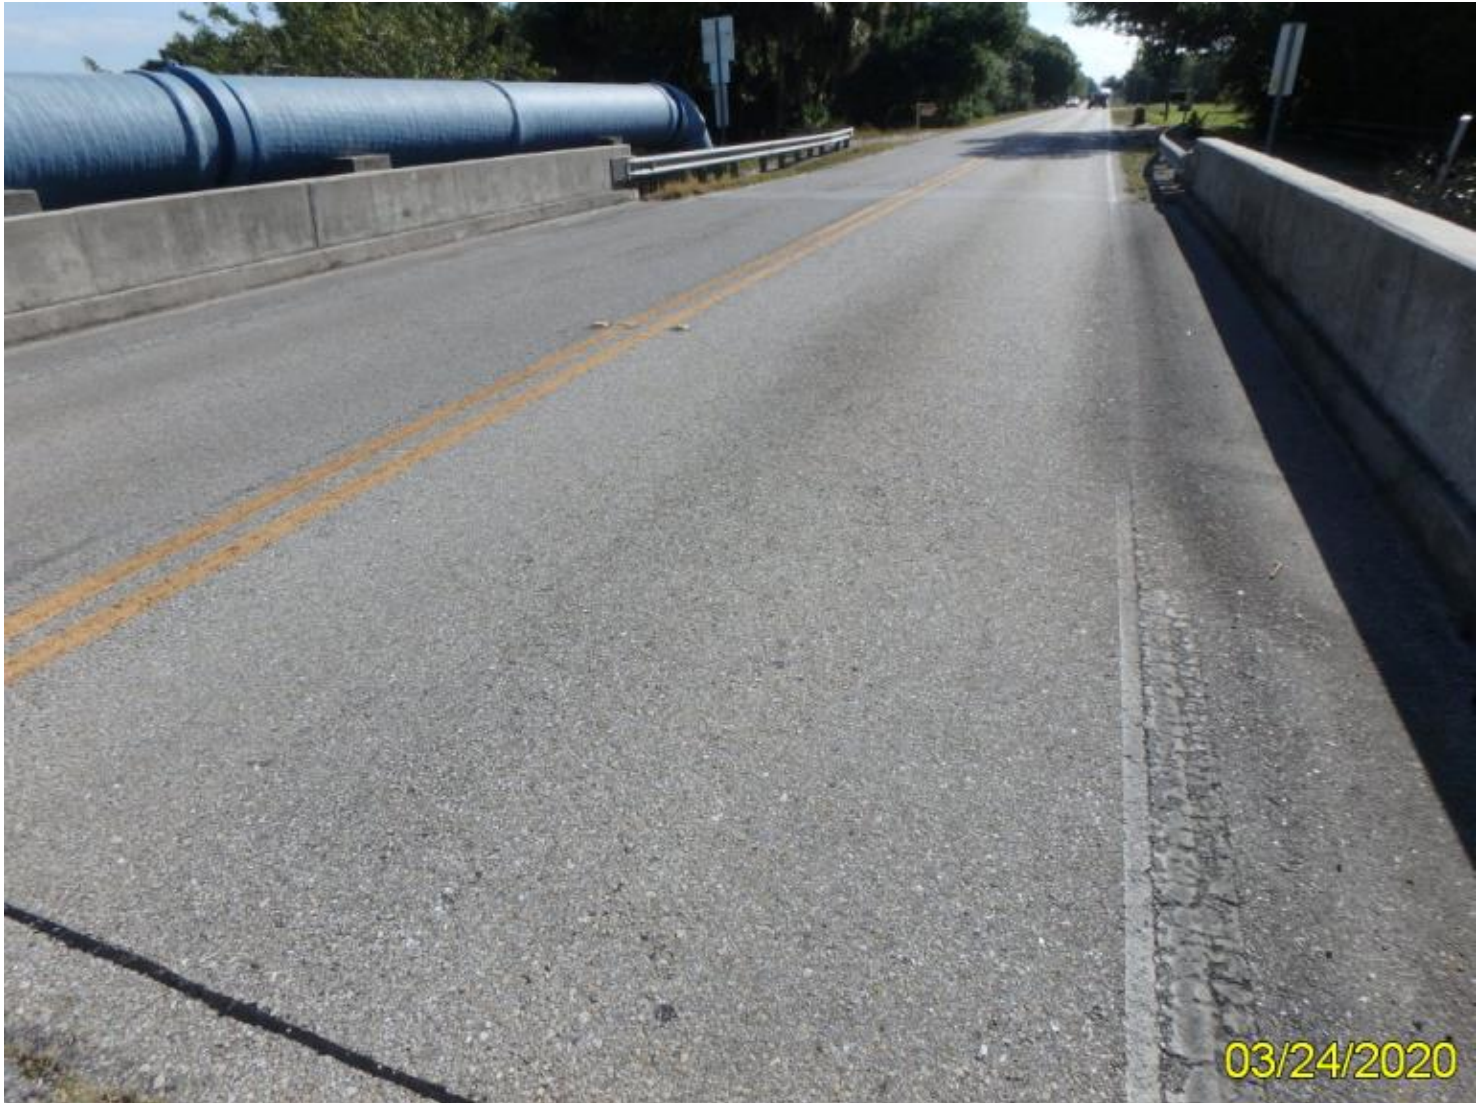
Photo 3 - Inspection Notes

Heavily faded roadway edge striping across the structure

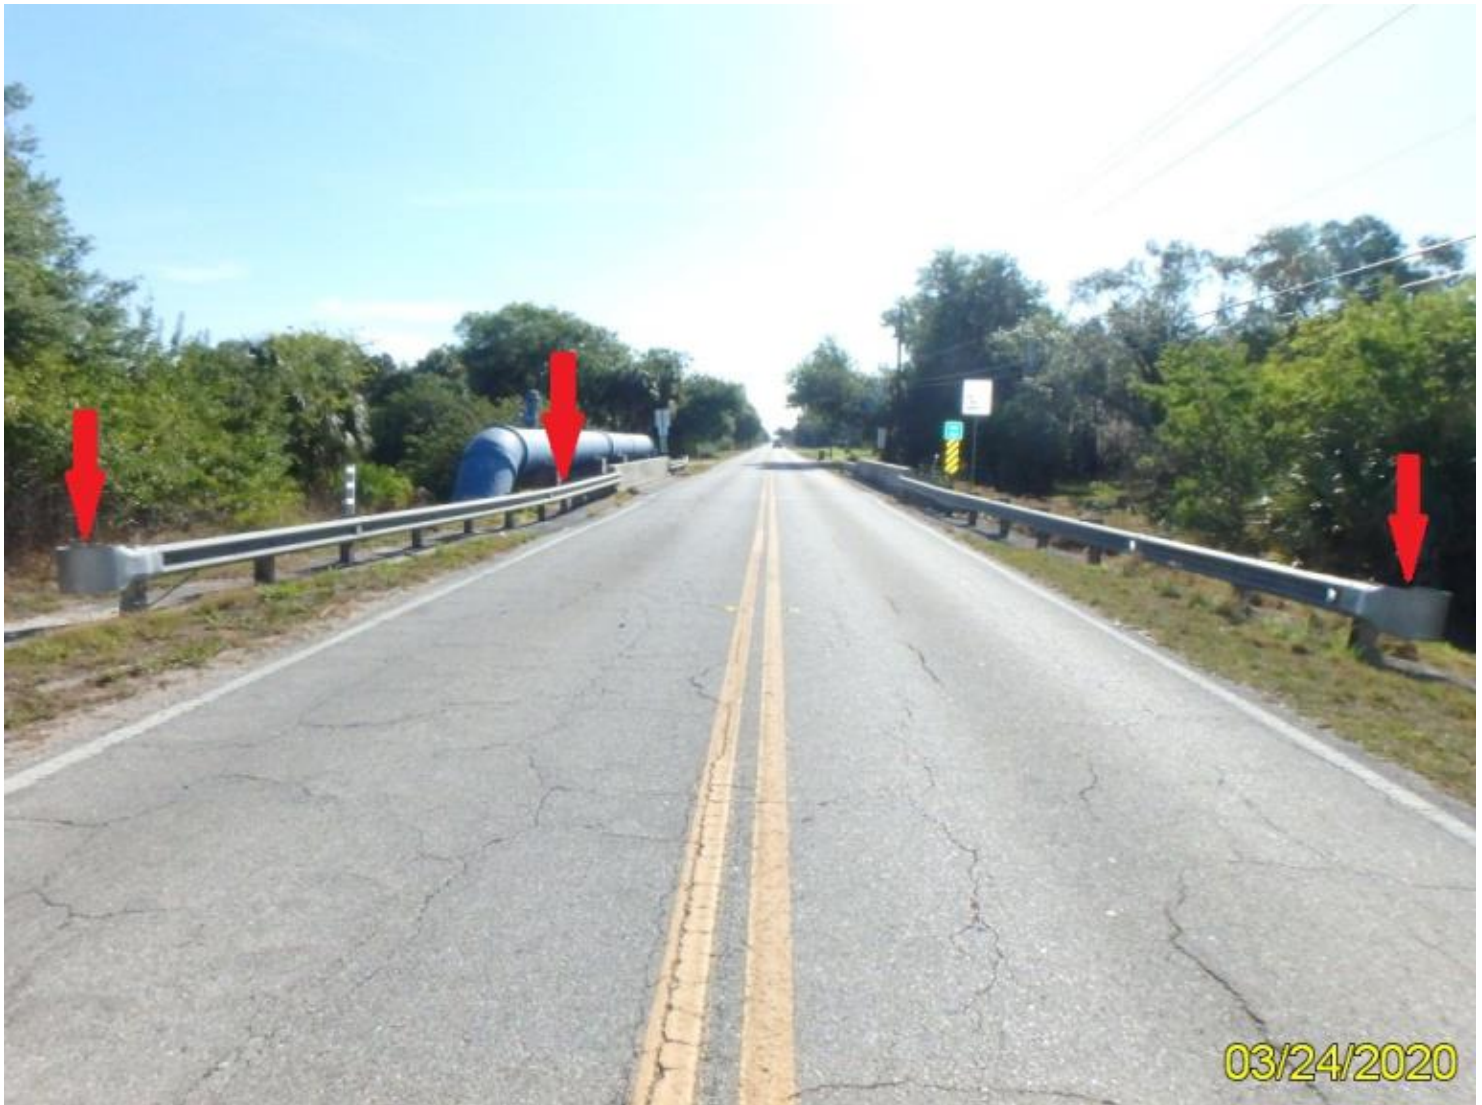
Photo 4 - Inspection Notes

Missing reflective tape on the approach guardrail end terminals and northwest object marker
