# TECHNICAL MEMORANDUM FOR BRIDGE REPLACEMENT FOUR-LANE ALTERNATIVES

## Bridge Replacement at Upper Manatee River Road over Mill Creek

Contract No. 15-0909JE - Work Assignment No. 10  
County CIP No. 6030662

Draft Report  
November, 2021

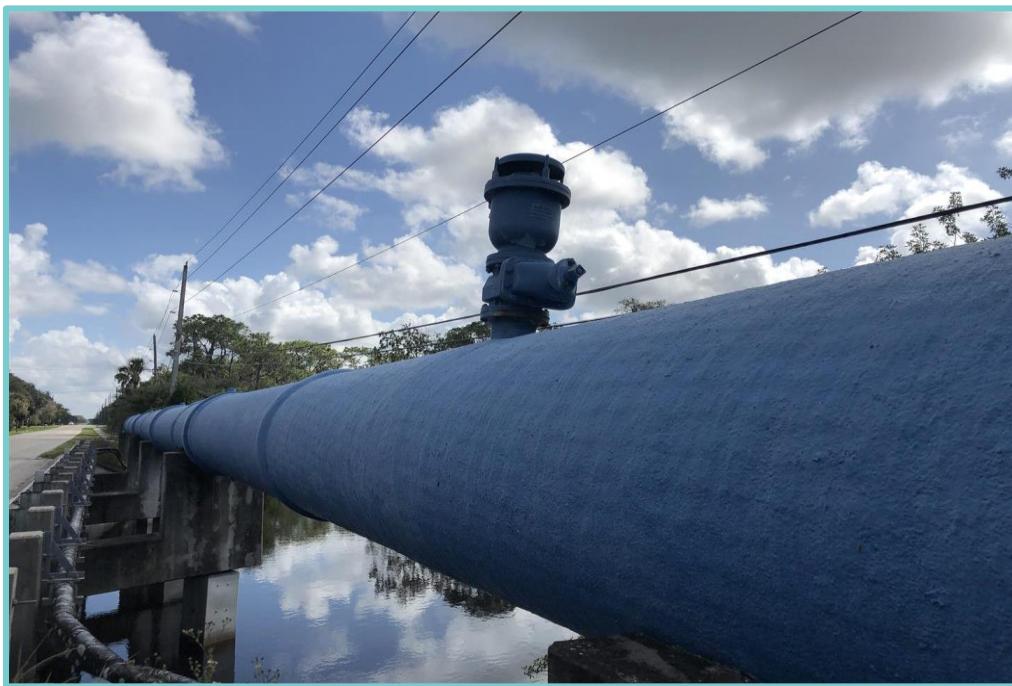
***Photo 2-1 – 42" PWM Spanning Mill Creek South of Bridge No. 134023***

Constructed in 1995, the 42" PWM aerial crossings over Mill Creek is part of a water transmission main that conveys potable water from the Lake Manatee Water Treatment Plant to the intersection of S.R. 64 and Upper Manatee River Road. The aerial crossing is supported on the south side of the bridge by concrete piles with reinforced concrete caps. Lateral support is provided for the utility by connection to the bridge bent caps. The PWM extends 164' over Mill Creek, with 45 degree bends at either channel bank, which return the utility underground. Based on a review of photos taken during a site visit in October 2020 by KCA, the aerial crossings are constructed of prestressed concrete cylinder pipe (PCCP) which consists of a concrete core, a thin steel cylinder, high tensile prestressing wire and an exterior concrete mortar. Refer to **Photo 2-1** for photographic representation of the 42" PWM.

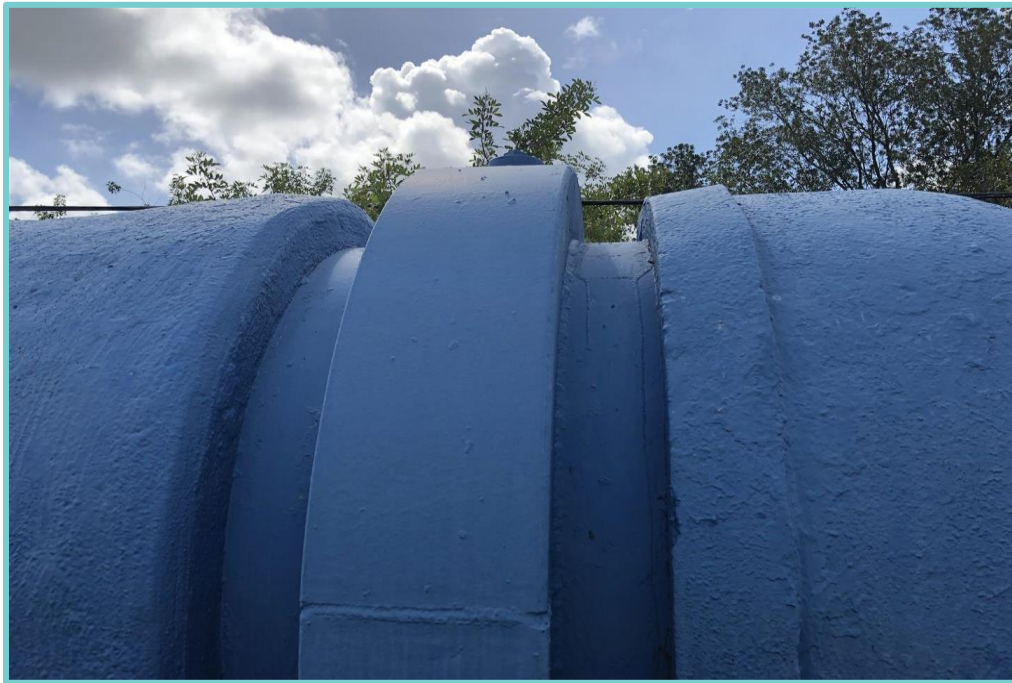
***Photo 2-2 – Past joint repair at 42" PWM***

The 42" PWM appears to be in good condition, approaching 30 years of service. No leaking or settling was observed. Joint repairs have been performed at some point (Refer to **Photo 2-2**) and the concrete mortar does show signs of distress from the elements, with hairline cracks in the mortar which allow rainwater to pull calcium out of the mortar to form the stalagmites (Refer to **Photo 2-3 & Photo 2-4**). There is also evidence pipe straps once secured the pipes to the concrete saddles but have since been removed.

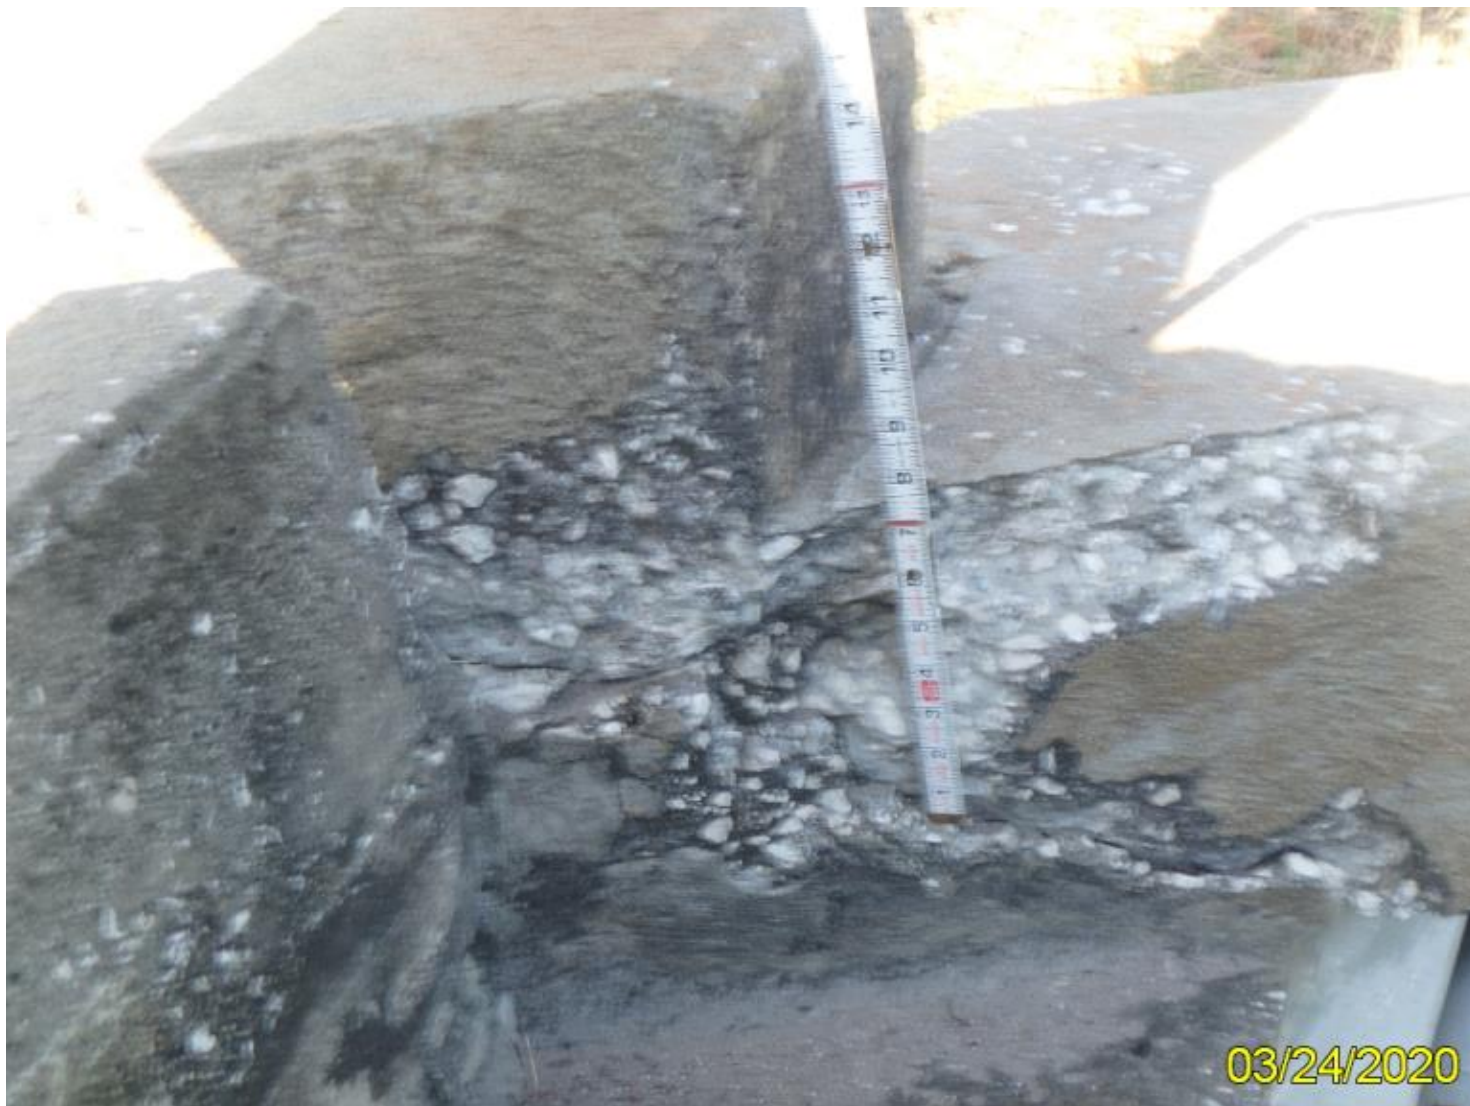
**Photo 1 - Element 8475 R/Conc Walls**

Spall/delamination in the northwest wingwall cap at Abutment 1

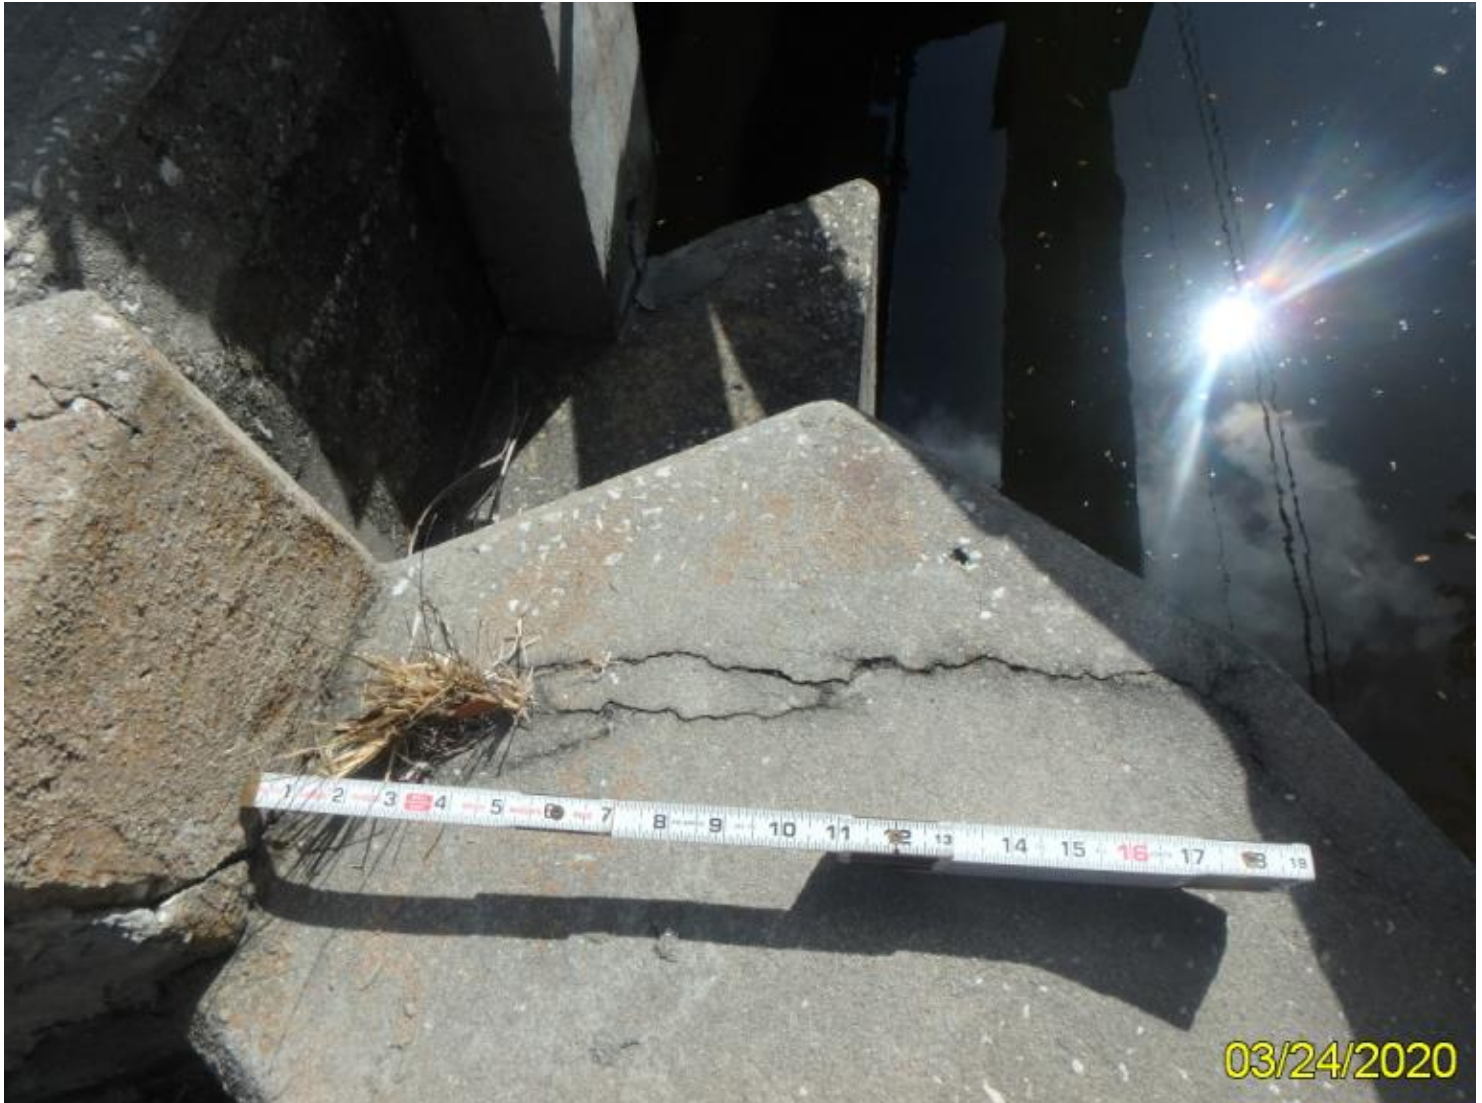
**Photo 2 - Element 8475 R/Conc Walls**

Delamination in the southwest wingwall cap

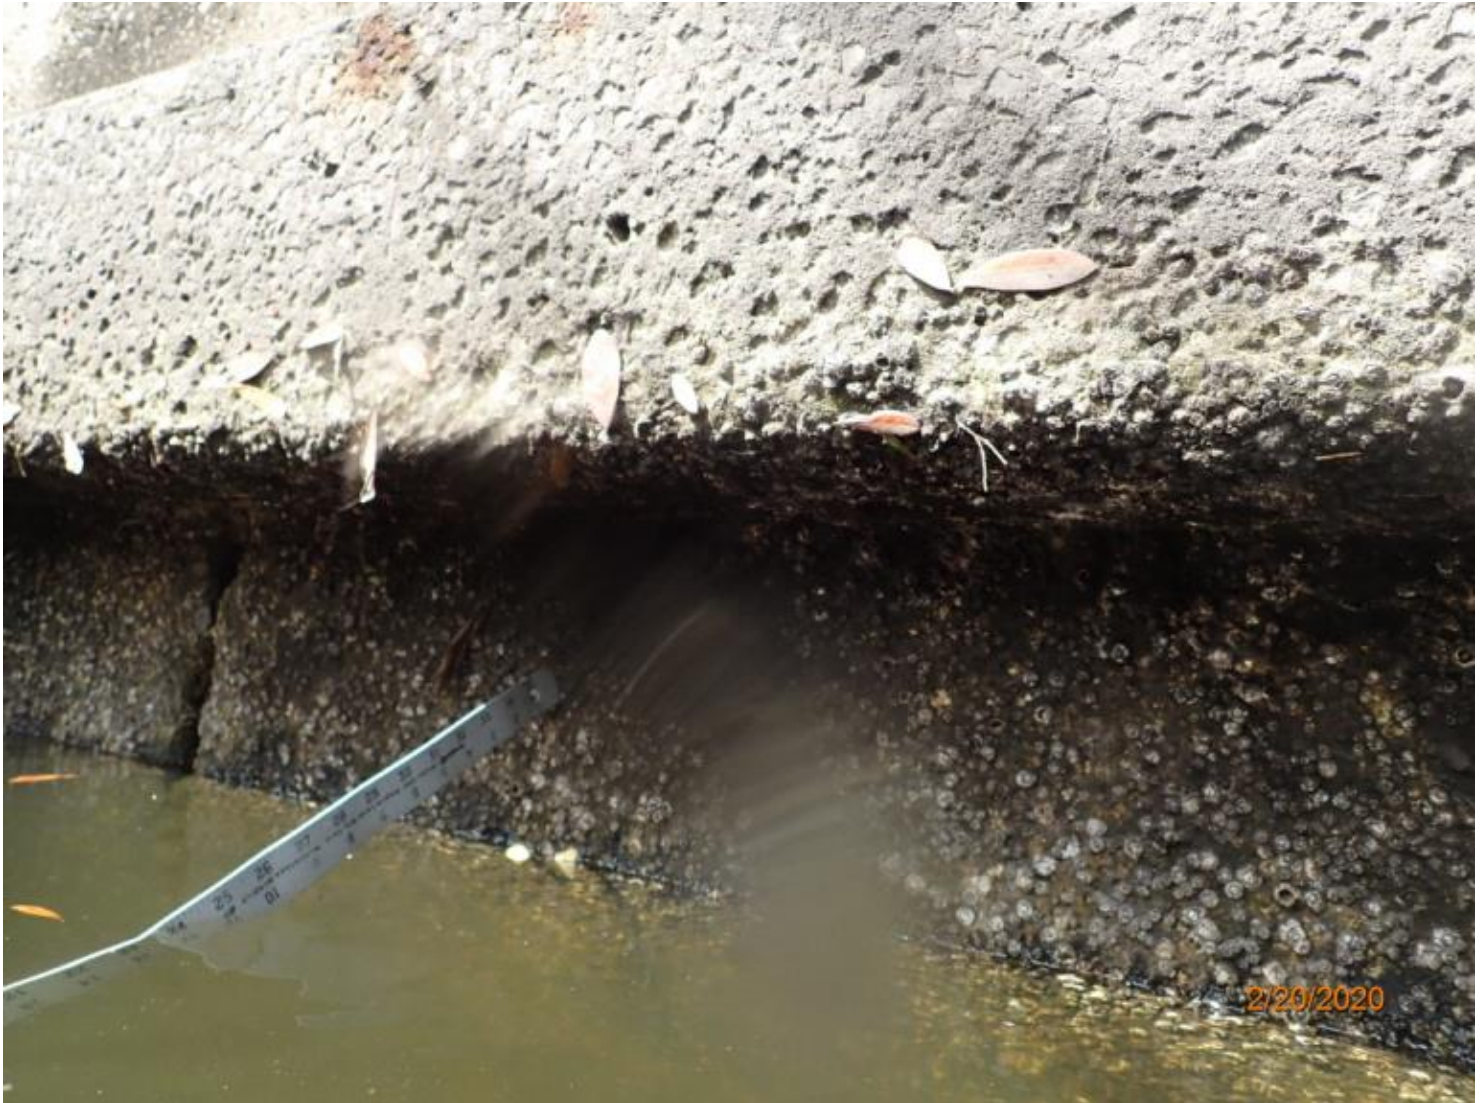
**Photo 3 - Element 8475 R/Conc Walls**

CS3 1190 = The wingwalls and struts have scale damage (loss of aggregate) up to 1/2in. deep. Refer to photo 3. (158FT)

Typical wingwall scale damage (loss of aggregate) up to 1/2in. deep

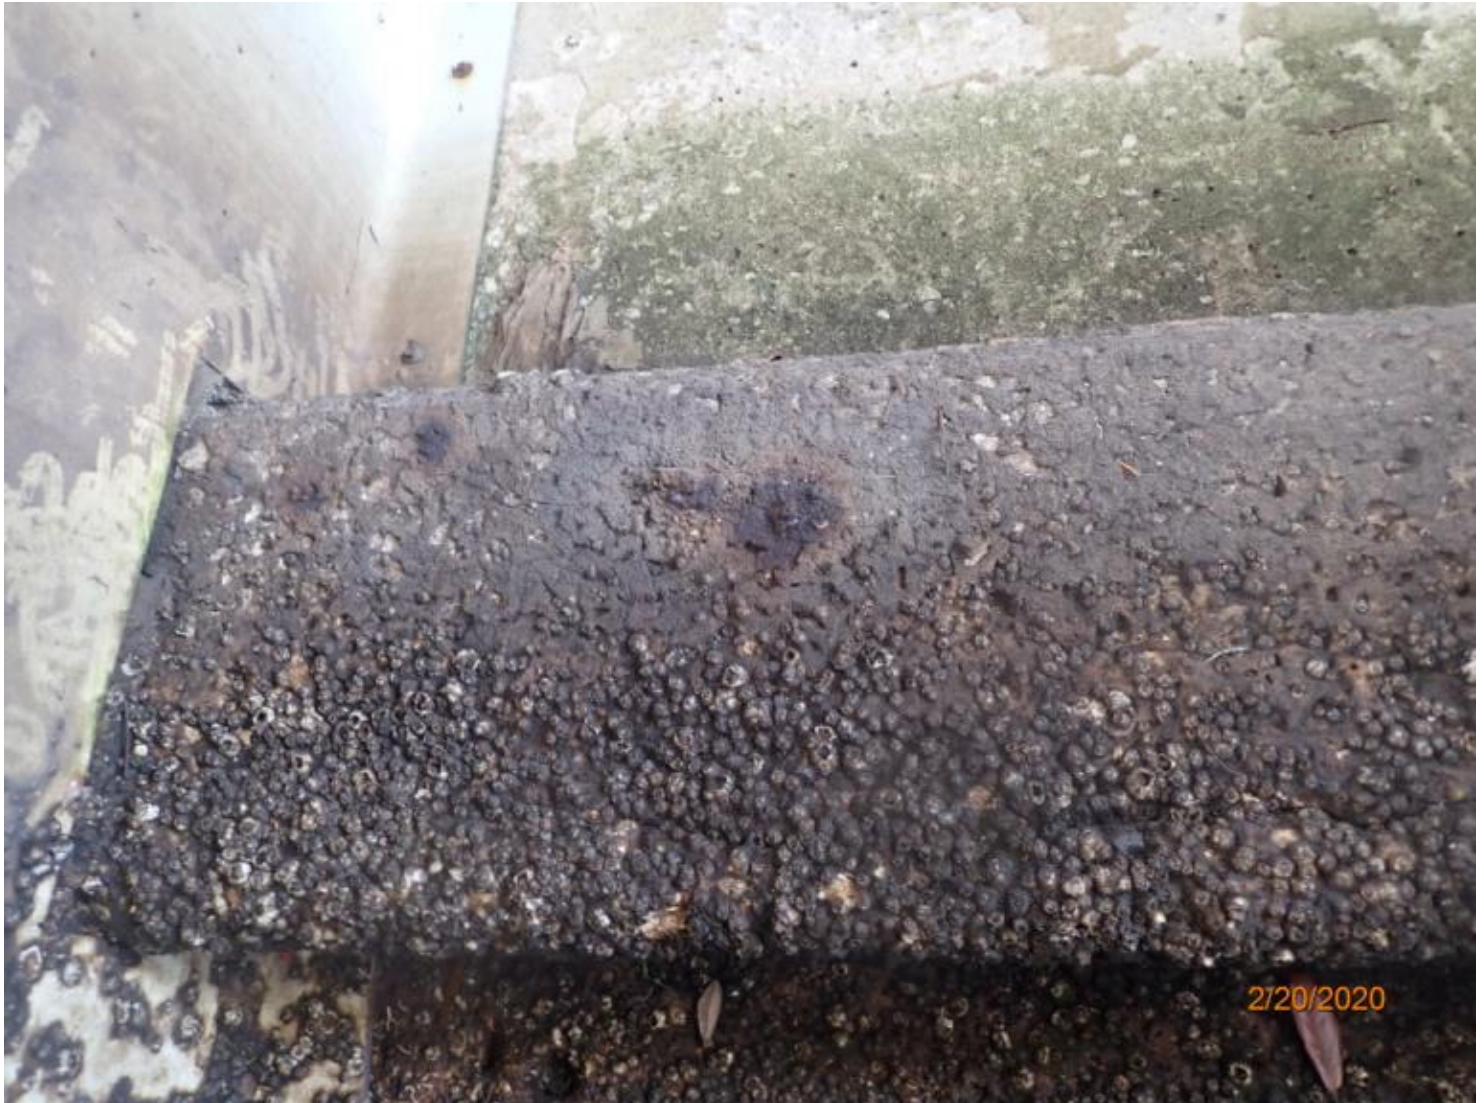
**Photo 4 - Element 8475 R/Conc Walls**

CS3 1120 = The west and east struts along the backwalls and wingwalls have isolated corrosion bleed out. Refer to photo 4. (2FT)

Typical area of corrosion bleed out at the west backwall strut

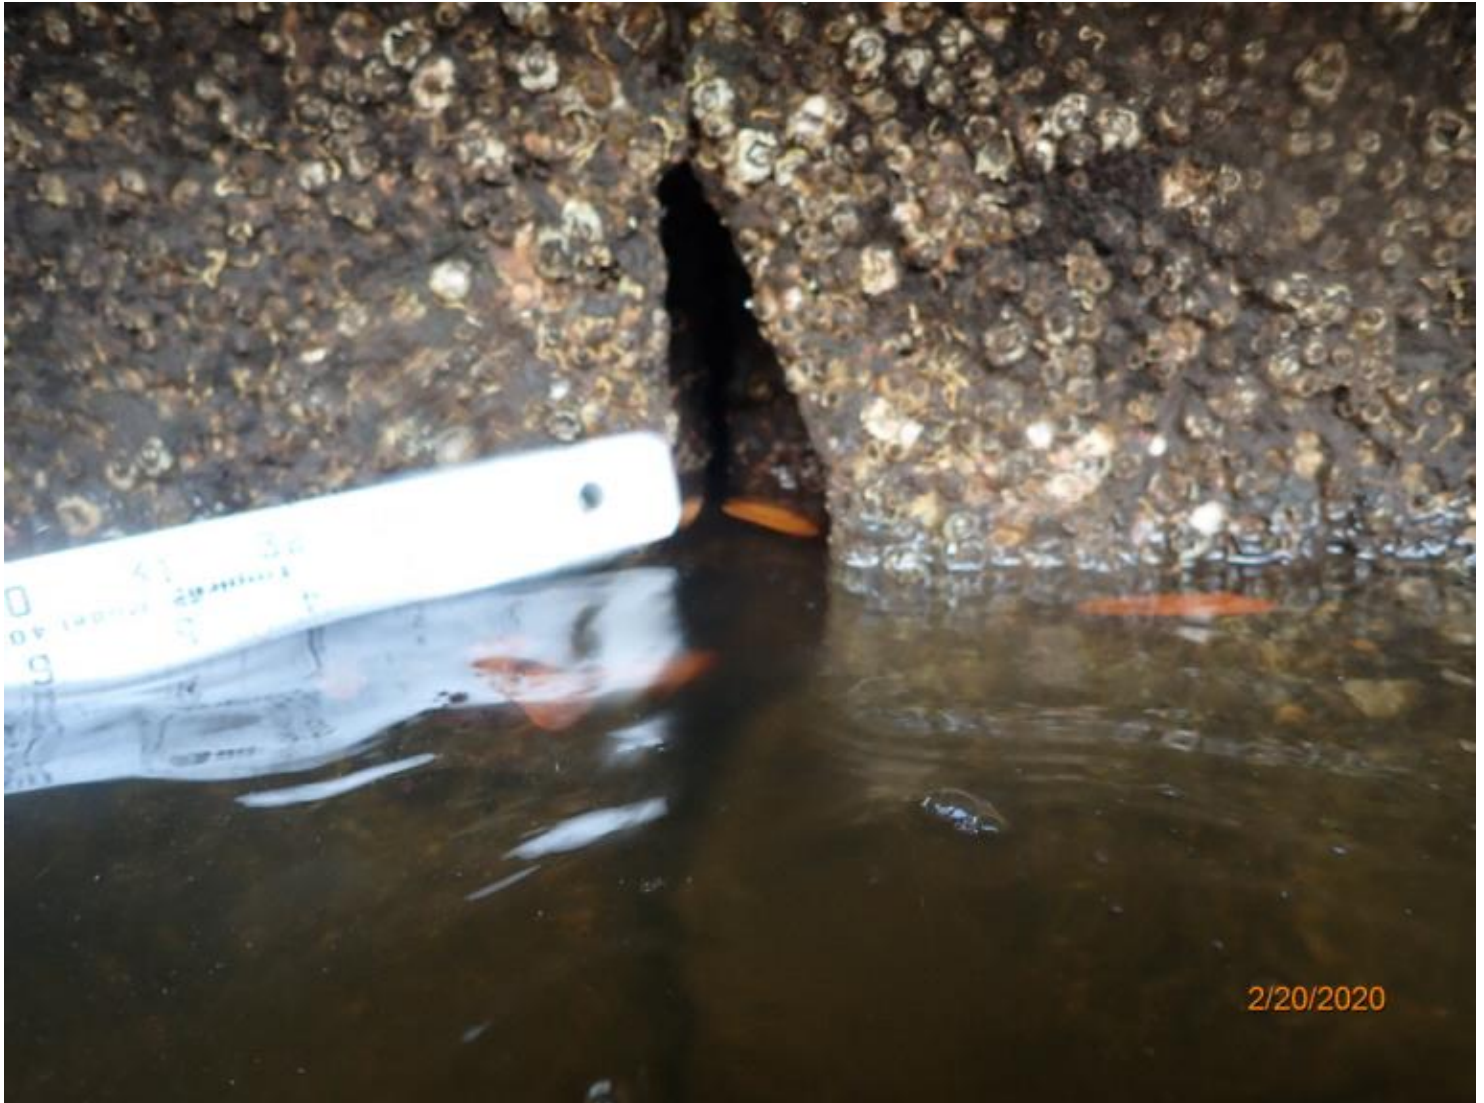
**Photo 5 - Element 8475 R/Conc Walls**

CS3 1080 = The west backwall has a 12in. x 3in. x 24in. spall at the joint between Piles 1-1 and 1-2, 6in. below the strut with backfill leakage. Refer to photo 5. (1FT)

Spall in the west backwall at the joint between Piles 1-1 and 1-2, 6in. below the strut with backfill leakage

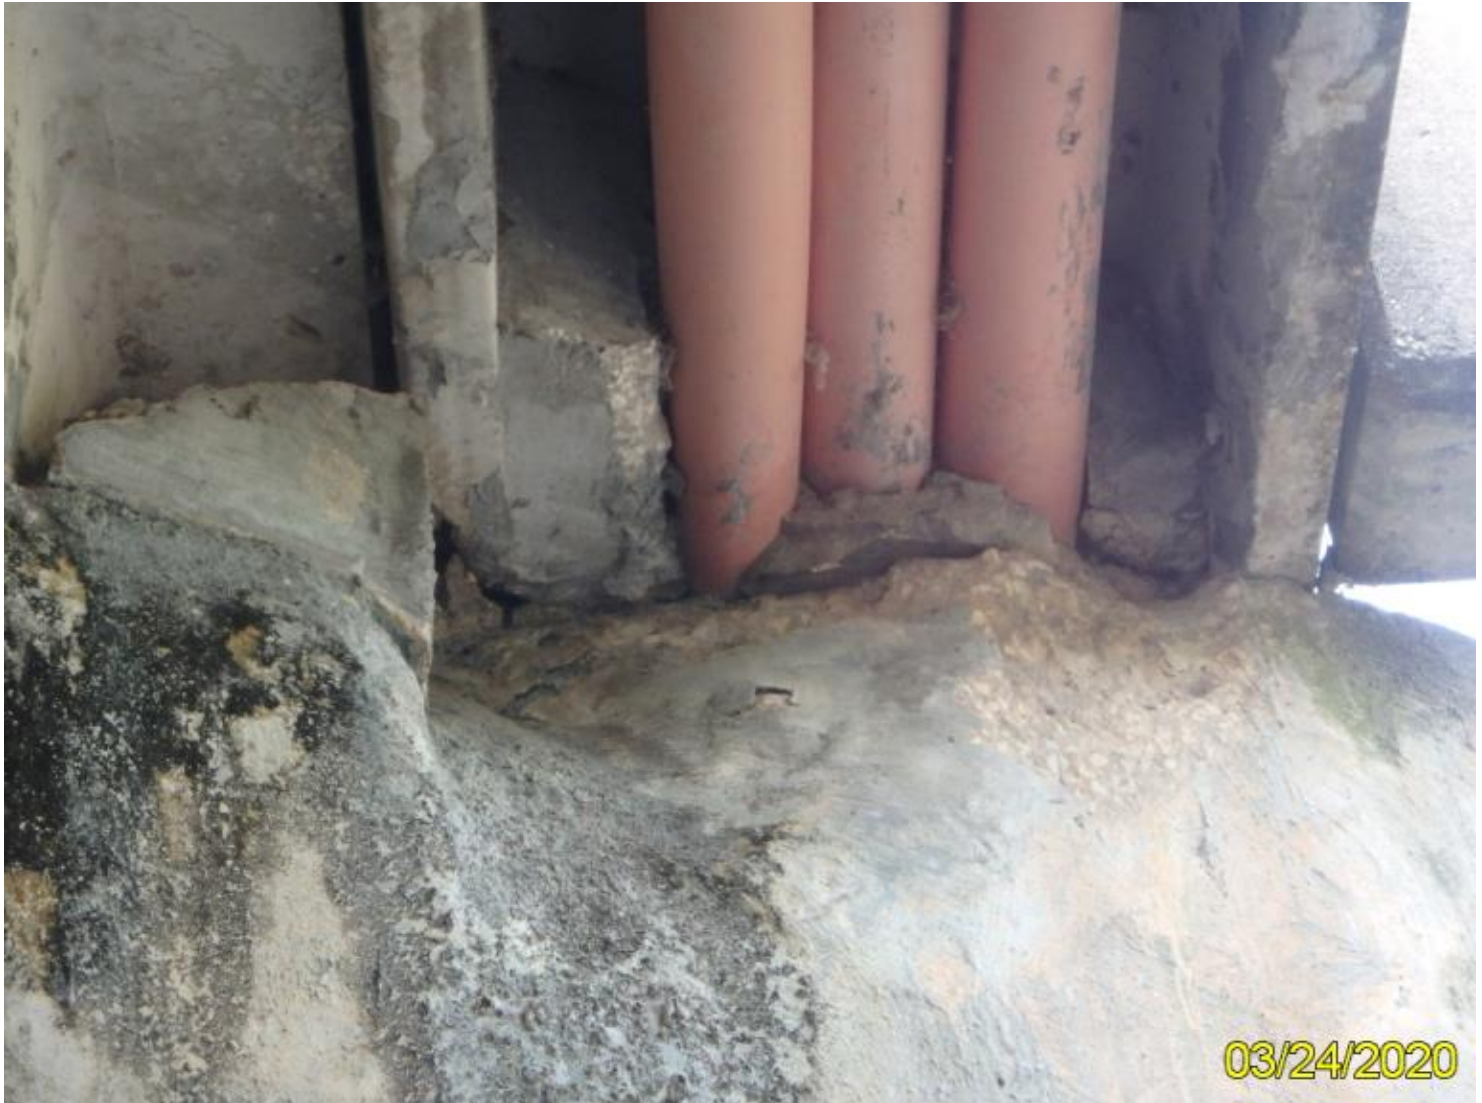
**Photo 6 - Element 215 Re Conc Abutment**

below Beam 1-1 at the utilities. Refer to photo 6. REPAIR (3FT)

Spall/delamination at the north end of Abutment 1 cap

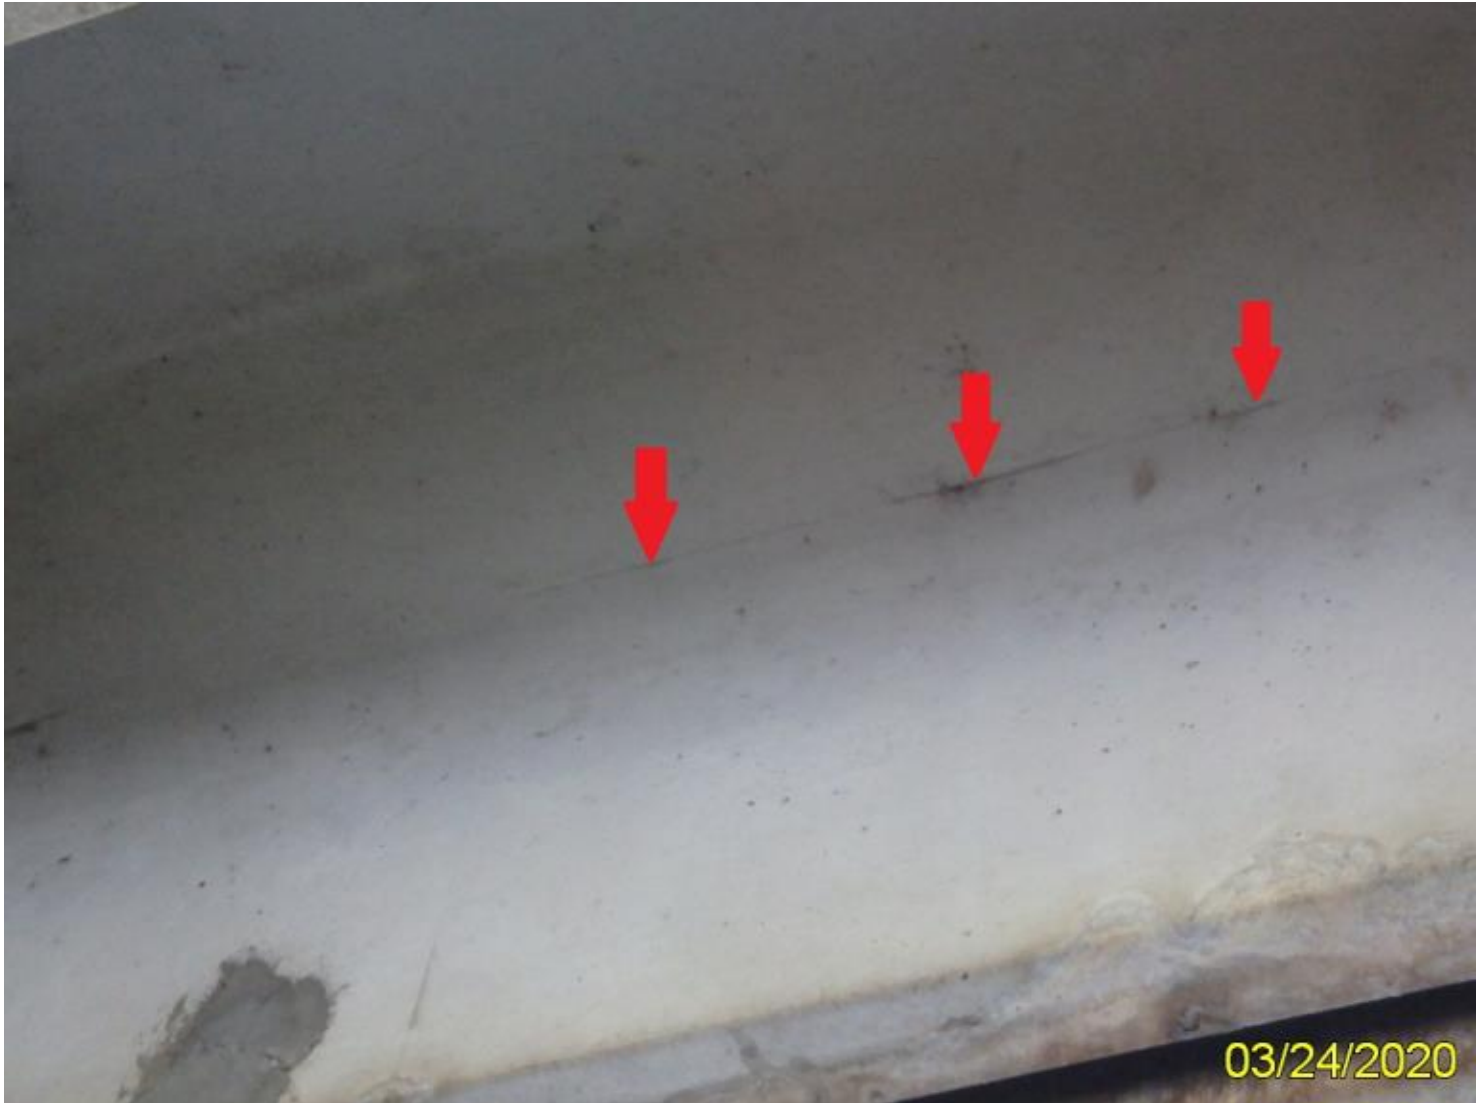
**Photo 8 - Element 109 Pre Opn Conc Girder/Beam**

109/4 CS2 1110 = The channel beams along the fillets have intermittent longitudinal cracks up to 3ft. long x up to 0.008in. wide. Refer to photo 8.(850FT)

Typical longitudinal crack along channel beam fillet areas in Beam 1-5

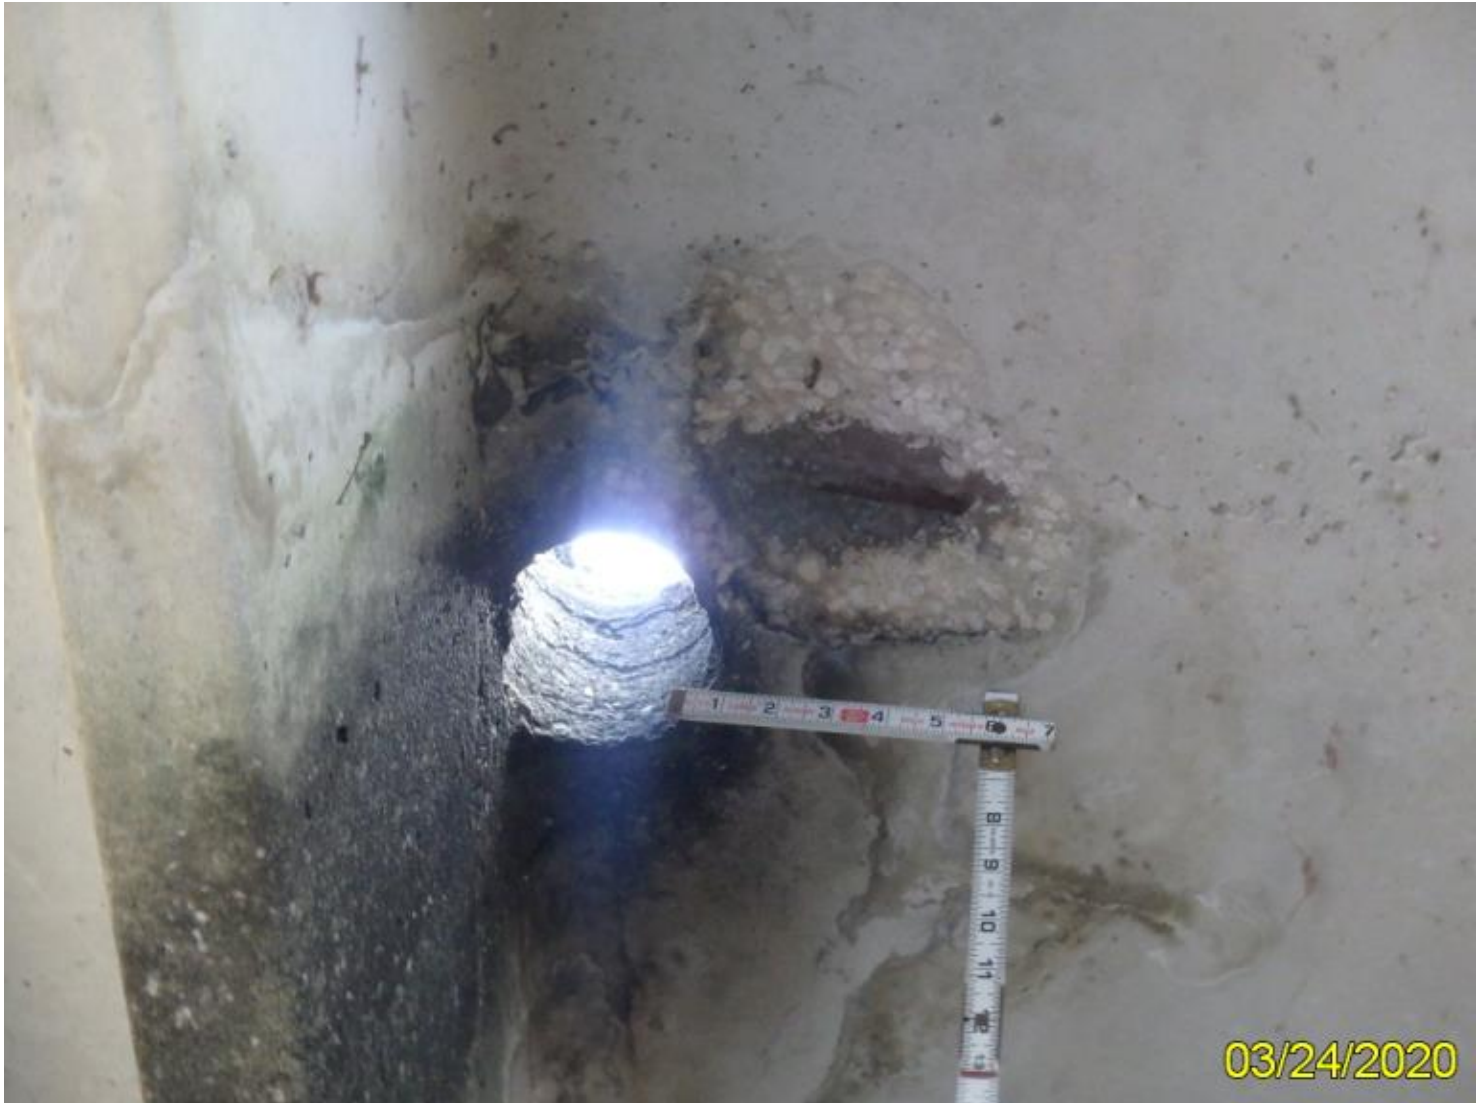
**Photo 9 - Element 109 Pre Opn Conc Girder/Beam**

CS3 1080 = Beam 3-2 has a 6in. diameter x 1/4in. deep spall with exposed steel with no measurable section loss in the bottom face of the top flange, adjacent to the eastern most scupper, at Bent 4. Refer to photo 9. REPAIR (1FT)

Spall with exposed steel in Beam 3-2

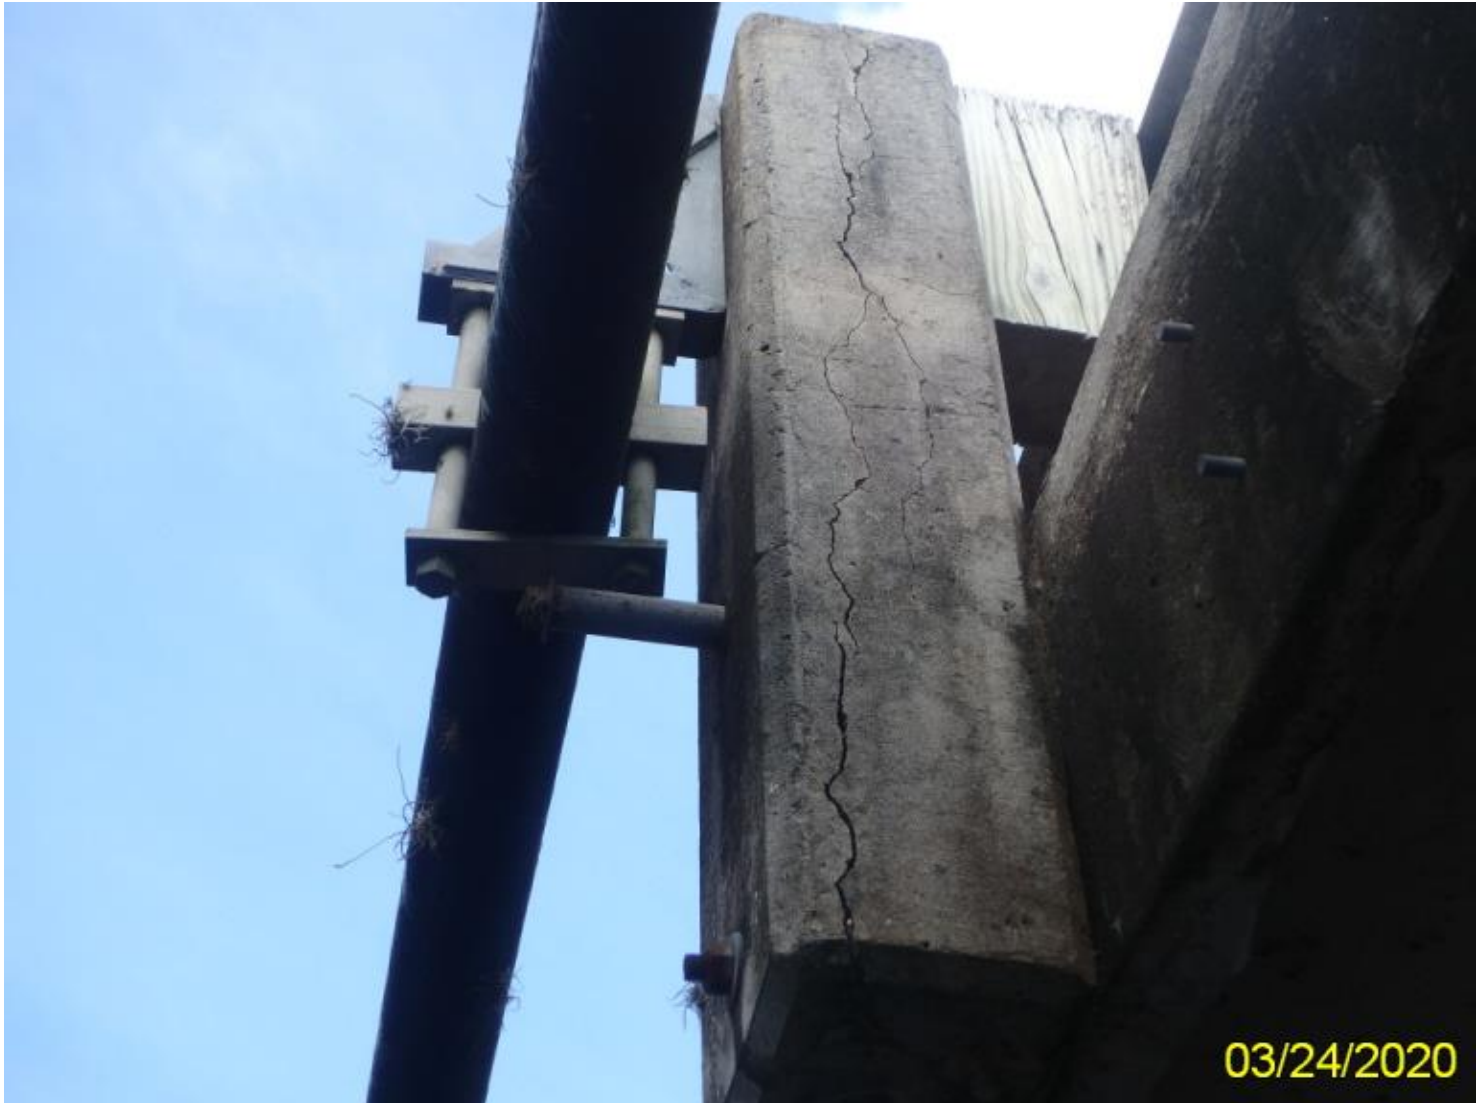
**Photo 10 - Element 333 Other Bridge Railing**

CS2 1010 = Post 4-4 Right has full height cracks x 1/16in. wide and is delaminated full height x 8in. wide with exposed lack of cover steel in the top face. Refer to photo 10. REPAIR (1FT)

Post 4-4 right typical full height delamination

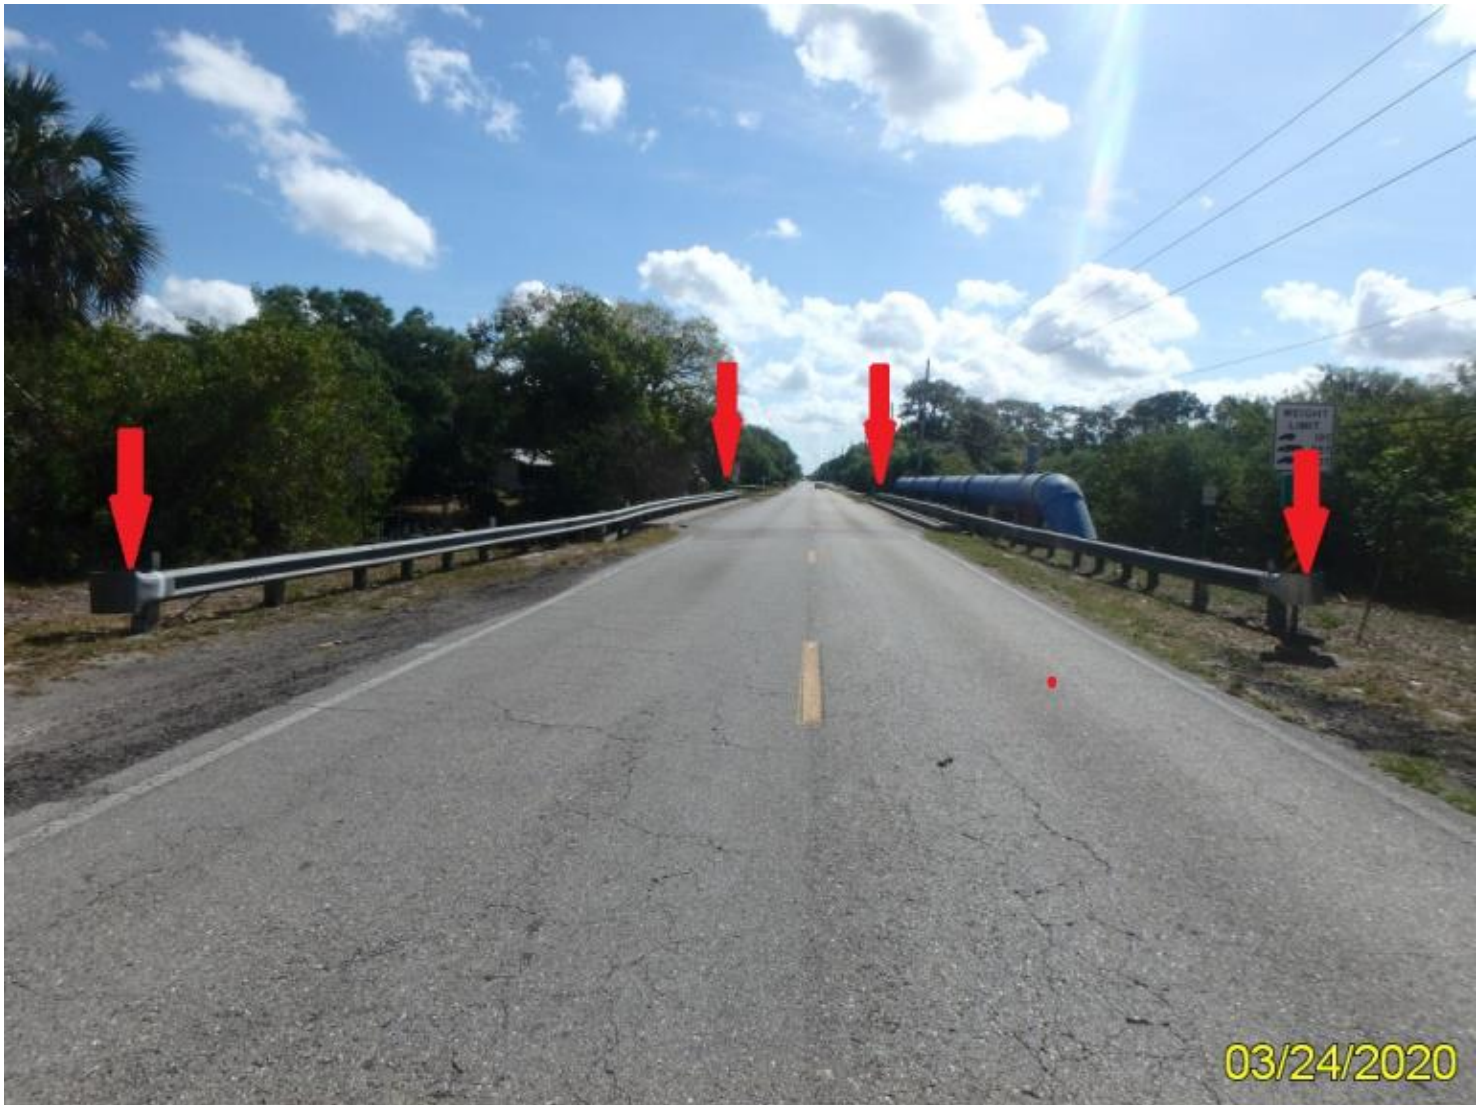
**Photo 11 - Inspection Notes**

The guardrail end terminals at all four corners of the structure are missing reflective tape. Refer to photo 11. REPAIR

Missing reflective tape on the guardrail end terminals

The guardrail end terminals at all four corners of the structure are missing reflective tape. Refer to photo 11. REPAIR
