Manatee County  
Lake Manatee WTP Basin A Inspection

## SUMMARY REPORT

DRAFT | March 2021

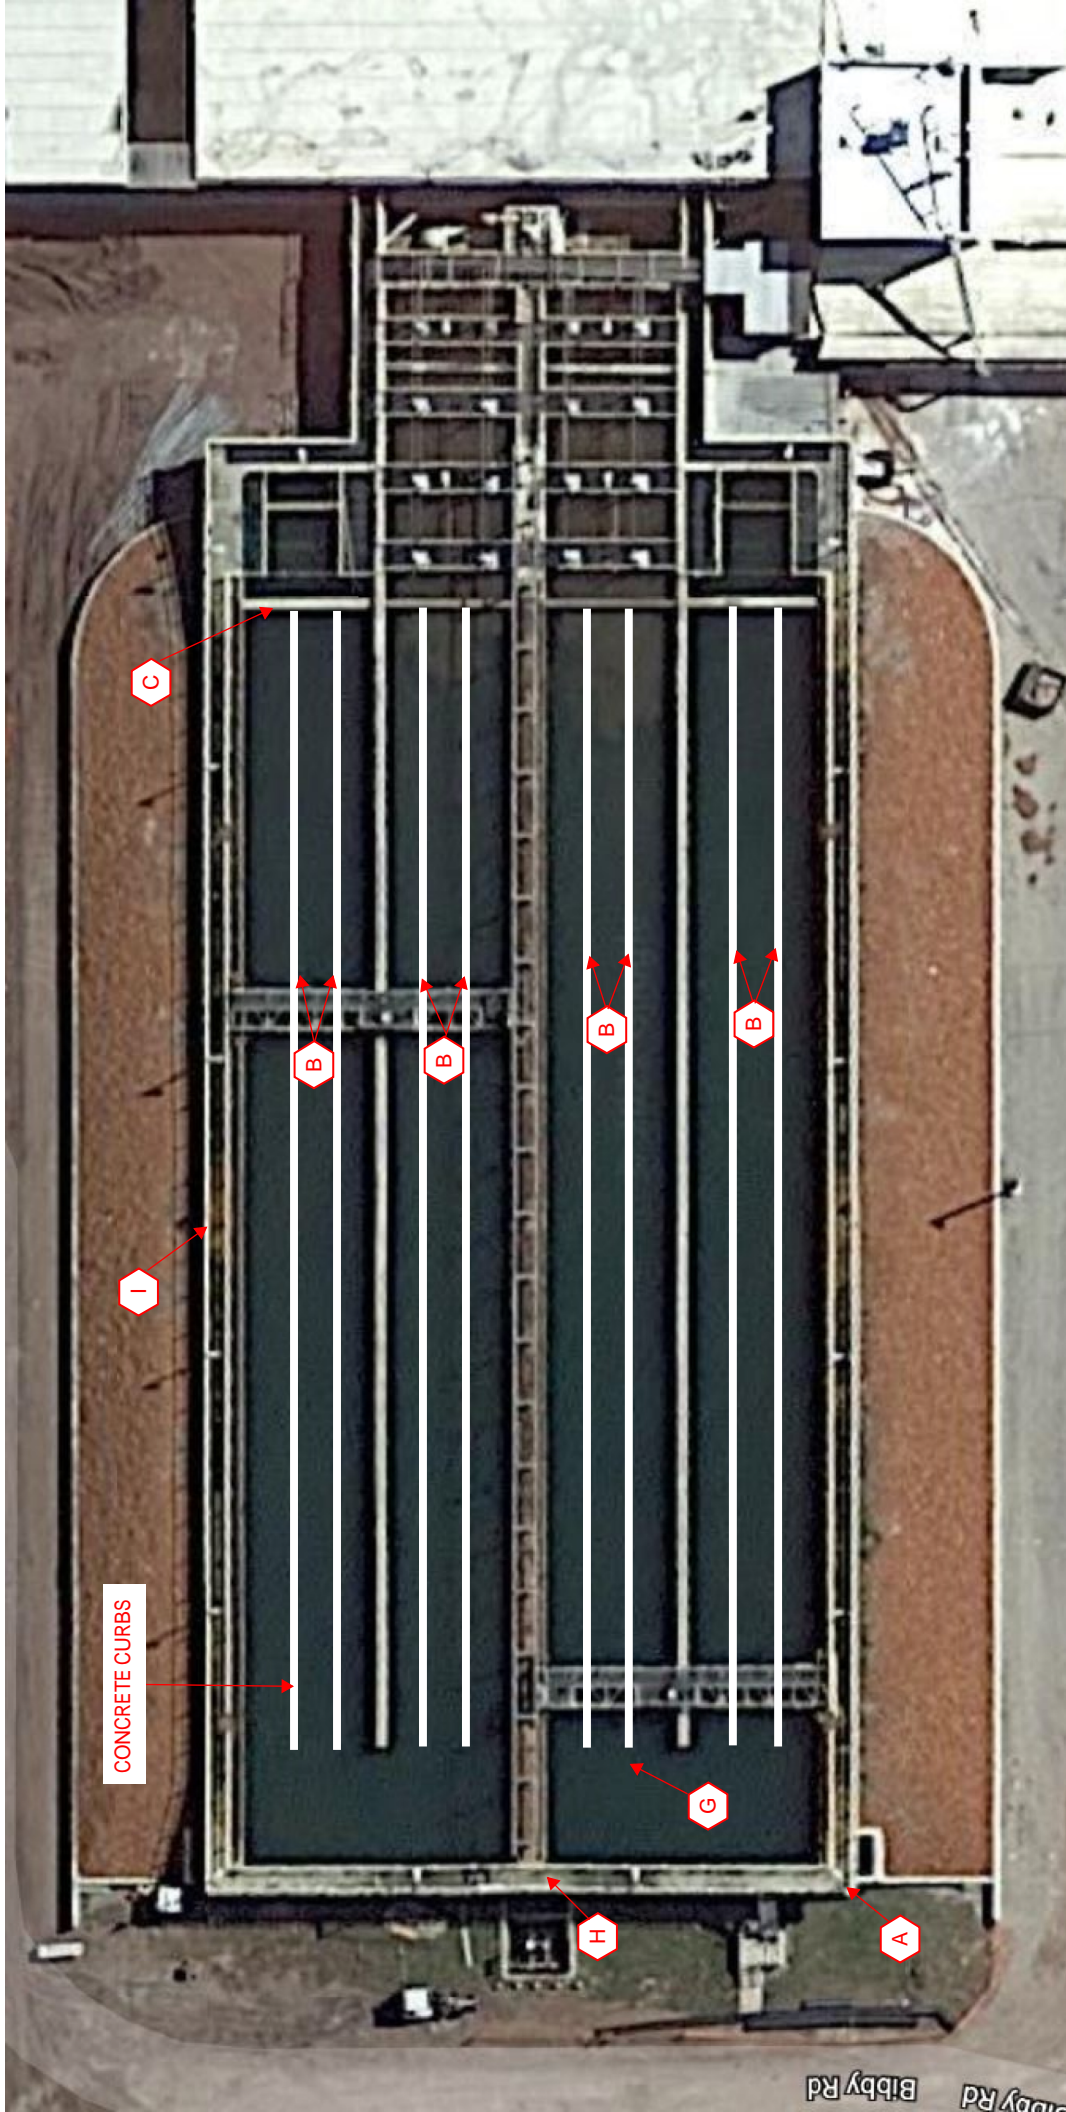
# AERIAL

The walls, and floor of the basin were observed to be generally in good condition. Appendix A includes photographs of each condition issue. Appendix B includes an aerial indicating the location of each photograph.
