**PORTSUENO PARK
SOUTH SEAWALL REPLACEMENT
GENERAL NOTES (2 OF 3)**

**PORTUENNO PARK
SOUTH SEAWALL REPLACEMENT**
TYPICAL SECTIONS (1 OF 2)

**PORTOSUENO PARK
SOUTH SEAWALL REPLACEMENT
ESP DETAILS (1 OF 5)**

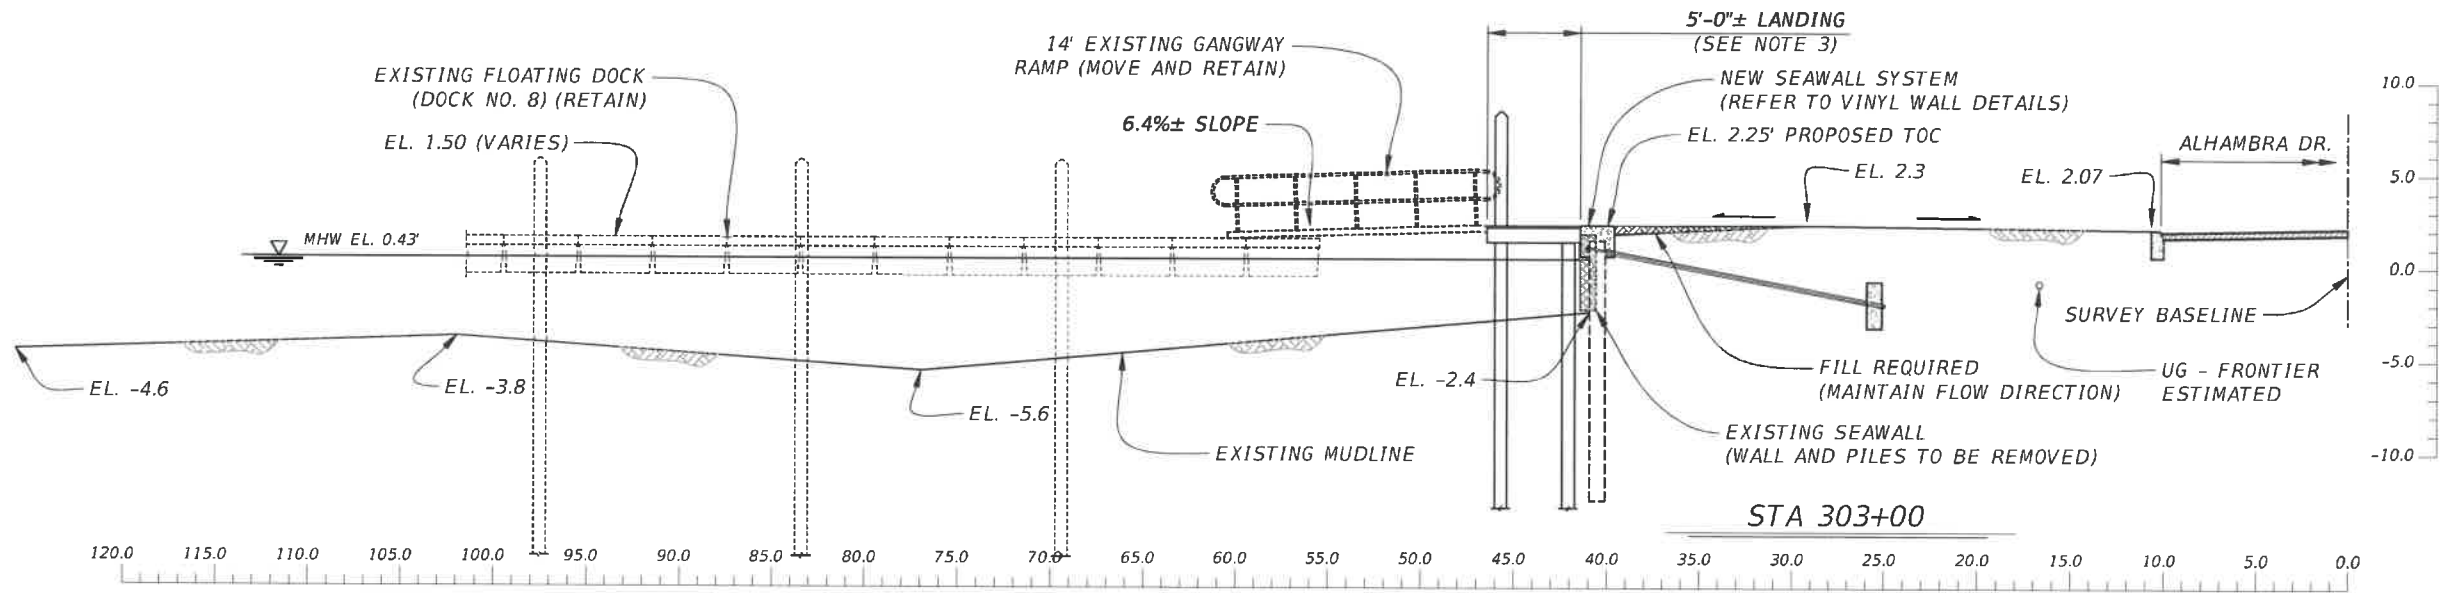
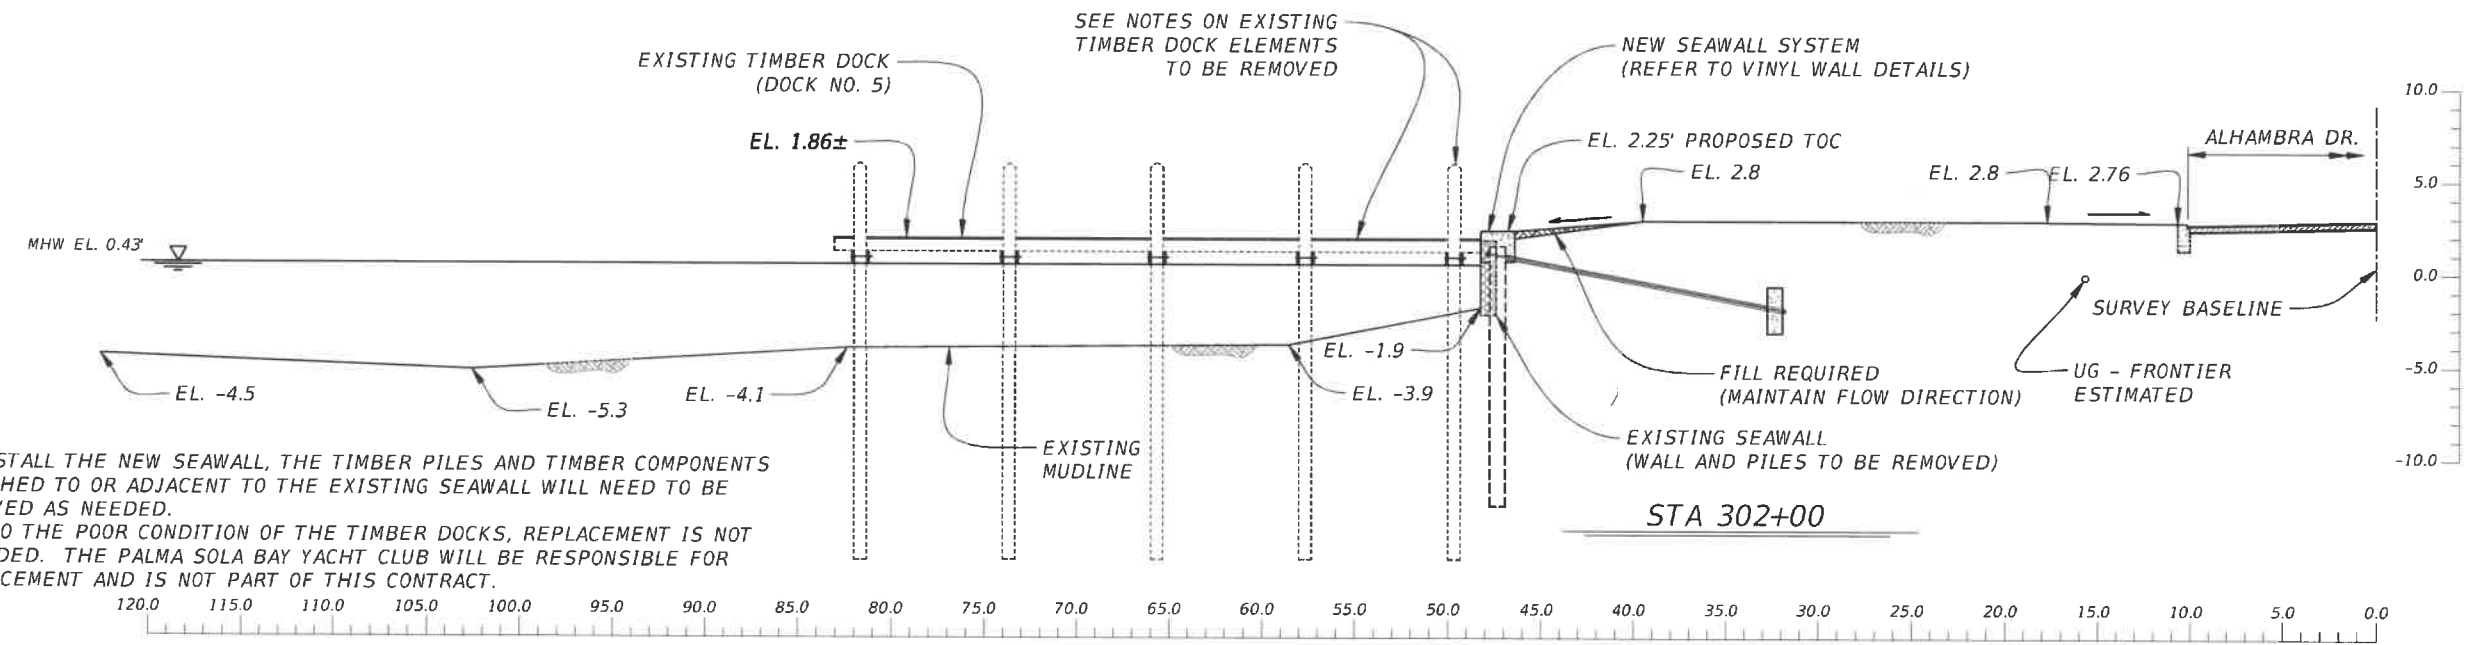
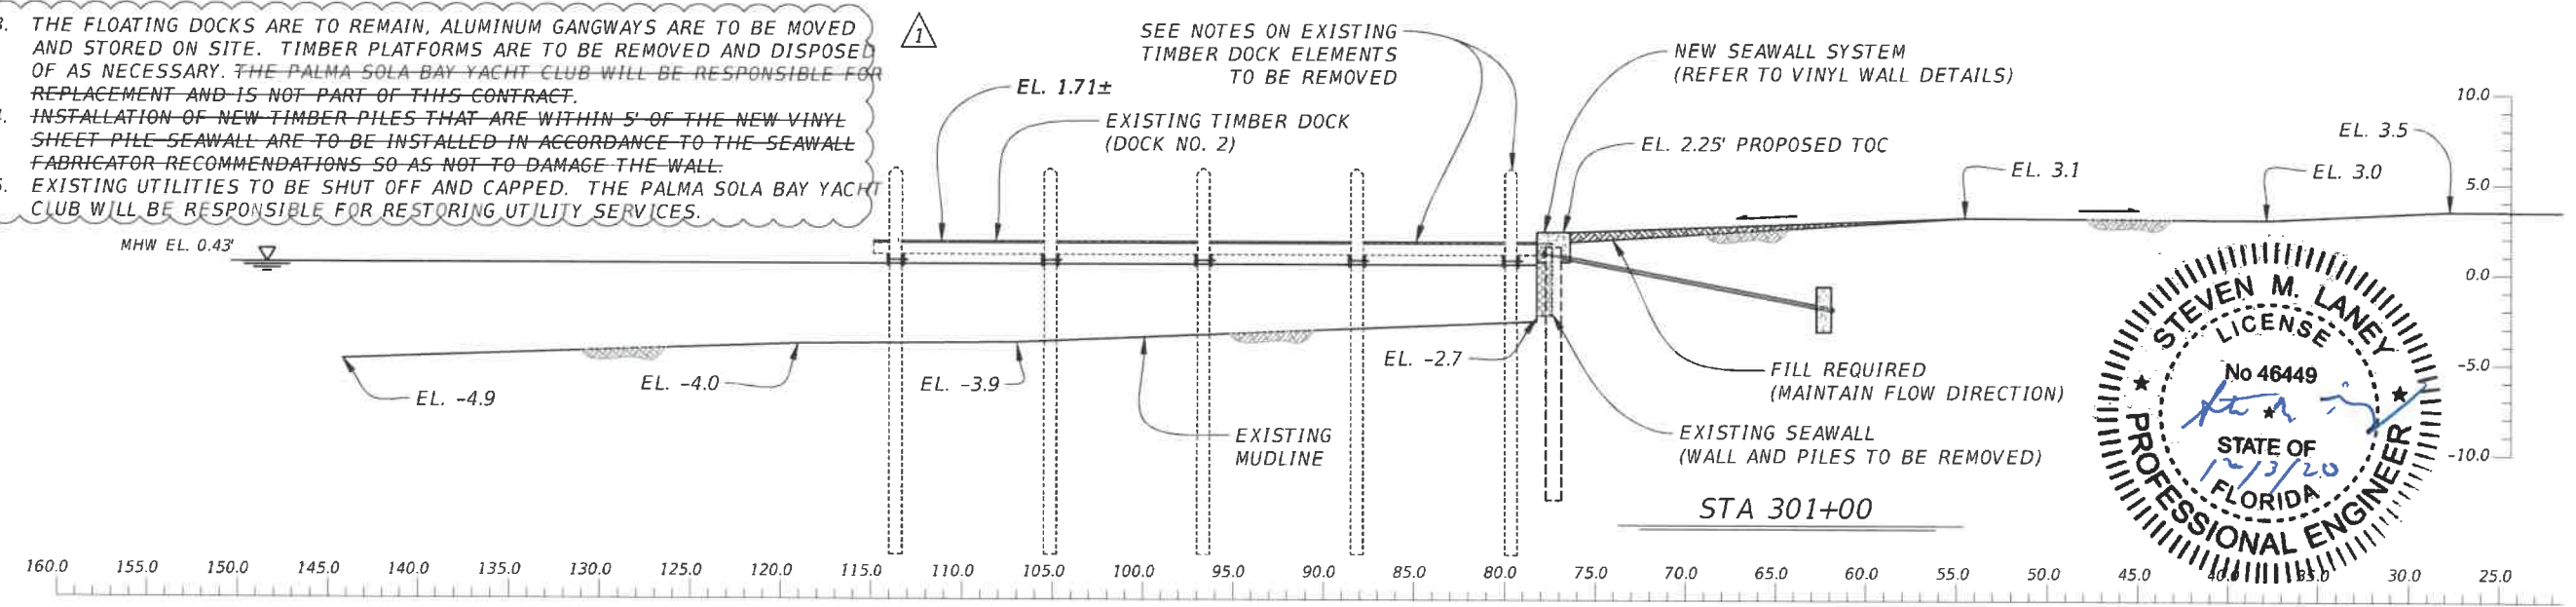
- NOTES:
1. TO INSTALL THE NEW SEAWALL, THE TIMBER PILES AND TIMBER COMPONENTS ATTACHED TO OR ADJACENT TO THE EXISTING SEAWALL WILL NEED TO BE REMOVED AS NEEDED.

2. DUE TO THE POOR CONDITION OF THE TIMBER DOCKS, REPLACEMENT IS NOT INCLUDED. THE PALMA SOLA BAY YACHT CLUB WILL BE RESPONSIBLE FOR REPLACEMENT AND IS NOT PART OF THIS CONTRACT.

3. THE FLOATING DOCKS ARE TO REMAIN, ALUMINUM GANGWAYS ARE TO BE MOVED AND STORED ON SITE. TIMBER PLATFORMS ARE TO BE REMOVED AND DISPOSED OF AS NECESSARY. THE PALMA SOLA BAY YACHT CLUB WILL BE RESPONSIBLE FOR REPLACEMENT AND IS NOT PART OF THIS CONTRACT.

4. INSTALLATION OF NEW TIMBER PILES THAT ARE WITHIN 5' OF THE NEW VINYL SHEET PILE SEAWALL ARE TO BE INSTALLED IN ACCORDANCE TO THE SEAWALL FABRICATOR RECOMMENDATIONS SO AS NOT TO DAMAGE THE WALL.

5. EXISTING UTILITIES TO BE SHUT OFF AND CAPPED. THE PALMA SOLA BAY YACHT CLUB WILL BE RESPONSIBLE FOR RESTORING UTILITY SERVICES.

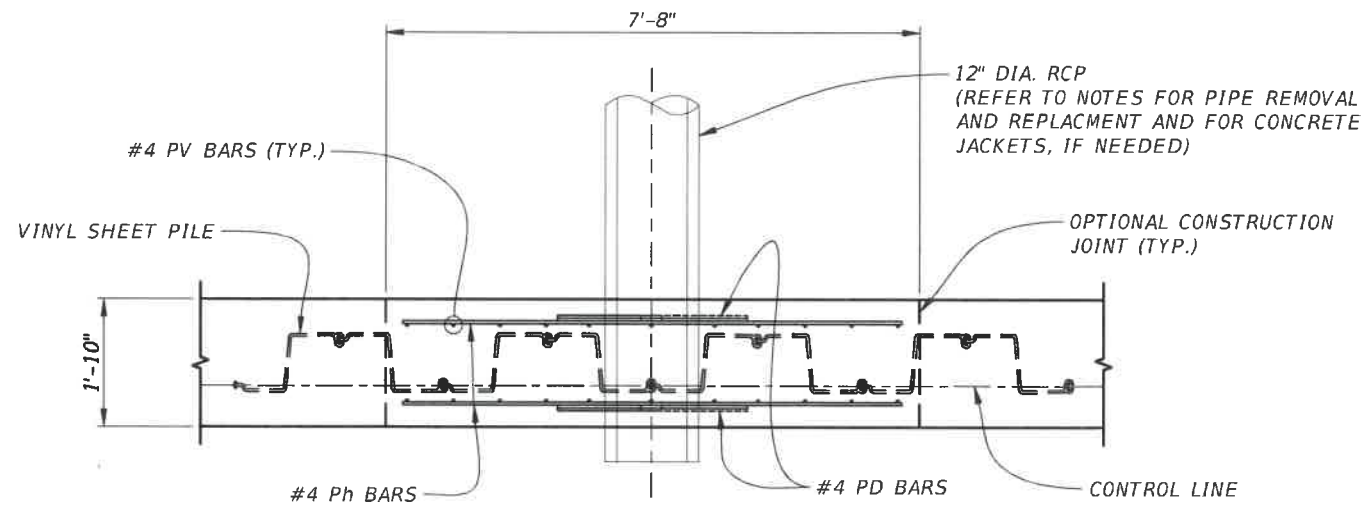
12" DIA. RCP SHEET PILE AND CAP MODIFICATION PARTIAL PLAN
(Scale: 3/8" = 1')

- WITH THE STORM DRAIN PIPE OUT OF THE WAY, INSTALL THE VINYL SHEET PILING TO THE ELEVATIONS BELOW THE INVERT ELEVATIONS AS SHOWN.
 - RE-INSTALL THE END SECTION OF STORM DRAIN PIPE IF THE EXISTING PIPE IS IN GOOD CONDITION. IF THE EXISTING SECTION OF PIPE IS IN POOR CONDITION, RE-INSTALL A NEW SECTION OF PIPE. REFER TO FDOT STANDARD SPECIFICATION 430.

- CONSTRUCT THE CONCRETE CAP WALL SECTION OVER THE PIPE AS SHOWN IN THE DETAILS ON THIS SHEET.
- PAYMENT FOR THE REMOVAL AND REPLACEMENT OF THE PIPE IS INCLUDED IN THE COST OF CONCRETE FOR THE SHEET PILE CAPS.

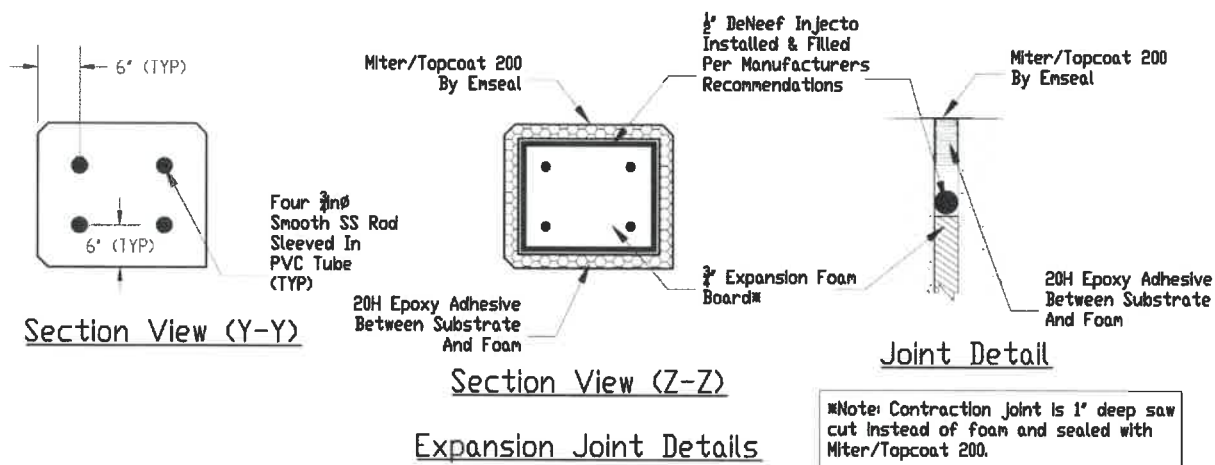
Note: Contraction Joint is 1\"/>

- 1.) $\frac{3}{4}$ " Expansion joints are to be located at no greater than 49' intervals.
- 2.) Expansion joints are to be located no closer than 10' from corners/turns.
- 3.) Two contraction joints are to be evenly spaced between expansion joints.
- 4.) Contraction joints shall be 1" depth saw cut with cut being sealed by 20H epoxy adhesive and Miter/Topcoat 200 as noted in joint detail, sheet B.
- 5.) All reinforcing steel to have a minimum cover of 3".
