Tabular Report of PSR 9029 (1-1)
X
for COLONY COVE INITIAL CCTV SANITARY 201
Setup 43 Surveyor TIM Certificate # U-307-1521 System Owner COLONY COVE

Drainage		Survey Customer COLONY COVE	
P/O #	Date 2012/04/16	Time 9:46	Street AMELO AVE
City ELLENTON	Further location details 9029.1 214 AMELO AVE		
Start 22875 (1-1)	Rim to invert 7.30	Grade to invert	Rim to grade Ft
Finish 9029 (1-1)	Rim to invert 5.10	Grade to invert	Rim to grade Ft
Use Sanitary	Direction Up	Flow control	Media No 9029.1
Shape Circular	Height 8	Width ins	Preclean J
Material Vitrified Clay Pipe	Joint length Ft	Total length 165.4 Ft	Length Surveyed 165.4
Lining	Year laid	Year rehabilitated	Weather Dry
Purpose	Cat	Pressure	
Additional info SOUTHWEST		Structural	O&M
Location Easement/Right of Way		Miscellaneous	Constructional
Project		Work Order	
Northing 1163452.33	Easting 497461.06	Elevation	
Coordinate System US STATE PLANE1983 (NAD 1983)		GPS Accuracy

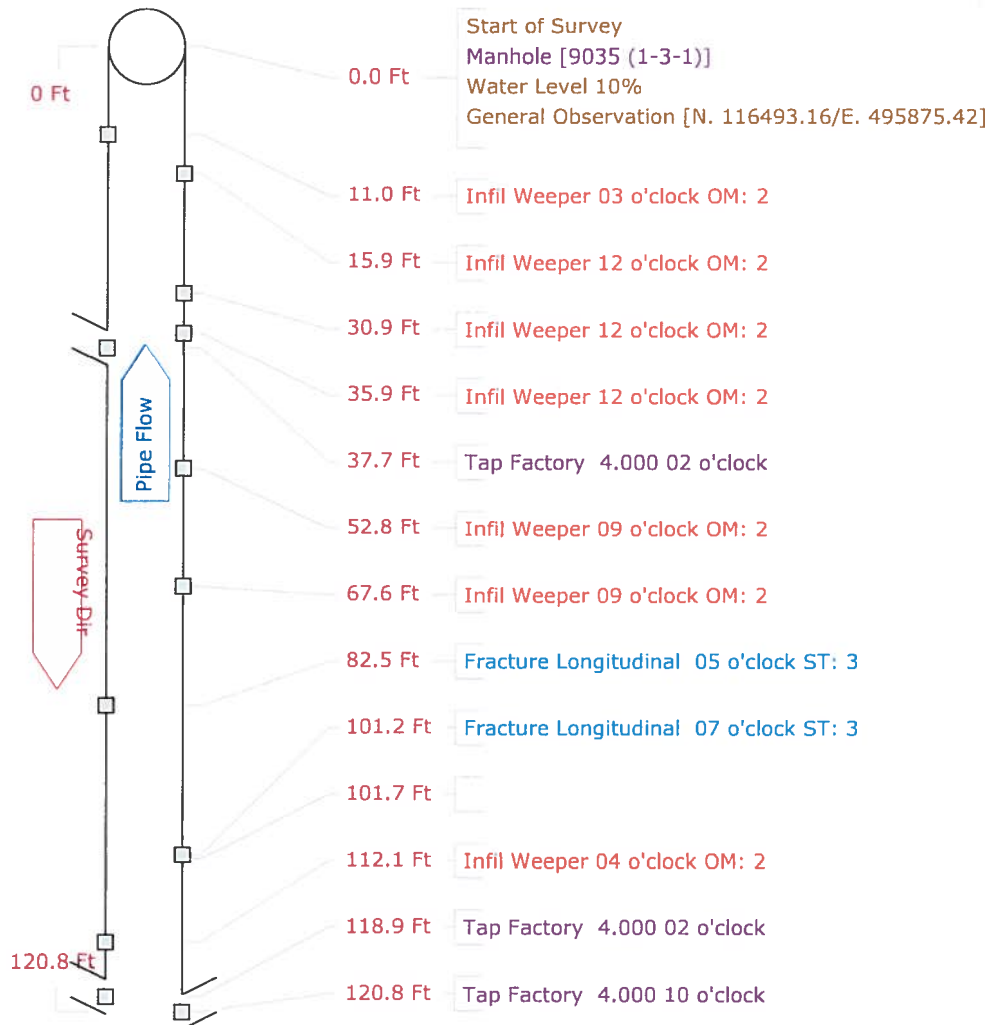
Pipe Graphic Report of PSR 9035 (1-3-1) X for COLONY COVE INITIAL CCTV SANITAR'

Setup 7	Surveyor TIM	Certificate # U-307-1521	System Owner COLONY COVE
Drainage	Survey Customer COLONY COVE		
P/O #	Date 2012/03/29	Time 9:36	Street HOLLAND ST
City ELLENTON	Further location details 9035.1 117 HOLLAND ST.		
Start 9040 (1-3-1C)	Rim to invert 7.60	Grade to invert	Rim to grade Ft
Finish 9035 (1-3-1)	Rim to invert 6.70	Grade to invert	Rim to grade Ft
Use Sanitary	Direction Upstream	Flow control	Media No 9035.1
Shape Circular	Height 8	Width ins	Preclean J
Material Vitrified Clay Pipe	Joint length Ft	Total length 142.5	Year Cleaned 2012/03/29
Lining	Year laid	Year rehabilitated	Weather Dry
Purpose	Cat		
Additional info EAST			Structural O&M Constructional
Location Easement/Right of Way			Miscellaneous Hydraulic
Project			Work Order
Northing 1163473.09	Easting 496734.54	Elevation	
Coordinate System US STATE PLANE1983 (NAD 1983)		GPS Accuracy

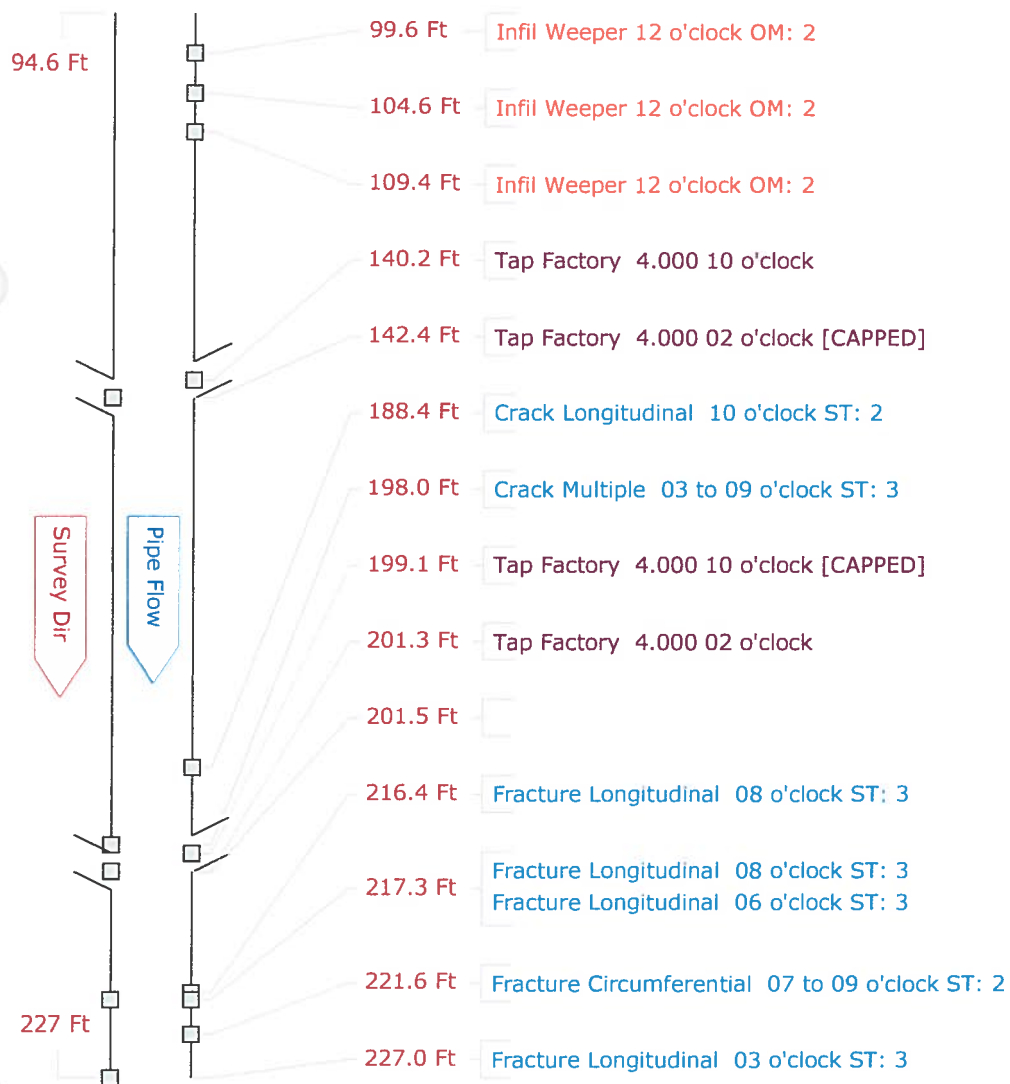
Pipe Graphic Report of PSR 9040 (1-3-1C) X for COLONY COVE INITIAL CCTV SANITARY

Setup	8	Surveyor	TIM	Certificate #	U-307-1521	System Owner	COLONY COVE
Drainage		Survey Customer	COLONY COVE				
P/O #		Date	2012/03/29	Time	10:15	Street	HOLLAND ST
City	ELLENTON	Further location details	9040.1 202 HOLLAND ST.				
Start	9040 (1-3-1C)	Rim to invert	7.60	Grade to invert		Rim to grade	Ft
Finish	9028 (1-3-B)	Rim to invert	5.70	Grade to invert		Rim to grade	Ft
Use	Sanitary	Direction	Downstream	Flow control		Media No	9040.1
Shape	Circular	Height	8	Width	ins Preclean J	Year Cleaned	2012/03/29
Material	Vitrified Clay Pipe	Joint length	Ft	Total length	287.9	Ft	Length Surveyed 287.90
Lining		Year laid		Year rehabilitated		Weather	Dry
Purpose				Cat			
Additional info	SOUTH					Structural	O&M
Location	Easement/Right of Way					Miscellaneous	Hydraulic
Project						Work Order	
Northing	1163493.16	Easting	496875.42	Elevation			
Coordinate System	US STATE PLANE1983 (NAD 1983)			GPS Accuracy

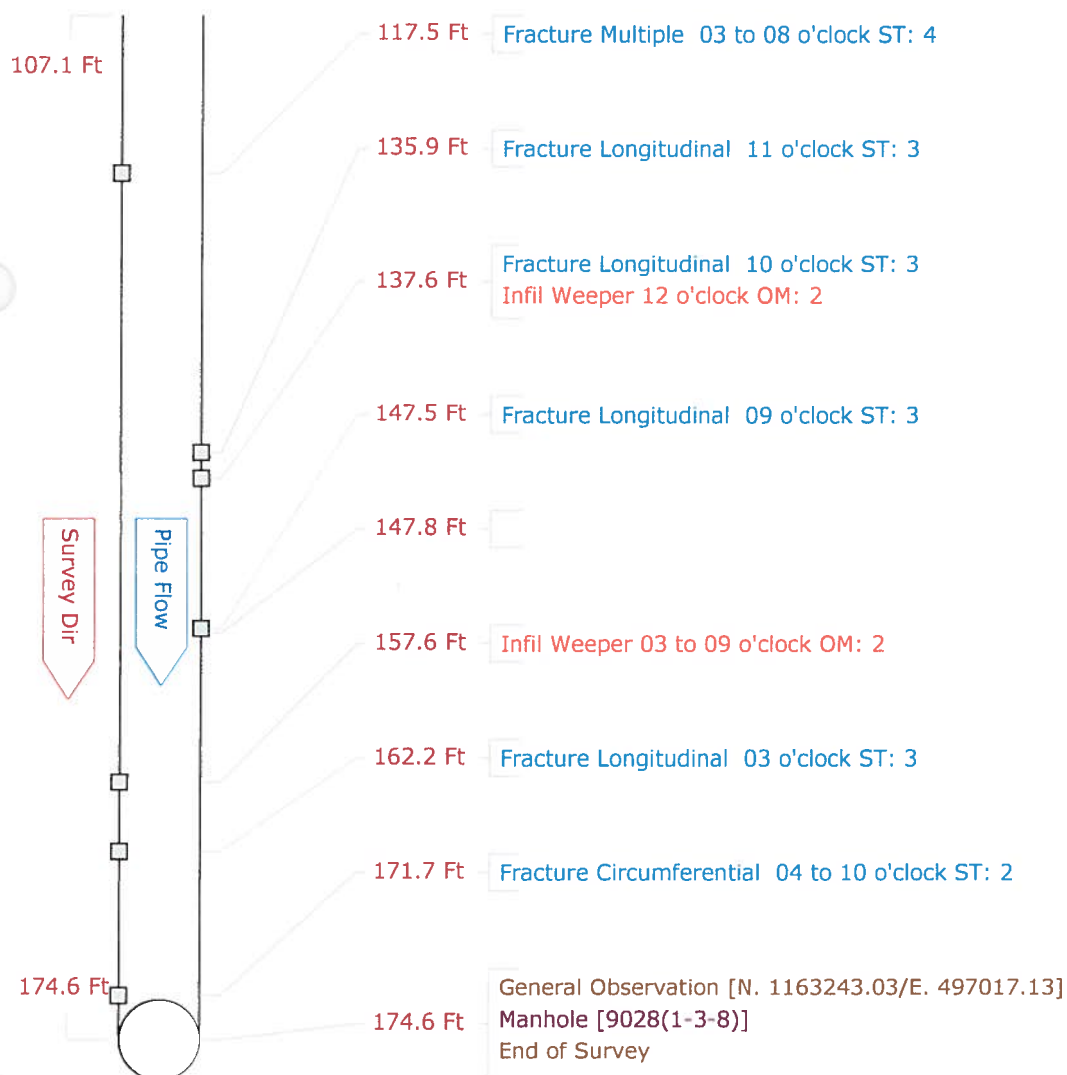
Pipe Graphic Report of PSR 11845 (1-3-10) X for COLONY COVE INITIAL CCTV SANITAR

Setup	9	Surveyor	TIM	Certificate #	U-307-1521	System Owner	COLONY COVE
Drainage		Survey Customer	COLONY COVE				
P/O #		Date	2012/03/29	Time	11:54	Street	DENMARK DR.
City	ELLENTON	Further location details	11845.1 212 DENMARK DR.				
Start	11845 (1-3-10)	Rim to invert	6.70	Grade to invert		Rim to grade	Ft
Finish	9028(1-3-B)	Rim to invert	5.70	Grade to invert		Rim to grade	Ft
Use	Sanitary	Direction	Downstream	Flow control		Media No	11845.1
Shape	Circular	Height	8	Width	ins	Preclean J	Year Cleaned 2012/03/29
Material	Vitrified Clay Pipe	Joint length	Ft	Total length	174.6	Ft	Length Surveyed 174.60
Lining		Year laid		Year rehabilitated		Weather	Dry
Purpose				Cat			
Additional info	NORTHEAST					Structural	O&M
Location	Easement/Right of Way					Miscellaneous	Hydraulic
Project						Constructional	
						Work Order	
Northing	1163144.63	Easting	496873.16	Elevation			
Coordinate System	US STATE PLANE1983 (NAD 1983)			GPS Accuracy

Count	Video	CD	Code	In1	In2	%	JntFr	To	ImRef	Remarks
0.0			ST Start of Survey							
0.0			AMH Manhole							11845 (1-3-10)
0.0			MWL Water Level			10				
0.0			MGO General Observation							N.1163144.63/E.496873.16
0.0			MGO General Observation							PVC AT START
6.0			JOM Joint Offset Medium							
24.1			FL Fracture Longitudinal				10			
24.1			RFJ Roots Fine Joint				J	10		
54.0			RFJ Roots Fine Joint				J	10		
59.0			RFJ Roots Fine Joint				J	08	04	
60.0			MMC Material change							FROM PVC TO VCP
73.6			RFJ Roots Fine Joint				J	09	03	
78.7			RFJ Roots Fine Joint				J	08	05	
84.0			RFJ Roots Fine Joint				J	09	03	
87.8			MMC Material change							FROM VCP TO PVC
88.5			LU Alignment Up			10				
97.0			MGO General Observation							N.1163090.98/E.49674.62
97.0			AMH Manhole							CO96086
97.0			FH End of Survey
