69th Avenue Water Main Loop
Manatee County, Florida May 19, 2017
Terracon Project No. HC175024

EXPLORATION PLAN	EXHIBIT
	GEOTECHNICAL ENGINEERING REPORT	
ists	69TH AVENUE WATERMAIN LOOP	20
, FL 34240) 379-5061	BRADENTON, MANATEE COUNTY, FLORIDA	20

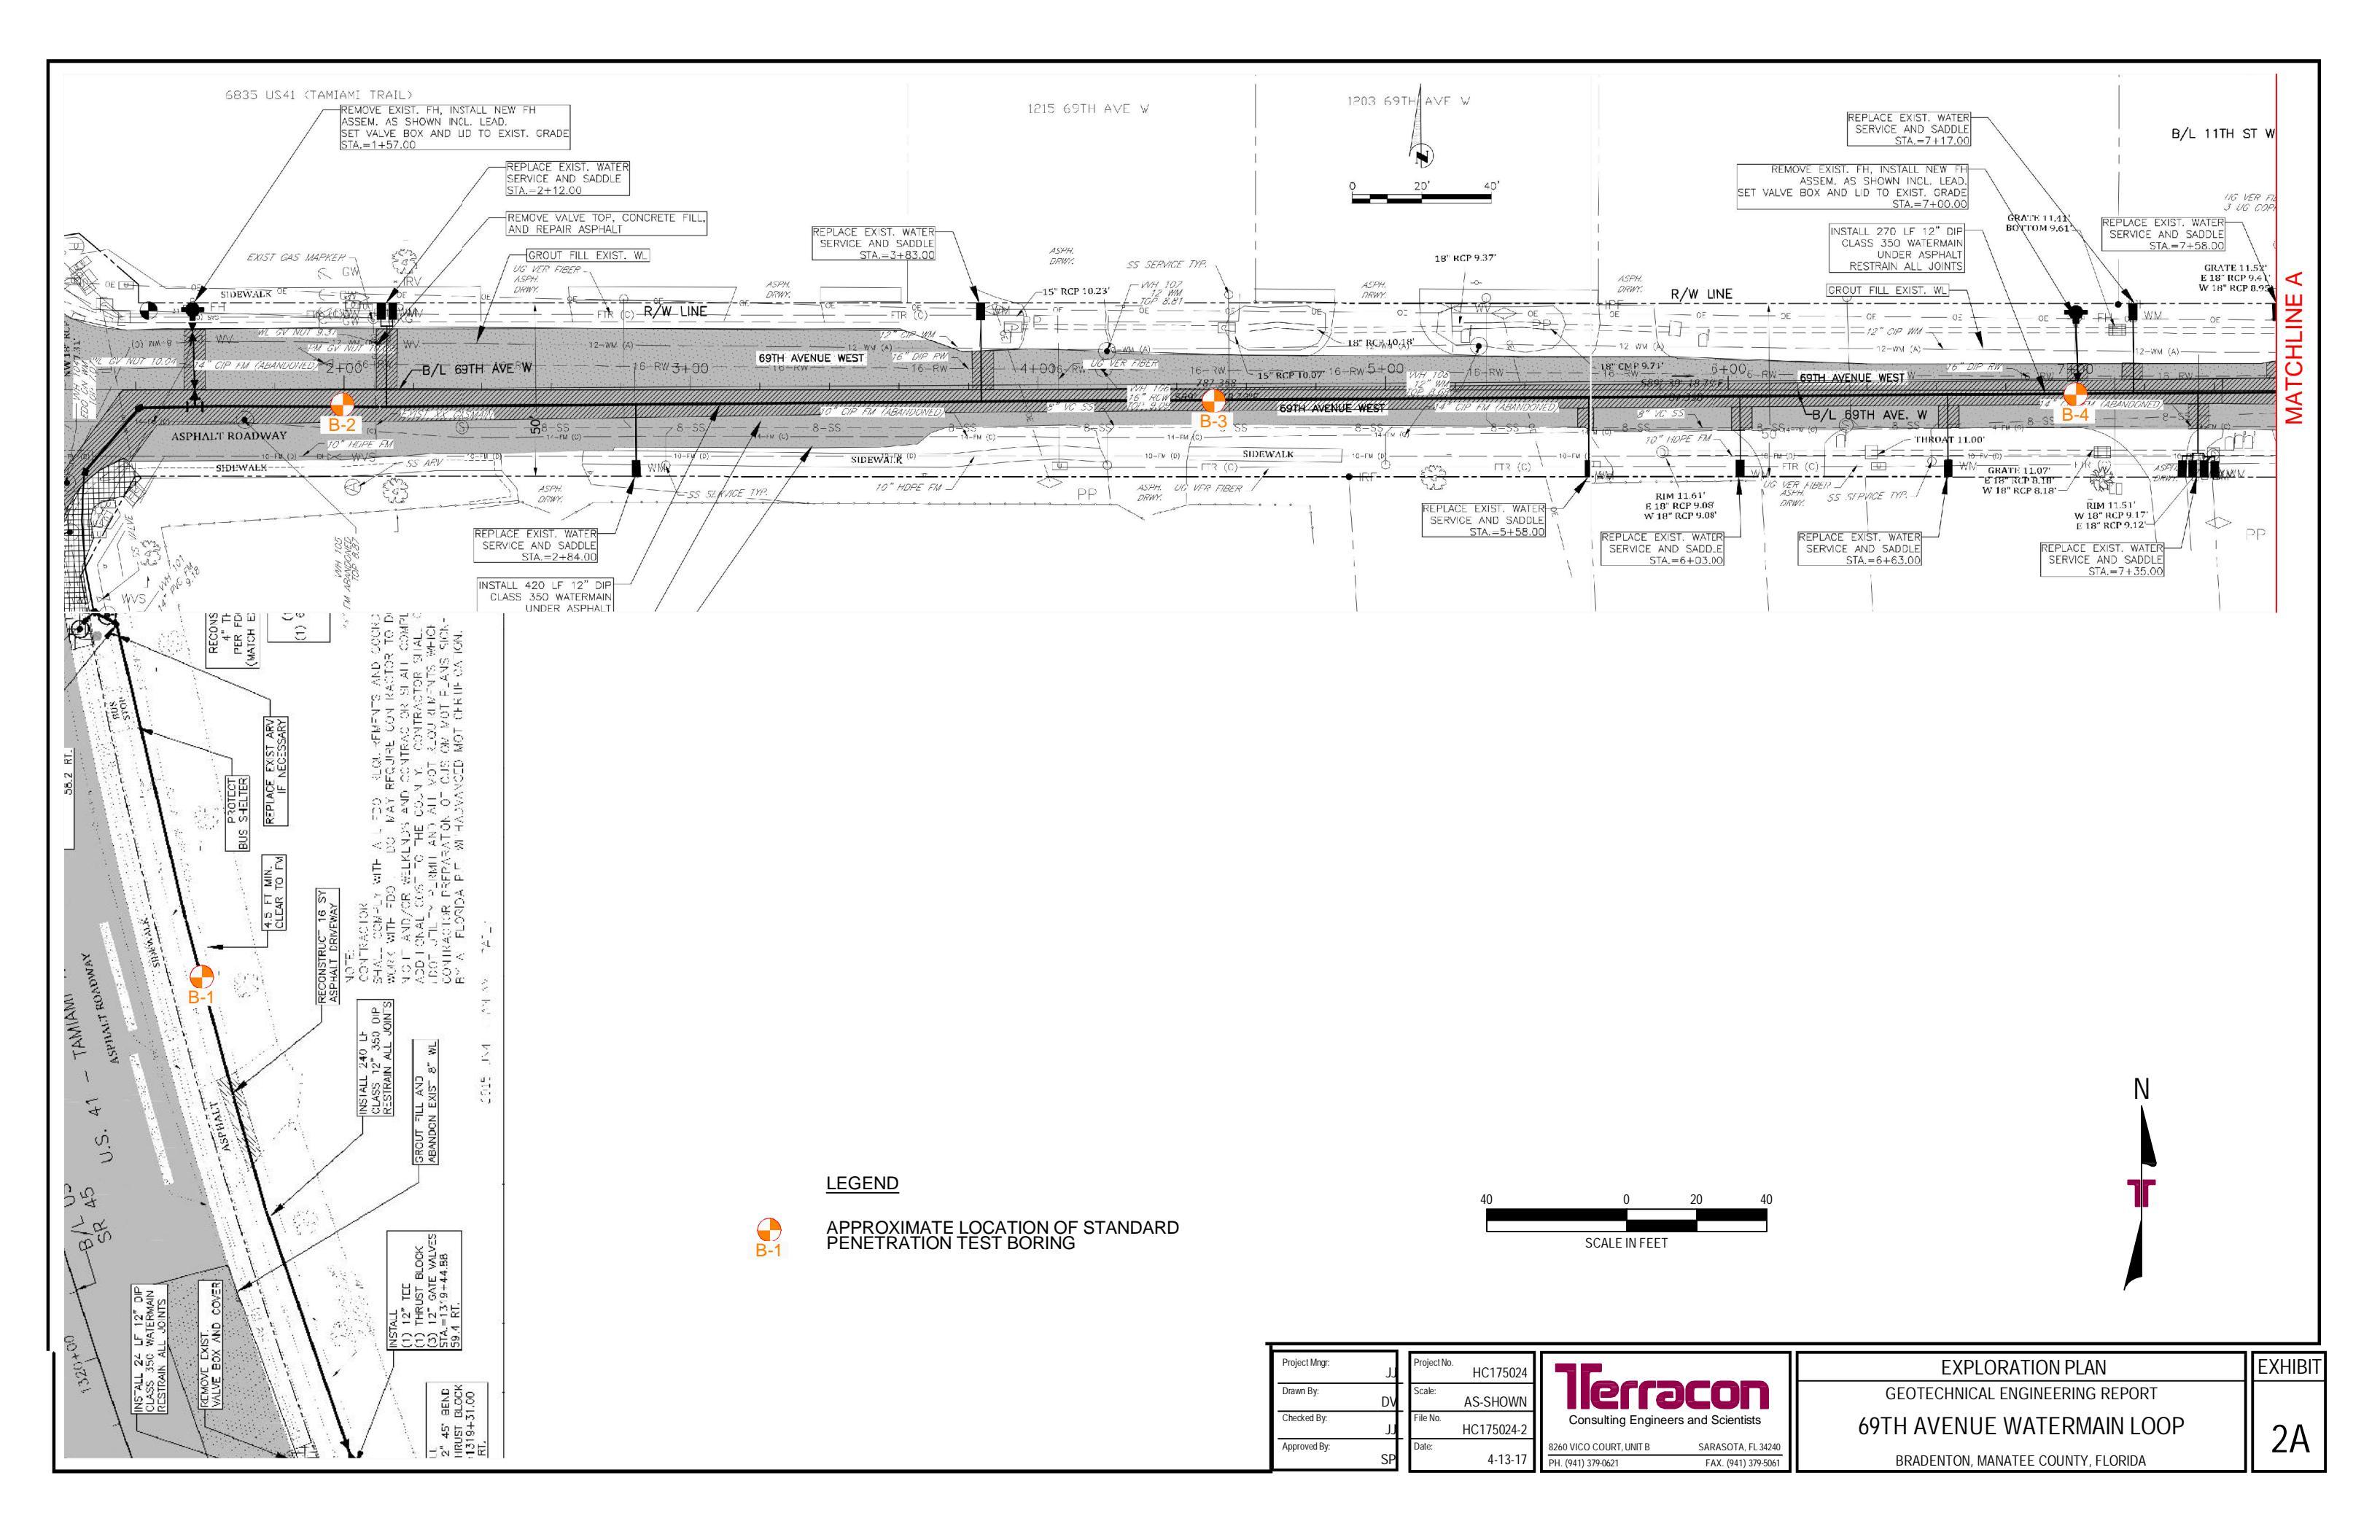
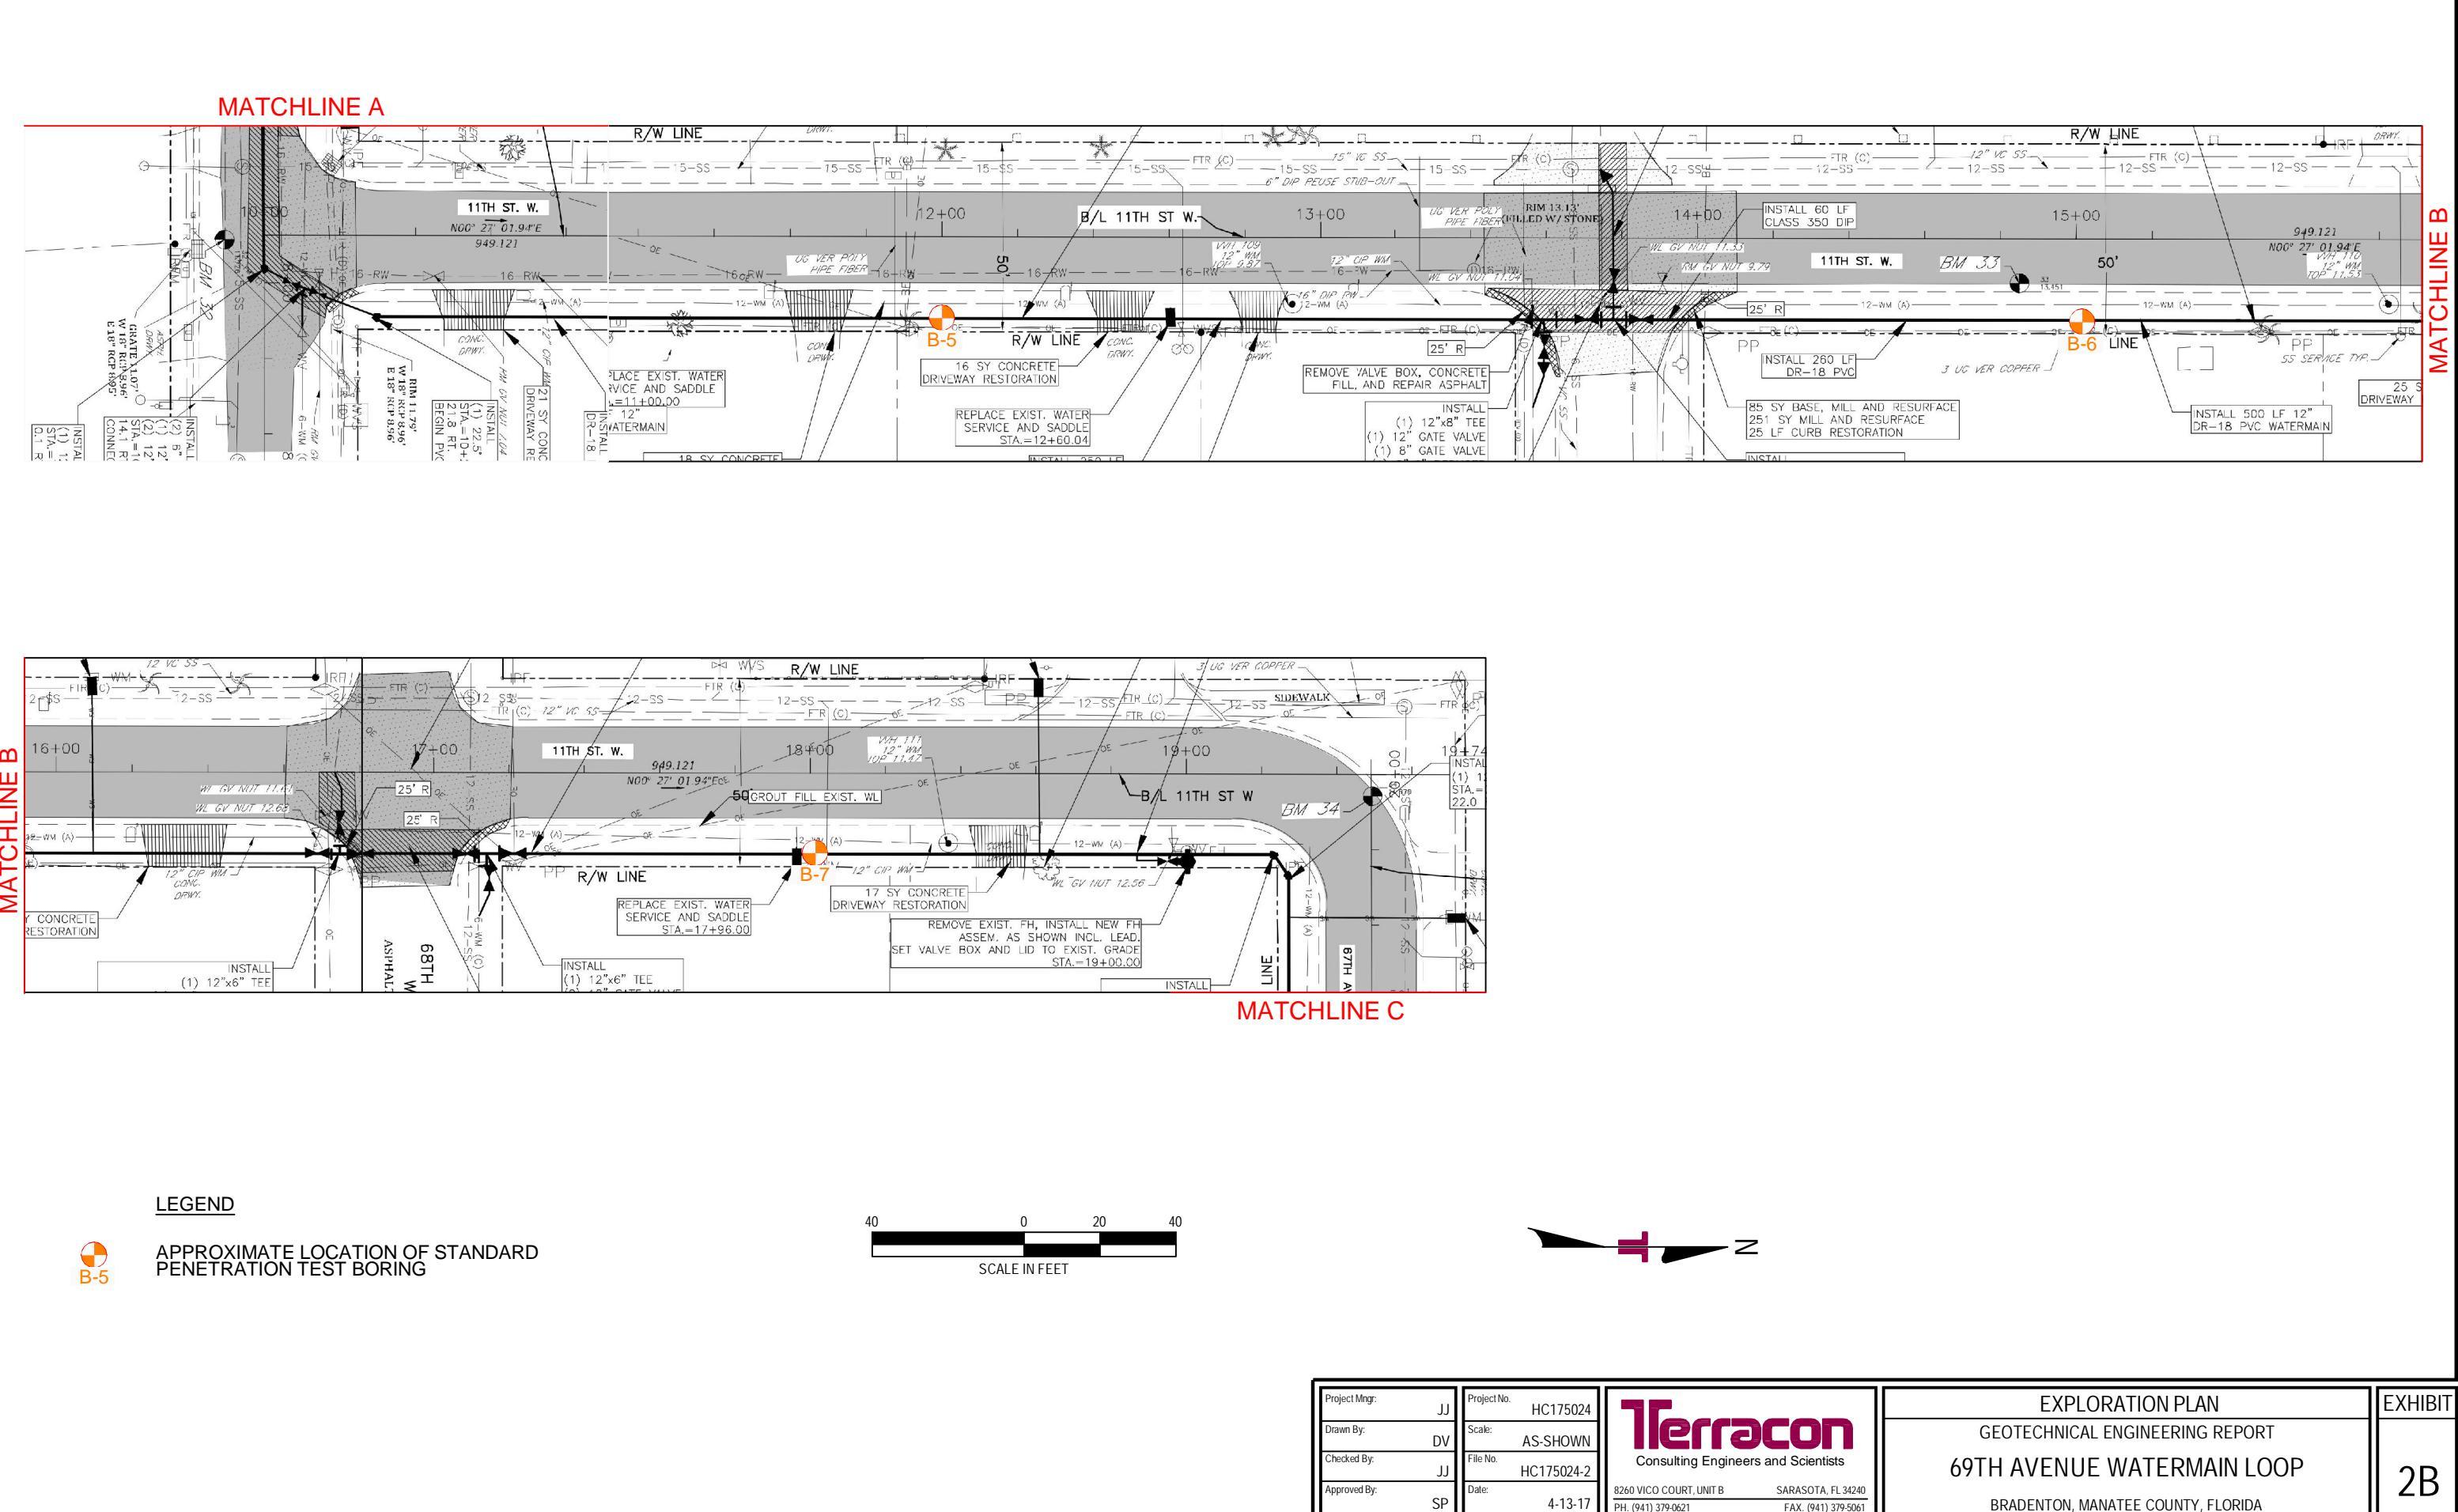
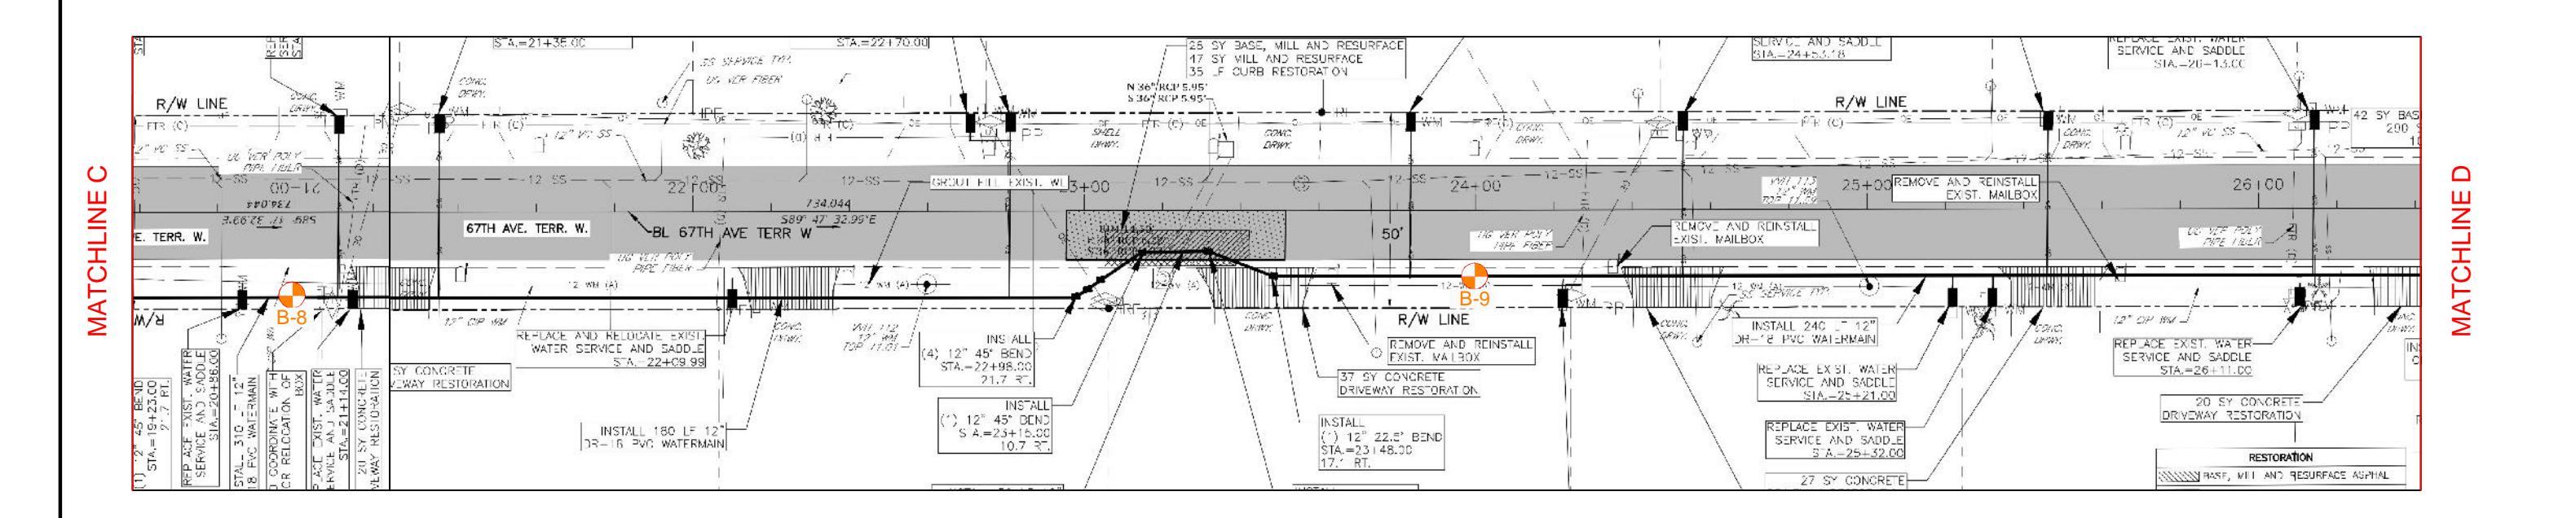
Locations of soil borings are provided on Exhibit 2A through 2G: Anticipated Exploration Plan. The locations were established in the field by Terracon's exploration team using a measuring wheel/tape and/or a hand-held GPS unit with reference to known points. The two 16-foot deep borings will be located in the vicinity of the planned Jack and Bore. The accuracy of the exploration points is usually within 10 feet of the noted location. The ground surface elevations are estimated from the most recent USGS topographic maps, and the accuracy of the ground surface at each point is probably about 2 feet.

APPROXIMATE LOCATION OF STANDARD PENETRATION TEST BORING

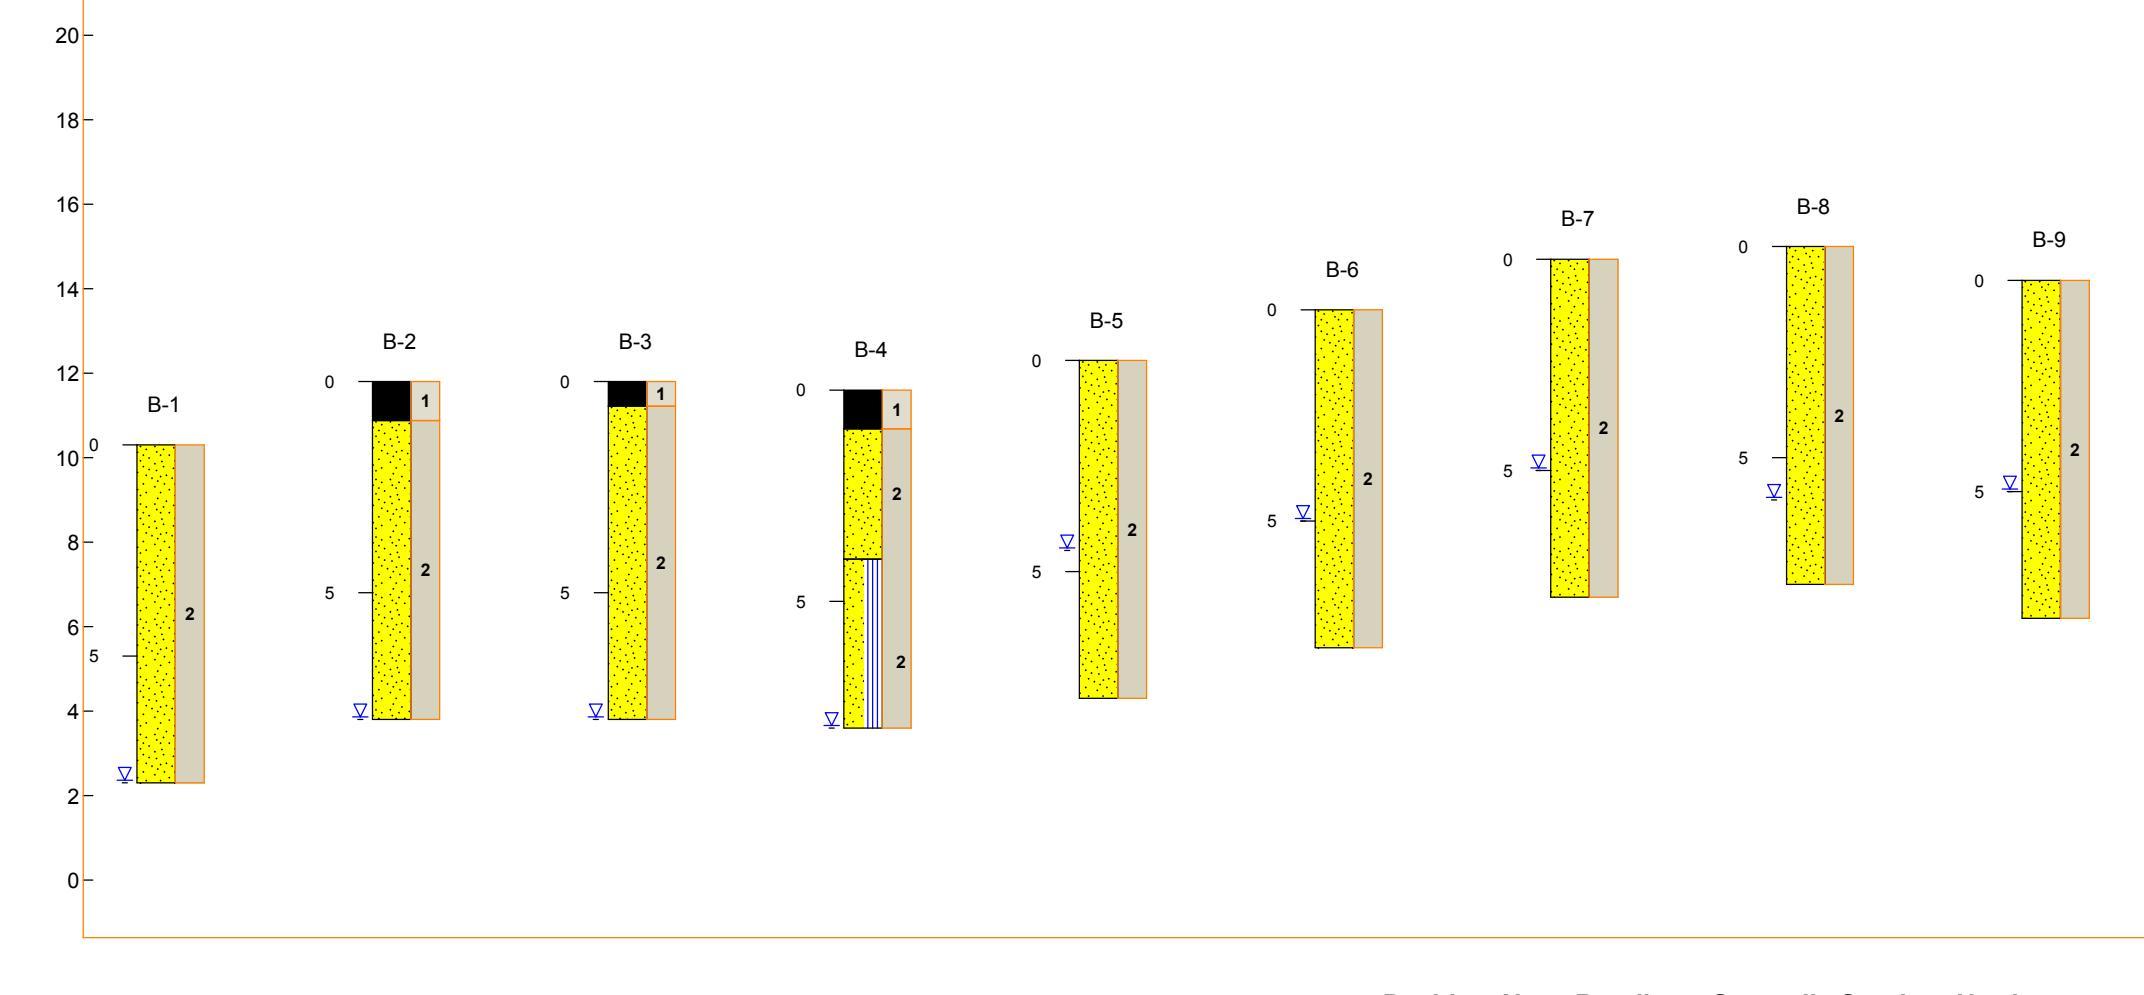
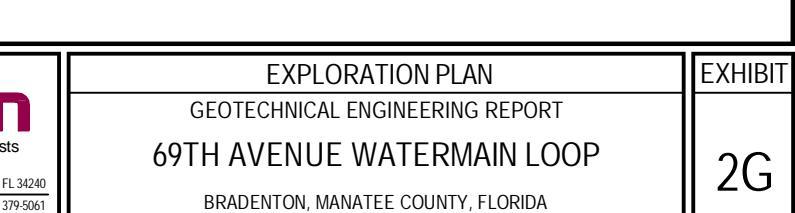
ELEVATION (NAVD) (feet)

Position Along Baseline - Generally South to North

Model Layer	Termed	General Description
1	PAVEMENT	4 to 6 inches of Asphalt 6 to 11 inches of Aggregate Base
2	SP, SP-SM	Fine SAND with trace to slight amounts of silt, trace shell fragments, and occasionally trace to some organic material
3	ORGANIC SAND	Organic SAND, with silt
4	Limestone	Weathered Limestone

NOTES: See boring logs for more detailed conditions specific to each boring. GeoModel provided for illustration purposes only. Actual subsurface conditions between borings will vary.

Layering shown on this figure has been developed by the geotechnical engineer for purposes of characterization of subsurface conditions as required for the subsequent geotechnical engineering for this project.

Stratum	Approximate Depth to Bottom of Stratum	Consistency/Density	
4	4 to 6 inches	Asphalt pavement	Not oppliachte
I	7 to 11 inches	Sand-shell base course	Not applicable
2 ¹	4 feet	Medium dense	
3	4 to 16 feet	Fine SAND with trace to slight amounts of silt, trace shell fragments, and occasionally trace to some organic material (SP, SP- SM)	Very loose to dense
4 ²	16 feet	Weathered LIMESTONE	Very hard

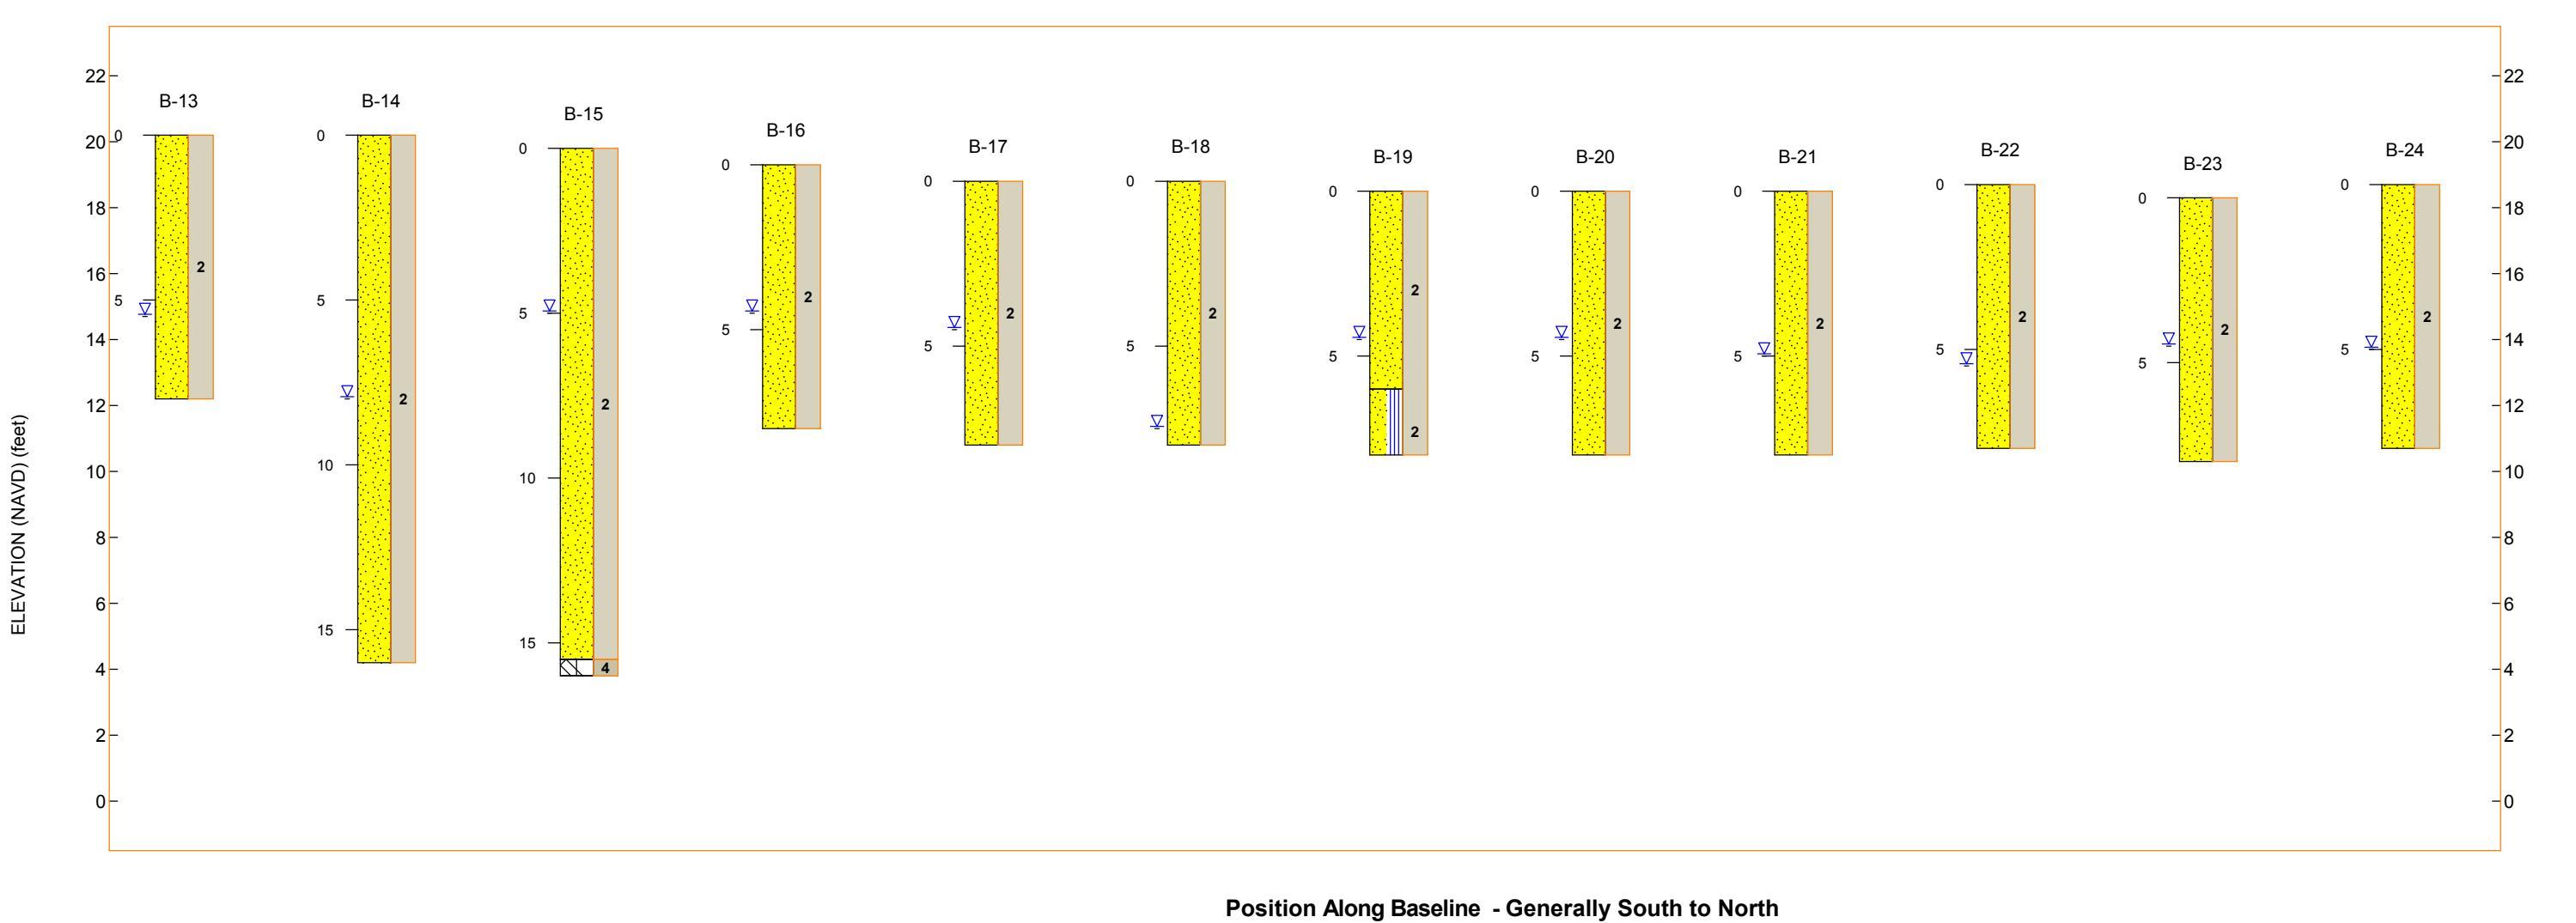
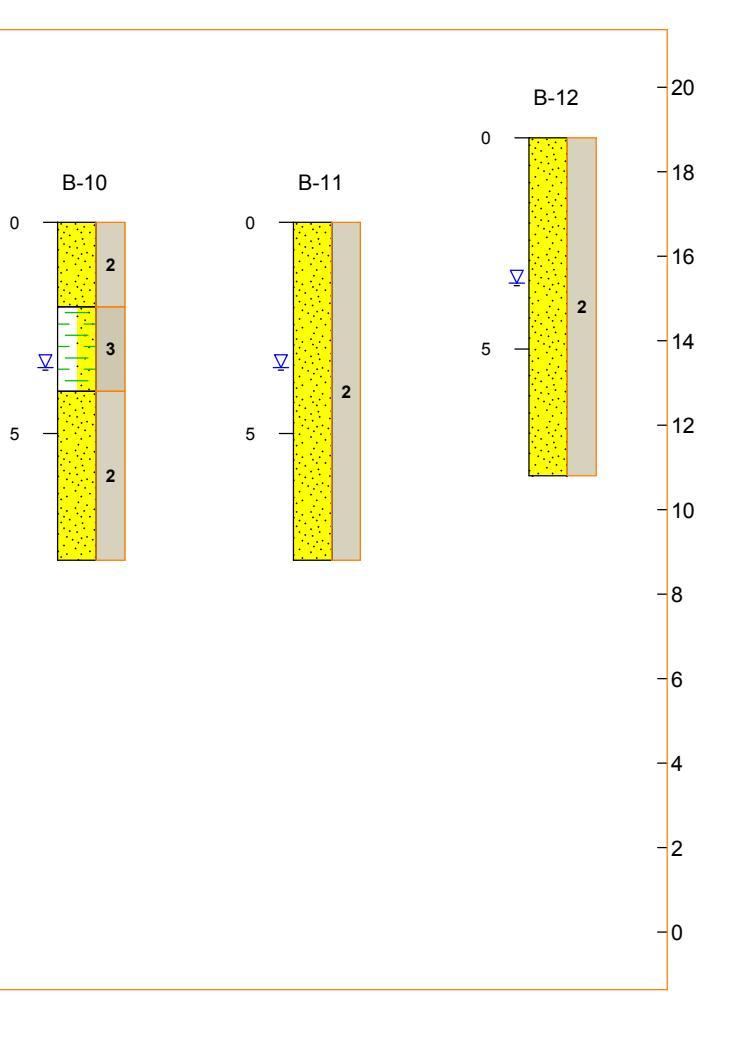
Model Layer	Termed	General Description
1	PAVEMENT	4 to 6 inches of Asphalt 6 to 11 inches of Aggregate Base
2	SP, SP-SM	Fine SAND with trace to slight amounts of silt, trace shell fragments, and occasionally trace to some organic material
3	ORGANIC SAND	Organic SAND, with silt
4	Limestone	Weathered Limestone

NOTES: See boring logs for more detailed conditions specific to each boring. GeoModel provided for illustration purposes only. Actual subsurface conditions between borings will vary.

Layering shown on this figure has been developed by the geotechnical engineer for purposes of characterization of subsurface conditions as required for the subsequent geotechnical engineering for this project.
