PEARCE DRAIN/GAP CREEK WATER QUALITY STUDY TASK #5 FINAL REPORT April 2022

Prepared for: Manatee County
Parks and Natural Resources Department
Environmental Protection Division
1501 Dam Rd.
Bradenton, Florida 34212

Prepared by: Wood Environment & Infrastructure Solutions, Inc.
1101 Channelside Drive, Suite 200
Tampa, Florida 33602

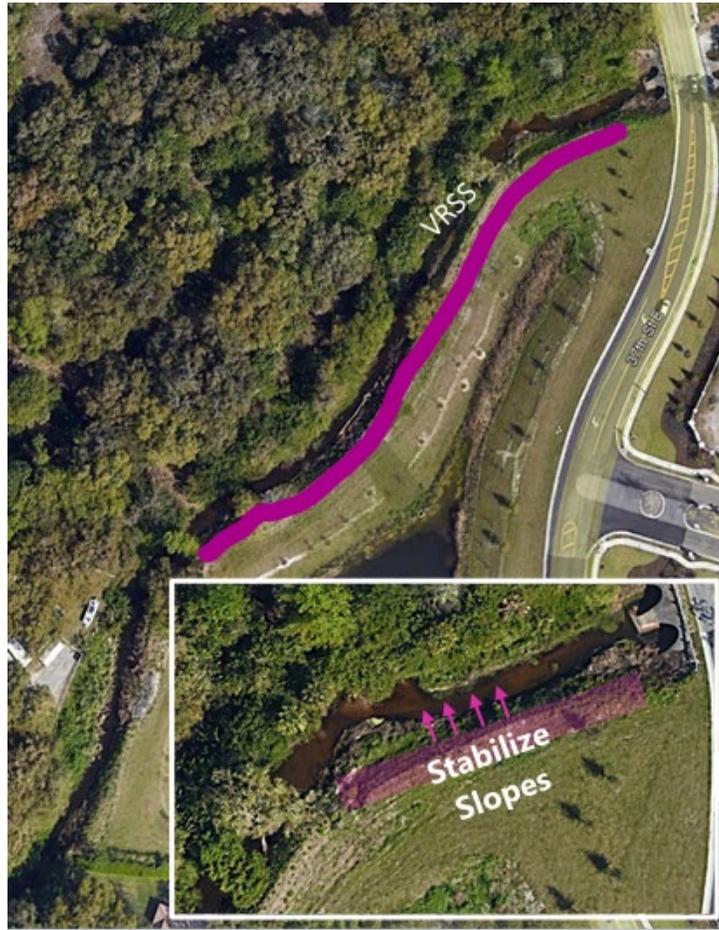
Figure 7.10
PD-5 Stream Enhancement

As discussed in **Section 5.2**, the stream segment near the confluence of Gap Creek and Pearce Drain (adjacent to the Moss Creek subdivision and Wood sample site PD-5) is characterized by unstable and steep banks. The right bank is extremely steep, and the site is a candidate for Vegetated Reinforced Slope Stabilization (VRSS). The site conditions appear to be able to support VRSS and exotic vegetation removal along this segment of Gap Creek (**Figure 7.10**). This type of enhancement stabilizes and treats, which indirectly helps with flooding by reducing downstream sedimentation in addition to providing additional water quality treatment via the vegetated banks. A developer owns the parcels on either side of the creek, however this segment of Gap Creek flows through a County ROW just downstream of the site. Stream enhancement may be possible through a temporary site access agreement rather than complete land acquisition.

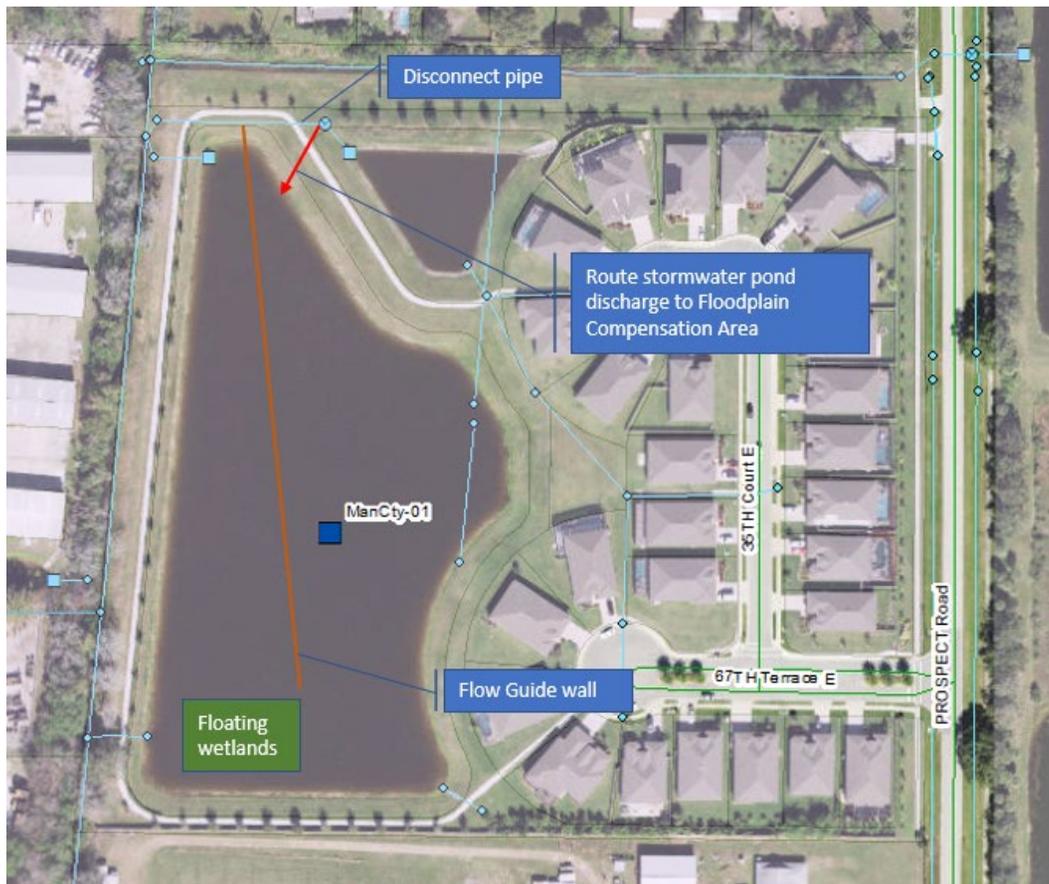
Figure 7.11
Fiddler's Creek Stormwater Improvements

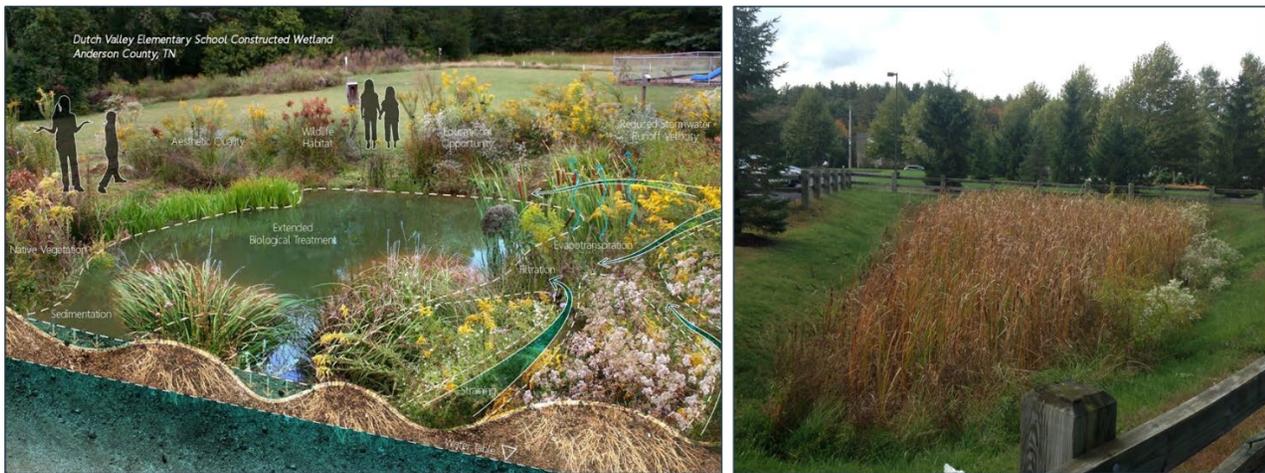
Figure 7.14
Examples of Stormwater Treatment Wetlands

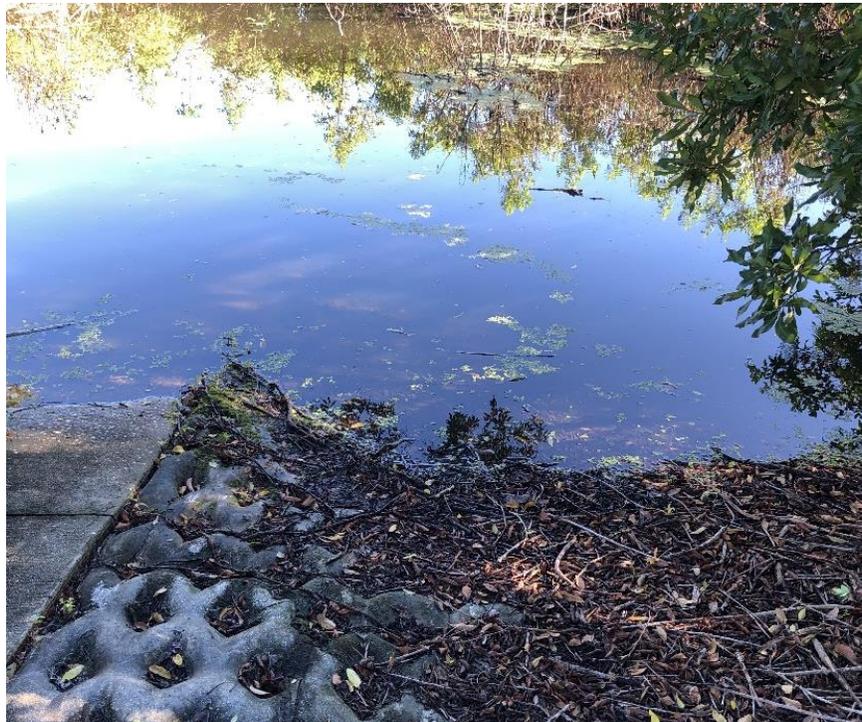
Photograph #5: GC5- Park Pond Paved Spillway

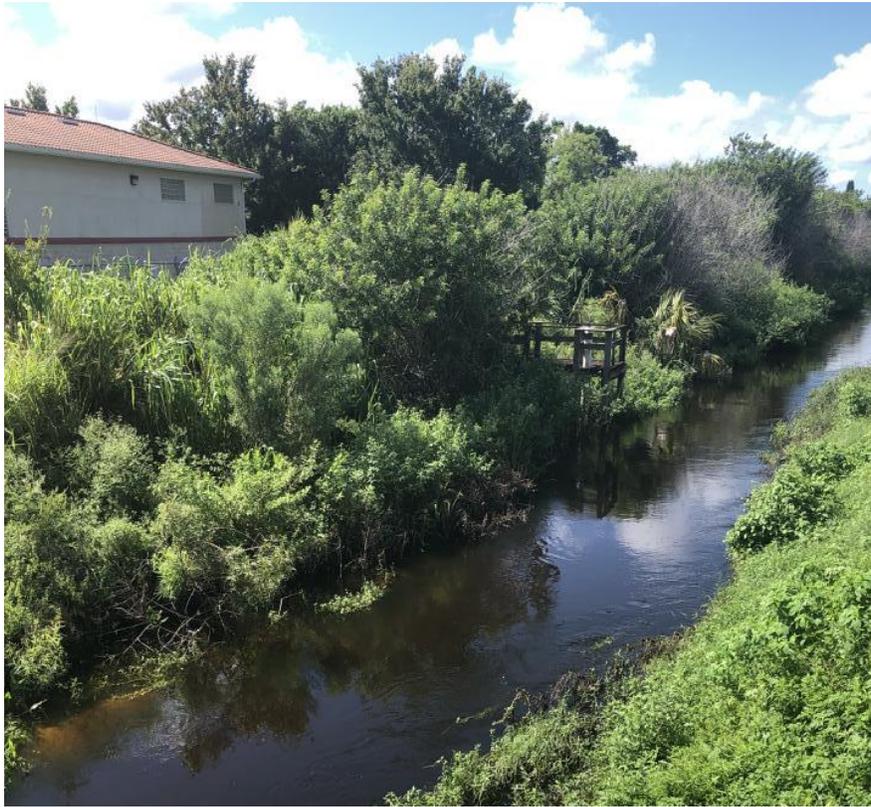
Photograph #6: GC5- Park Pond Erosion Control

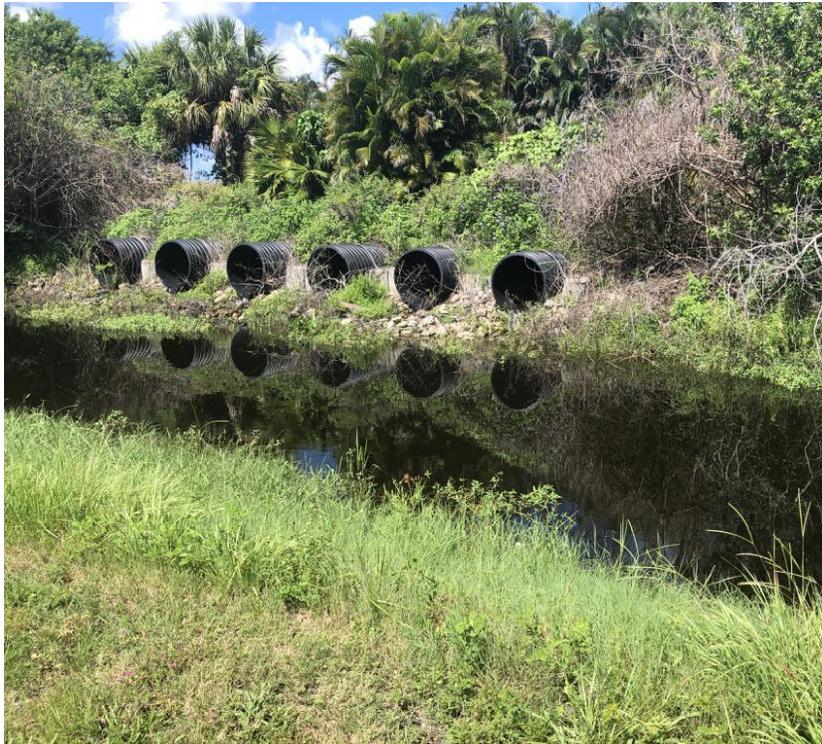
**Photograph #13: PD2- Pearce Drain County Conservation Easement Stormwater Outfall on Left Bank
(downstream of Photo 12)**

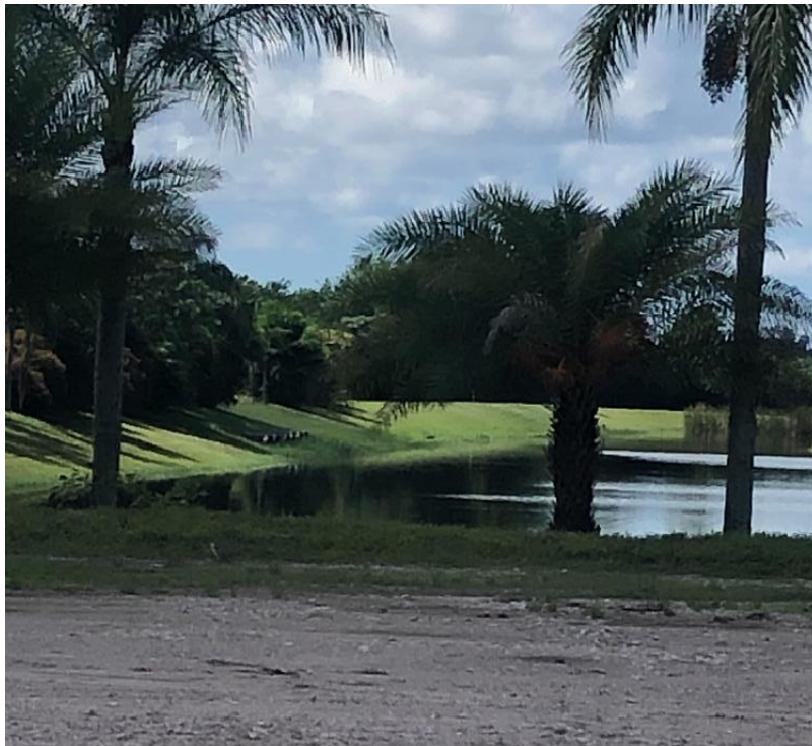
Photograph #14: PD2- Pearce Drain County Conservation Easement Culvert from Tailing Pond on Left Bank (upstream of Photo 10)
